FINAL REPORT  
DEFICIENT 312 STAINLESS STEEL BUTTERING  
ON FLUED HEAD FITTINGS  
FOR PRIMARY CONTAINMENT PENETRATIONS  
AT  
LIMERICK GENERATING STATION  
UNITS 1 AND 2

PHILADELPHIA ELECTRIC COMPANY

NOVEMBER, 1978

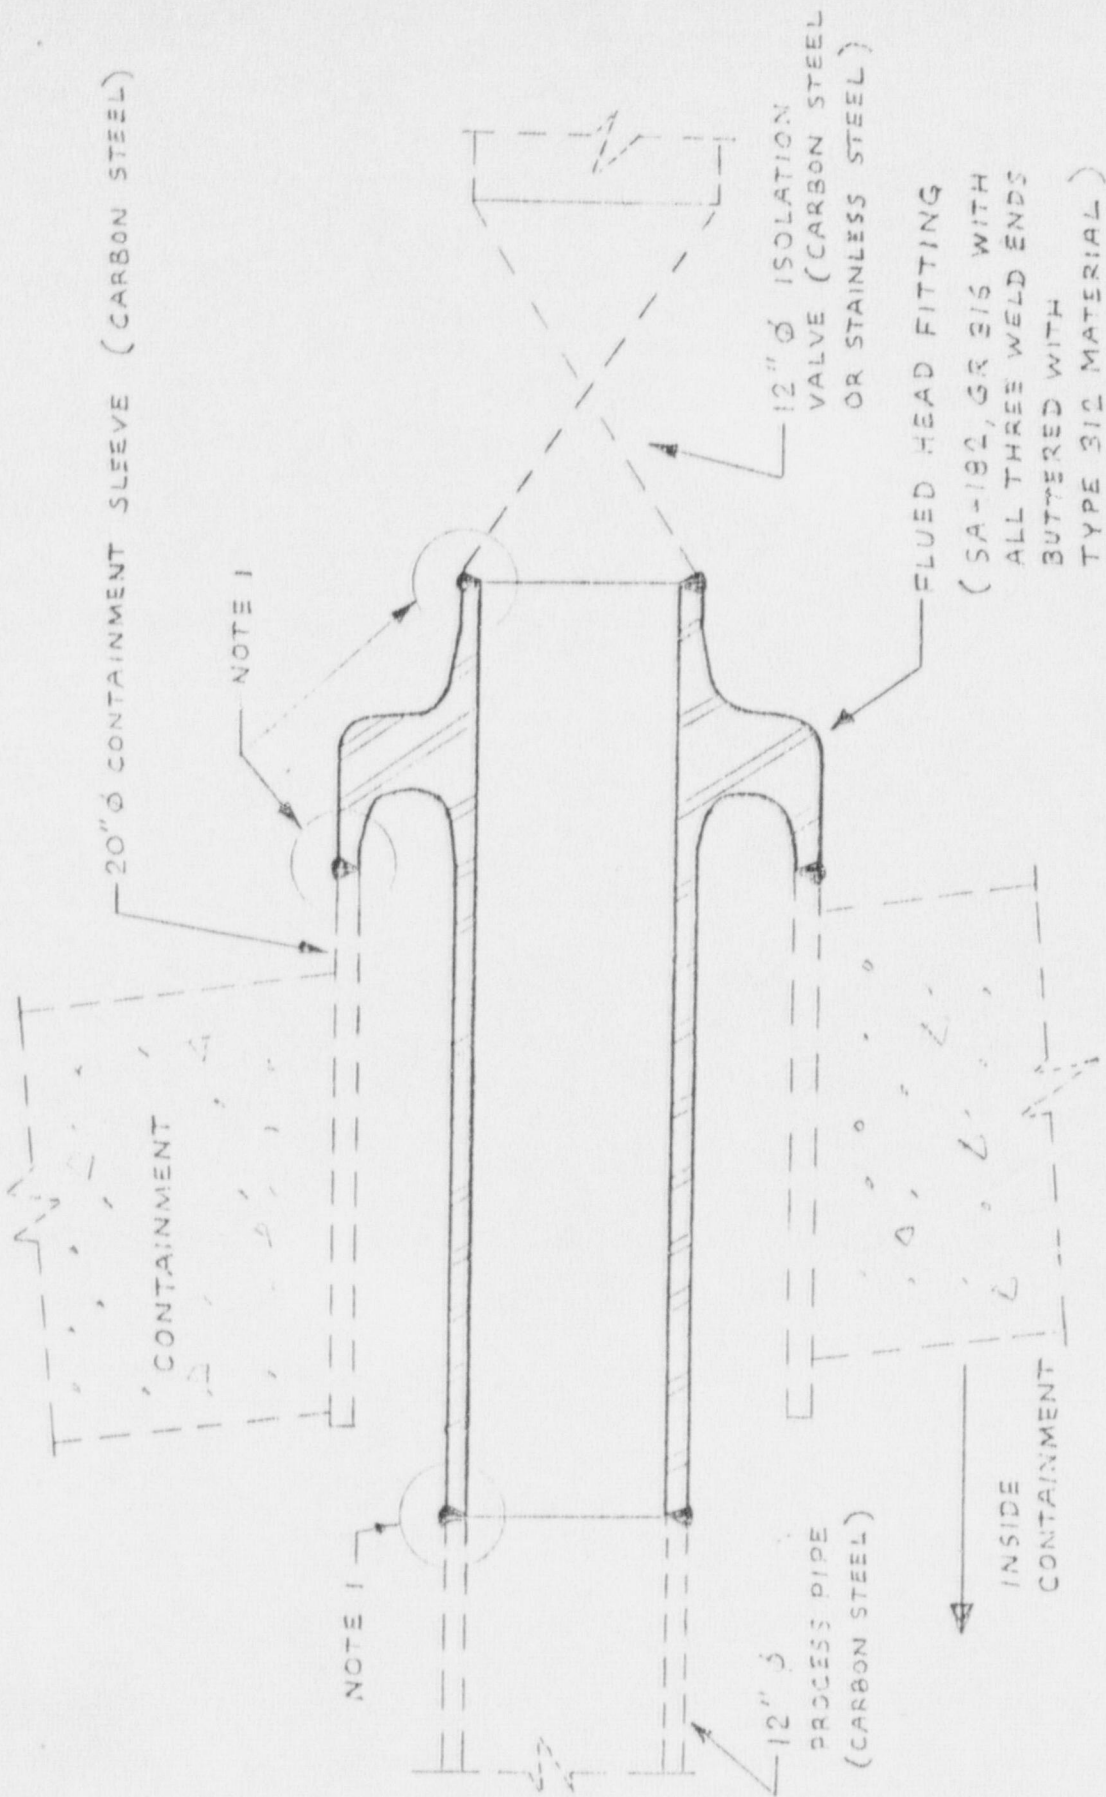
FIGURE 1

TYPICAL FLUED HEAD FITTING DETAIL FOR CORE SPRAY AND LPCI

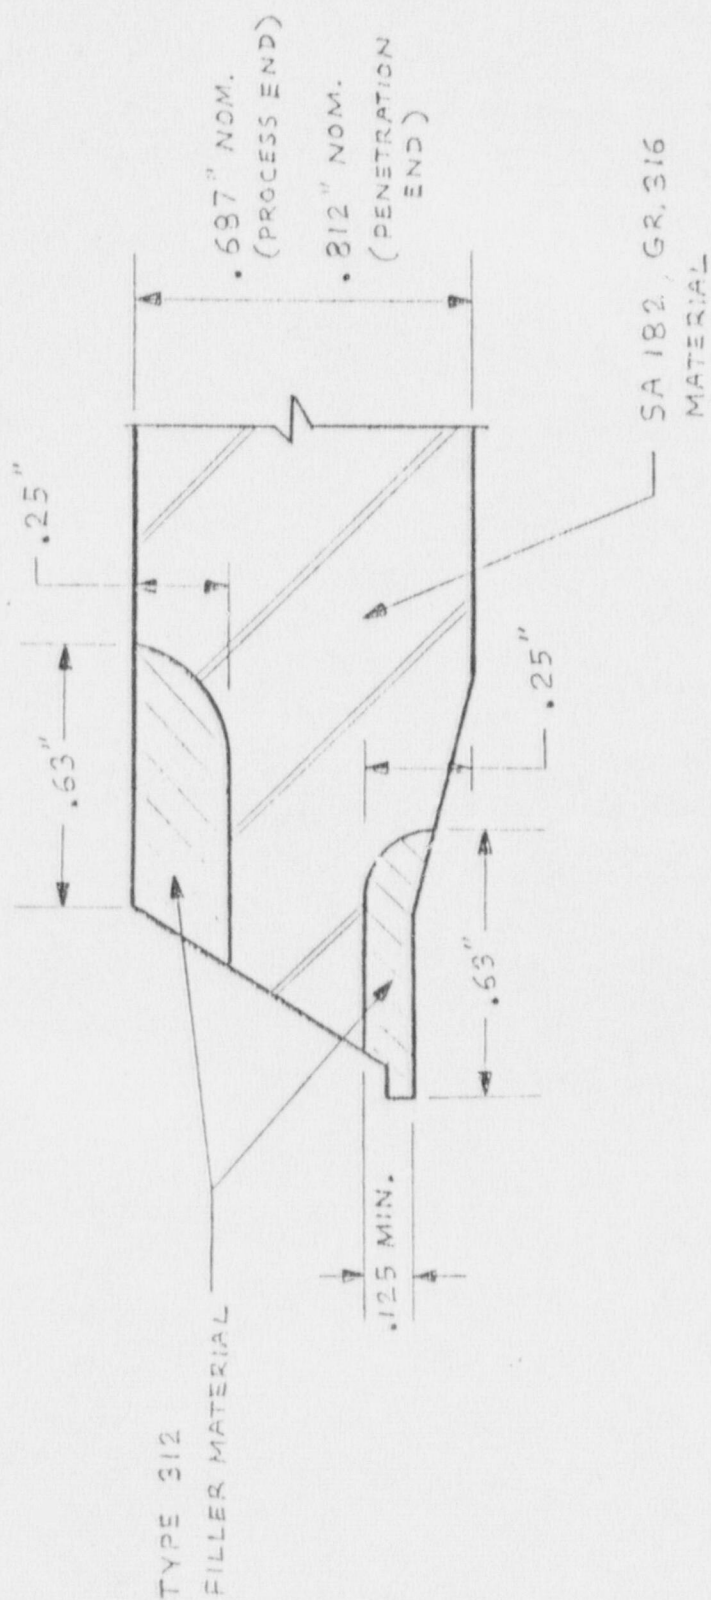
FIGURE 2

- 2.2.2.1 Circumferential linear indications are present in all twelve fittings.
  - 2.2.2.2 While indications are primarily on the OD buttered surfaces, linear indications are also present on the ID buttered surfaces.

- 2.2.2.3 The indications are short (less than 3/4 inch), numerous, and in some cases appear around 360° of the weld end preparations.
  - 2.2.2.4 The indications are cracks. The crack width is less at the surface. The largest crack found to date is approximately 3/16" deep and 5/8" long.

- 2.2.2.5 Subsurface cracks exist in the 312 material.
  - 2.2.2.6 No defects in the Gr. 316 base material have been found.

TYPICAL FLUED HEAD FITTING WELD END PREPARATION

- 4.2.1 The two installed flued head fittings will be removed.
- 4.2.2 Because of the quantity of cracks and the presence of subsurface defects it has been determined that successful repair of the 312 material cannot be assured.

- 4.2.3 Based on an analysis of cost and schedule impact one or more of the following alternatives will be taken:
  - 4.2.3.1 Remove the 312 material, re-machine weld end preparations, and use the Grade 316 flued heads in systems where IGSCC is not considered a significant risk.

- 4.2.3.2 Remove the 312 material and rebutter using 309L material for flued head ends which will be welded to carbon steel pipe and 308L material for flued head ends which will be welded to stainless steel pipe. In addition to the requirements for ultrasonic and liquid penetrant examination which were specified for Type 312 buttering, radiographic examination would also be specified.

- 4.2.3.3 Replacement of the flued heads with a material which would not require weld end preparation buttering.
