**Florida  
Power**

CORPORATION  
Crystal River Unit 3  
Docket No. 50-302

Subject: Licensee Event Report (LER) 96-001-02

Personnel Error by Contractor Results in Operation Outside 10 CFR 50 Appendix R Design Basis

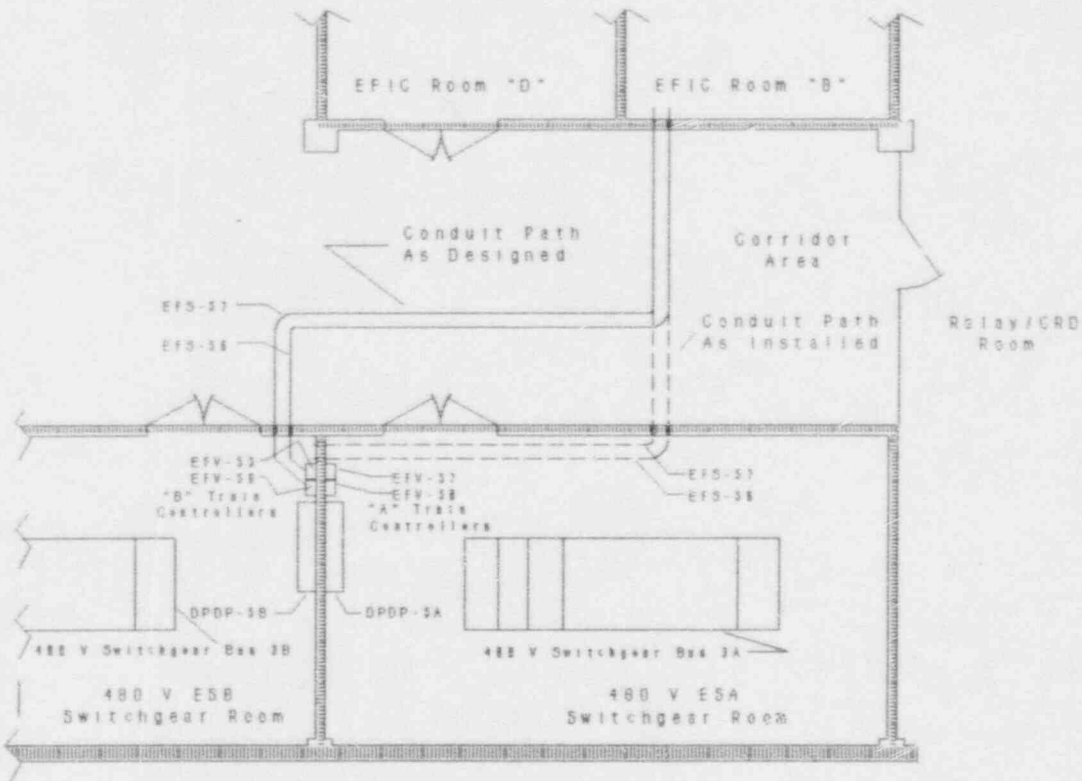
FIGURE 1

On January 10, 1996, Florida Power Corporation's (FPC) Crystal River Unit 3 (CR-3) was in MODE THREE (HOT STANDBY). During a walkdown by personnel involved in developing a modification for upgrading CR-3's Thermo-Lag fire barriers, it was noted that conduits EFS56 and EFS57, which contain "B" Train circuits for Emergency Feedwater System [BA] (EFW) components, were routed through the "A" 480-Volt Engineered Safeguards (ES) Switchgear Room. The portion of the "B" Train conduits in the "A" Switchgear Room were not protected by fire barriers and are within 20 feet of redundant "A" train circuits. See Figure 1.

resistive material called Thermo-Lag 330. As shown on Figure 1, Conduits EFS56 and EFS57, which contain control power and instrumentation circuits for the "B" train EFW flow control valves, were routed with no protection through the "A" 480 Volt Engineered Safeguards (ES) Switchgear Room within 20 horizontal feet of the controllers for the "A" train control valves. The 480V Switchgear Rooms are 3-hour fire areas. Conduits EFS56 and EFS57 were intended to be routed to the "B" 480 Volt ES Switchgear Room through the corridor area from EFIC Room "B". The Corridor area is a 1-hour fire area and the portion of EFS56 and EFS57 in this area is coated with Thermo-Lag. If there was a fire in the "A" 480 ES Switchgear Room in the area of the EFV-57 and EFV-58 controllers and the as-installed conduits EFS56 and EFS57, then flow control or level fill rate of emergency feedwater could be lost.

The primary cause of this event was cognitive personnel error by engineering personnel. Conduits EFS56 and EFS57 were installed in 1985 during Refuel 5 as part of a field change to modification 80-10-66-08A "EFIC Electrical Conduit and Cable Installation". The field change was a multi-discipline (electrical and structural) change initiated by the electrical discipline for the purpose of addressing Appendix R. After the electrical design was completed, structural engineering completed the balance of the design for the conduit installation and approved the change notice. The structural design engineer selected a different route for conduit supports from that depicted on layout sketches provided by electrical engineering. It is surmised that this route was selected to take advantage of existing conduit supports and/or due to interferences present in the route selected by electrical engineering. The structural engineer was apparently not aware of the impact this change had on Appendix R criteria. Further, design verification of the field change did not include a final review by electrical engineering.

1. Drawings which indicate the routing of Conduits EFS56 and EFS57 have been revised to depict the correct routing.
2. FPC conducted a validation of Appendix R drawings using a sample-based approach to compare the as-built configuration against the configuration confirmed by field walkdown. The sample involved a horizontal and vertical validation of all fire barrier protected raceways associated with the Emergency Feedwater system and Fire Areas CC-108-107 and CC-124-116 which are the 4160V 'B' and 480V 'B' Switchgear Rooms, respectively. Although additional discrepancies were identified consisting of tray labeling and color coding problems, small breaks in firewrap, and information missing from drawings, none were representative of design basis issues similar to those described in this report. Based on the results of the validations completed, additional walkdowns were determined to be unnecessary.

3. Circuits contained in Conduit EFS56 were relocated and wrapped with Mecatiss per the commitment described in FPC letter 3F1295-05 to NRC dated December 21, 1995. Circuits contained in Conduit EFS57 were rerouted such that firewrap is no longer required.
