LICENSEE EVENT REPORT (LER)

FACILITY NAME (1) Sequoyah, Unit 2										DOCKET NUMBER (2) 0 5 0 0 0 3 2 8 1 OF 1 0										PAGE (3) 1 OF 1 0																															
Title: Ice Buildup In The Flow Passages Of The Ice Condenser Due To Sublimation Which Could Result In Increased Containment Pressures																																																			
EVENT DATE (5)										LER NUMBER (6)										REPORT DATE (7)										OTHER FACILITIES INVOLVED (8)																					
MONTH			DAY			YEAR				YEAR			SEQUENTIAL NUMBER			REVISION NUMBER			MONTH			DAY			YEAR				FACILITY NAMES										DOCKET NUMBER(S)												
0 1			1 9			8 8				8 8			0 0			3 0			0 1			0 4			0 8			8 8														0 5 0 0 0 0									
0 1			1 9			8 8				8 8			0 0			3 0			0 1			0 4			0 8			8 8														0 5 0 0 0 0									
OPERATING MODE (9) 5										THIS REPORT IS SUBMITTED PURSUANT TO THE REQUIREMENTS OF 10 CFR 5. (Check one or more of the following) (11)

TENNESSEE VALLEY AUTHORITY - SEQUOYAH NUCLEAR PLANT UNIT 2 - DOCKET NO.
50-328 - FACILITY OPERATING LICENSE DPR-79 - REPORTABLE OCCURRENCE REPORT
SQRO-50-328/88003 REVISION 1

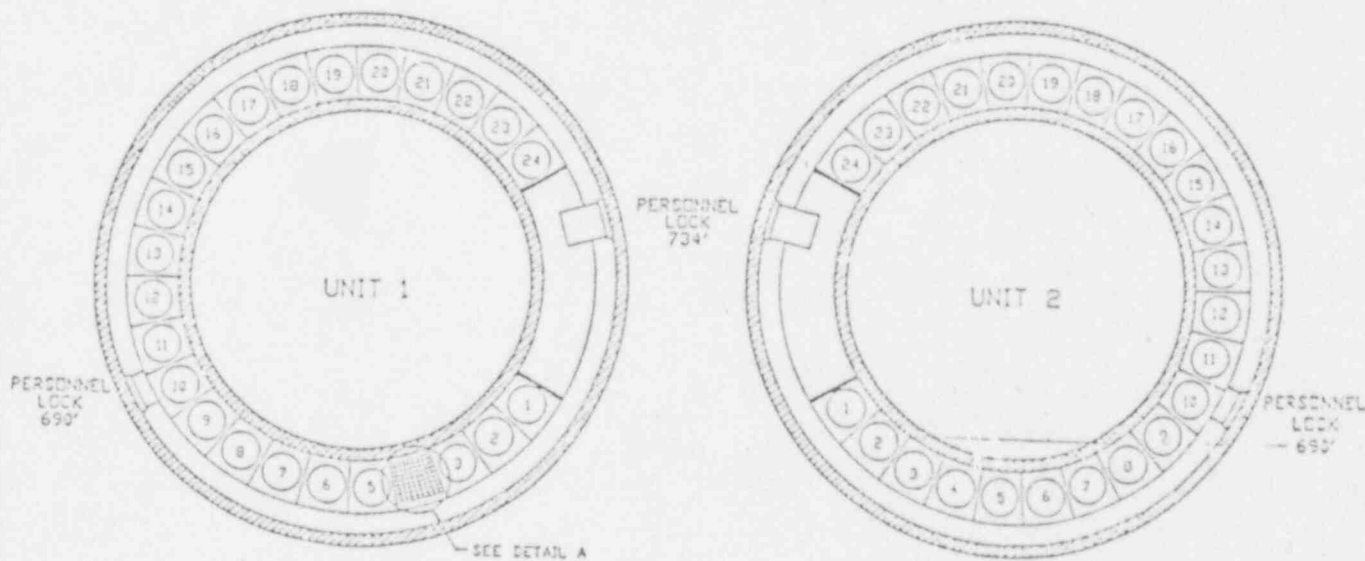
FIGURE 1

ICE CONDENSER NUMBERING OF BAYS

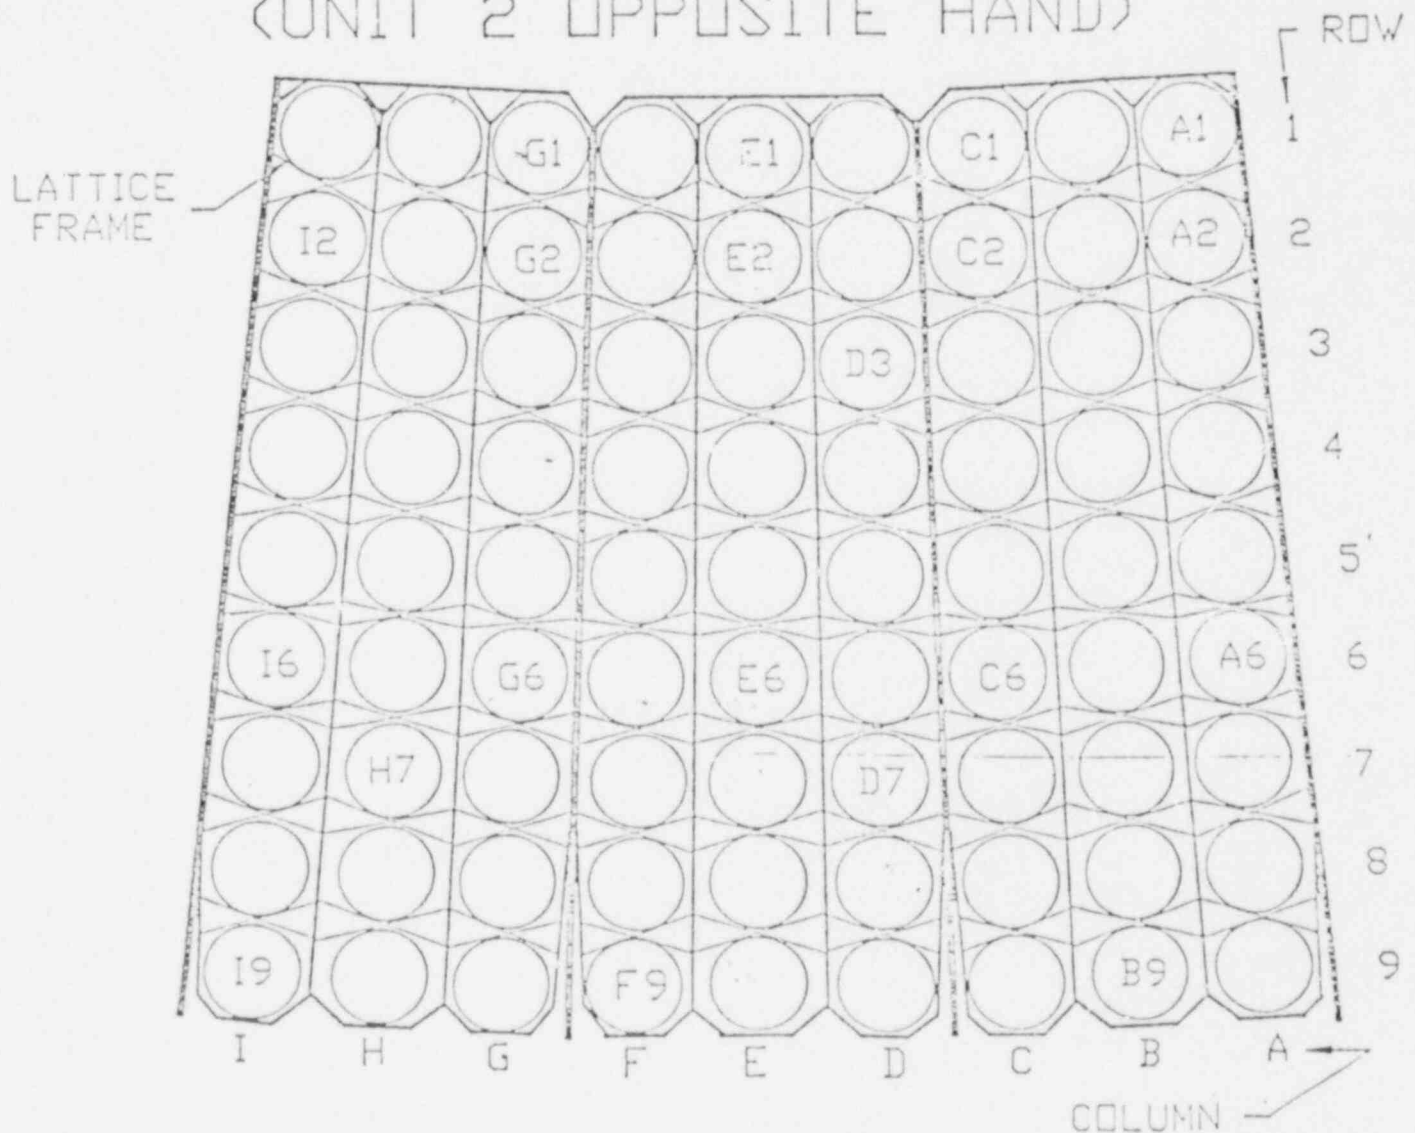
DETAIL A
FIGURE 2

ICE BASKETS NUMBERING SEQUENCE
TYPICAL FOR UNIT 1 ICE CONDENSER
(UNIT 2 OPPOSITE HAND)

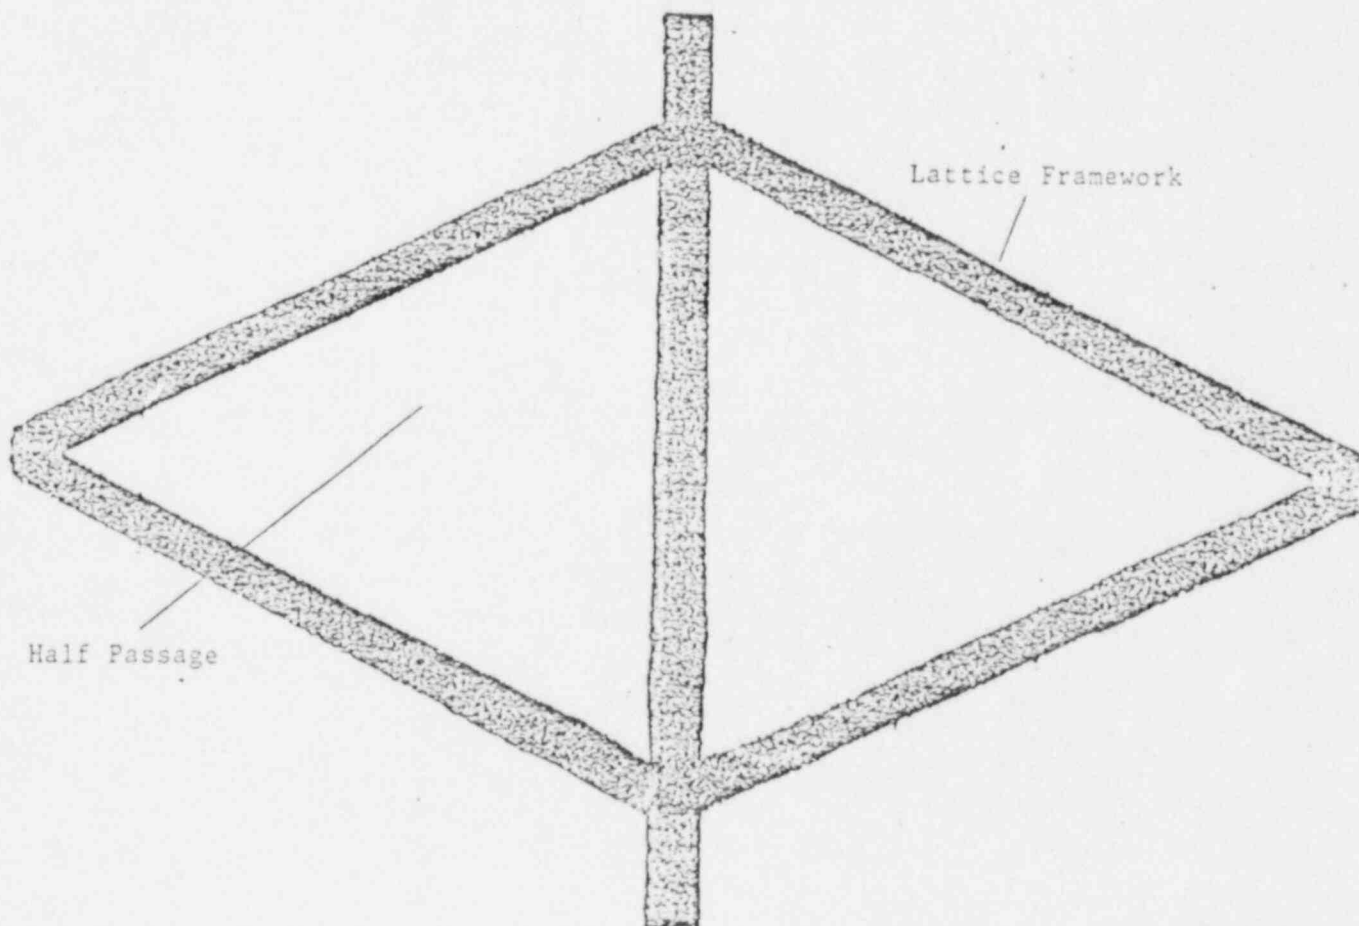
FIGURE 3

At this time, manual chipping and scraping of the ice in the flow passages was started. Parallel to that effort, Westinghouse was contacted to determine the requirements of an operable ice bed. Westinghouse indicated the purpose for maintaining ice/frost free flow passages was to ensure the lower compartments of containment were not overpressurized during the first 100 seconds of a large break loss of coolant accident (LOCA). Westinghouse also indicated that a computer analysis of the Sequoyah Nuclear Plant (SQN) ice condenser had been run with 15 percent total flow passage blockage. This analysis concluded the pressure from this condition would be within the design limits of containment. Thus, Westinghouse and TVA decided that the ice condenser had evidence of abnormal degradation but was not inoperable. An operable ice condenser consisted of an ice bed with less than 15 percent total flow passage blockage, where a flow passage is as shown in Figure 3.

ICE CONDENSER FLOW PASSAGE
(AREA INSIDE TRIANGLE)
