Seabrook Station  
Emergency Diesel Generator Exhaust Inspection

ENCLOSURE TO NYN-97068

# ULTRASONIC THICKNESS EXAMINATION REPORT

LOCATION DF-4355 Elbow SYSTEM DF WORK REQUEST 96W 000 966

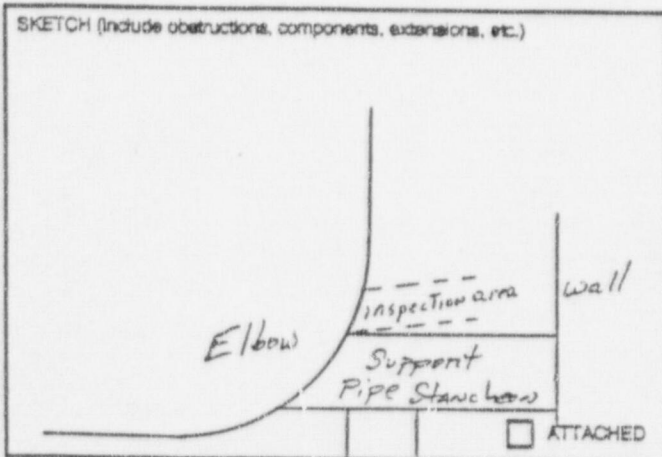
UT exam of outside of elbow from support upper weld to 3 (2") grids above.

N	M	L	K	J	I	H	G	F	
590	603	599	598	799	615	614	623	628	1
588	590	588	590	752	614	609	615	610	2
607	588	600	X	X	X	622	615	612	3
580							604	607	4

N	M	L	K	J	I	H	G	F	
X	40	43	57	42	35	40	23	21	1
X	51	53	55	93	41	46	30	36	2
34	51	41	X	X	X	27	33	33	3
60							42	40	4
PORT

In N4 at the support weld, the reading was .565 which is a difference of 75 mils from the baseline.  
 Remainder of inspection (rows 5-21) unable to be performed due to welded support interference.  
 Original exam performed on the ID of elbow.

The "A" Train DG exhaust elbow is acceptable for continued operation. This conclusion is based on the following rationale:

- The maximum wall loss at location J2 is 0.093" (0.845" to 0.752"). The existing pipe stress analysis, which is documented in Calculation MCD 600.10 considers the elbow at 0.375" thick. Maximum stress levels in the elbow based on 0.375" thickness are 713 psi (Deadweight), 712 psi (OBE) and 1080 psi (SSE). The allowable stress for the elbow material is 17500 psi. Minimum safety factor for ASME Equation (9) based on the elbow being 0.375" is  $(1.2 \cdot 17500) / (713 + 712) = 14.7$ .

To monitor any further wall loss, a second inspection shall be performed by the end of ORO 6 for evaluation.
