IMPROVING MOTOR RELIABILITY IN NUCLEAR POWER PLANTS

VOLUME 3: FAILURE ANALYSIS AND DIAGNOSTIC TESTS ON A NATURALLY AGED LARGE ELECTRIC MOTOR

November 1987

ENGINEERING TECHNOLOGY DIVISION
DEPARTMENT OF NUCLEAR ENERGY, BROOKHAVEN NATIONAL LABORATORY
UPTON, LONG ISLAND, NEW YORK, 11973

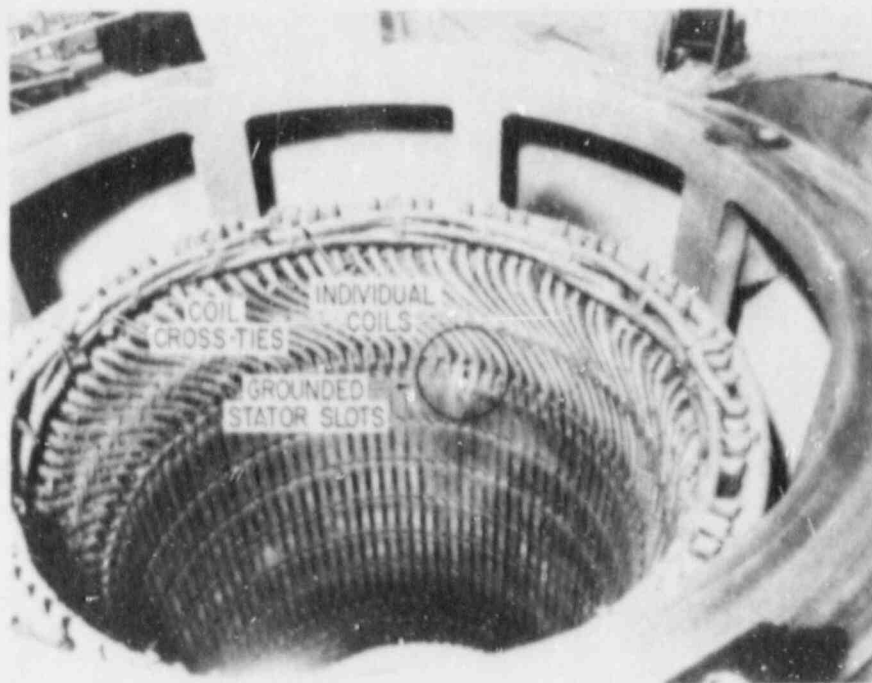
Prior to performing this study, it was not clear whether the motor failed first due to a turn to ground short, creating a current surge which failed the transformer cable, or the transformer cable failed first, resulting in an overload on the two phases in the motor winding which subsequently failed, or both motor and transformer failed simultaneously. However, the motor had been in service at this facility for over 20 years with minimal maintenance activities and without any appreciable problems. Figure 1.1 shows the failed motor stator winding and the burned out area.

Figure 1.1 - Failed HFBR 400 hp motor stator.

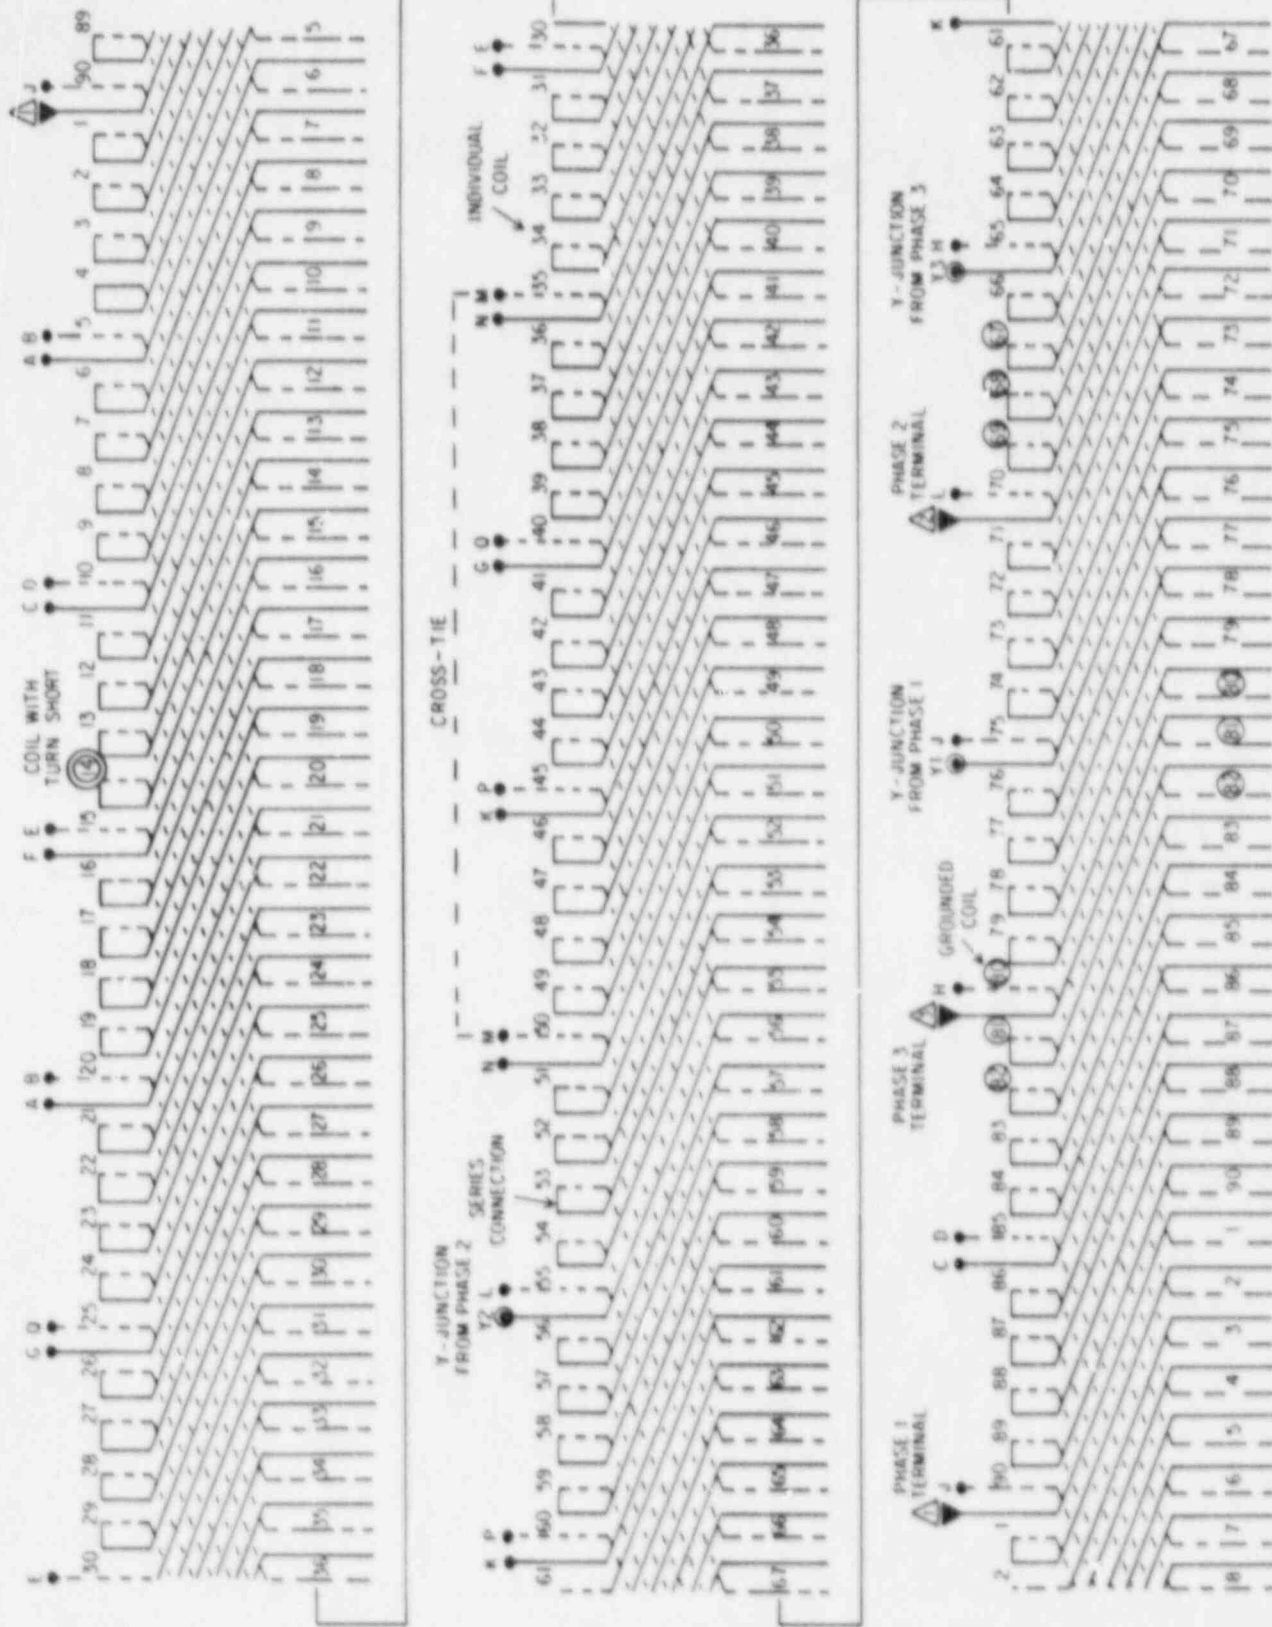
Figure 2.2 - Coil placement and failed coil locations.

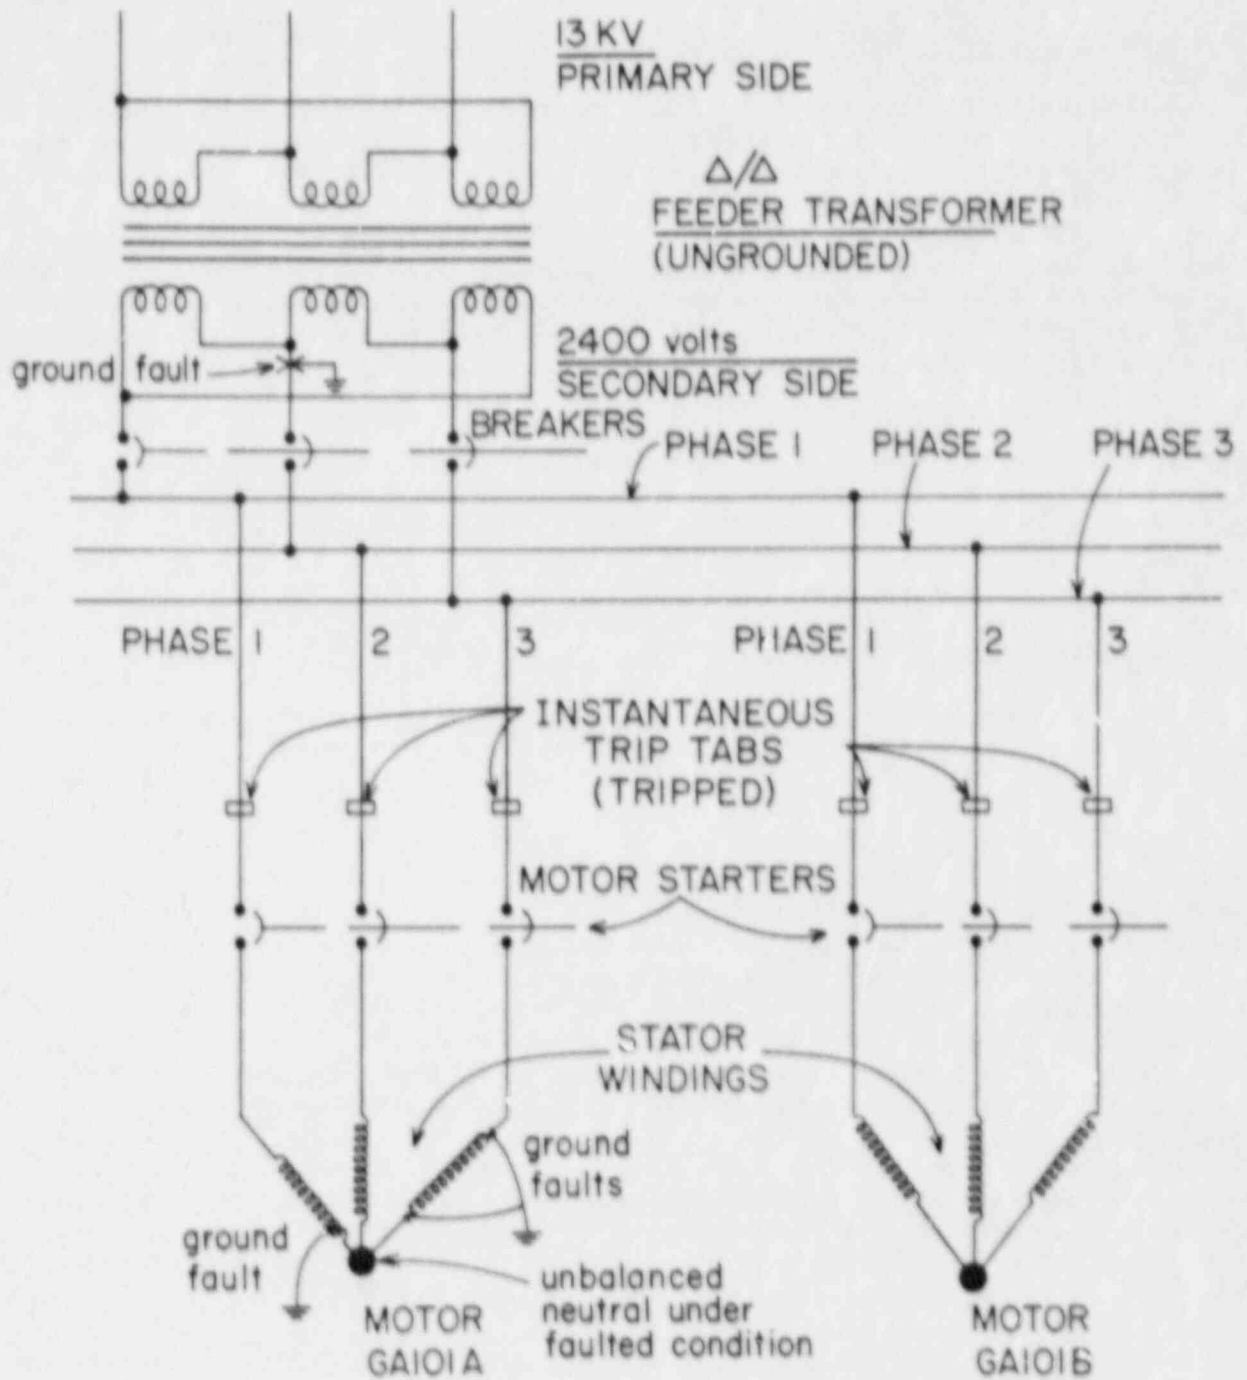
Figure 3.1 shows a schematic of the circuit between the feeder transformer and the two recirculating pump motors. The 2,400 v .t side of the Δ/Δ transformer and the two Y connected motors are ungrounded. Each phase from the transformer secondary consists of two cables in parallel to provide the required current carrying capacity. In such an arrangement, each phase line current is shared by the two cables. As indicated earlier, one of the two cables from the phase 2 of the transformer was found to have an open circuit and probably grounded as indicated in Figure 3.1. The post-failure tests also found that the Y-connected stator windings of motor GA101A had grounded coils in phases 1 and 3.

Figure 3.1 - Power supply to RCP motors from feeder transformer.

The above explanations lead to the conclusion that the oil saturated transformer cable grounded first and produced an arcing to ground which in turn failed the motor (mode 3). The following discussions justify this mode of system failure. Before the Phase 2 secondary transformer lead grounded, the voltage to ground on all phases was zero volts for the ungrounded system. Once one of the two cables from the Phase 2 transformer secondary grounded the voltage to ground on that phase remained at zero. This caused the corresponding phase terminal on the motor winding to be at zero potential to ground, whereas the voltage to ground at the motor terminals for phases 1 and 3 was raised to 2400 volts. The increase in potential resulted in overstressing the aged insulation in these two phases which caused them to fail. Usually the insulation between each line to ground is adequate to withstand full line-to-line voltage (i.e., 2,400 volts). However, if this voltage is applied to age-degraded insulation, it can result in failure. Insulation tests performed on the stator windings revealed weak and degraded conditions existed in a number of coils.

Based on the analysis presented, it is believed that the ground fault in the transformer cable was the initiating event leading to motor failure. The cable ground fault caused an over-voltage condition in the motor windings which resulted in failure of the age-degraded winding insulation. Since the same transformer supplies a second identical motor, it could also have experienced an over-voltage condition. The second motor is the same age as the failed motor and the high voltage could have further degraded the winding insulation. It is therefore recommended that replacement of the second motor (GA-1018) be considered in the near future.

To avoid future occurrences of this type of failure, it is additionally recommended that the motor-transformer system design be modified to include a ground. If a system ground cannot be provided, ground fault detectors should be installed.

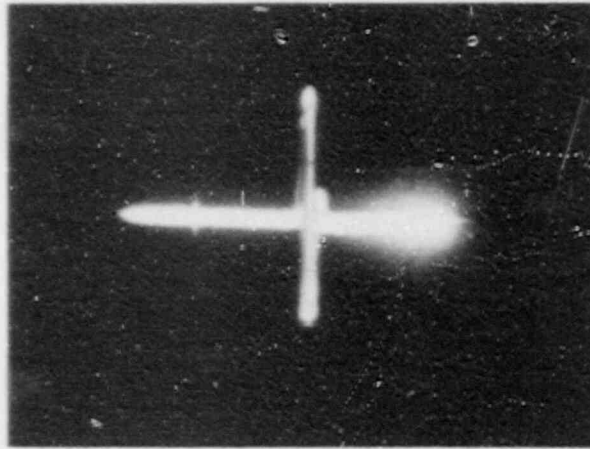
Figure 4.2 illustrates the superposition of standing voltage wave traces on the oscilloscope for four different coils tested. Coils 1 and 46 were first determined to be good coils. These coils were then used as a baseline to compare against other coils for evaluating their condition. Figure 4.2(a) indicates a perfect match between coils 1 and 46. A perfect match indicates that both coils are good since it is extremely unlikely that two coils would degrade to exactly the same degree, which is what would be required to produce the same wave pattern. Therefore, it is concluded that the insulation on

(a) COILS 1 & 46: PERFECT MATCH

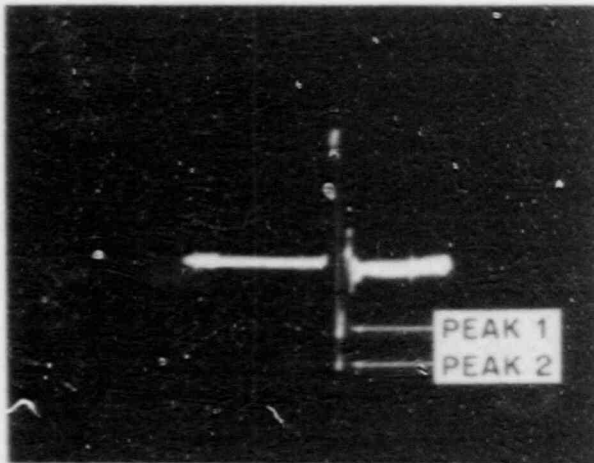
All coils in the motor were surge tested at 2,500 volts after the series connections were cut. This particular test indicated the obviously grounded coils and a turn short in coil 14.

(b) COILS 14 & 1 : SIGNAL MISMATCH (SHORT)

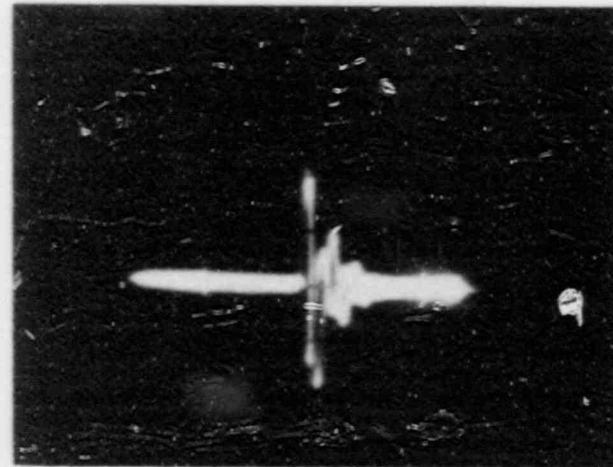
(c) COILS 1 & 67: SIGNAL MISMATCH (GROUND)

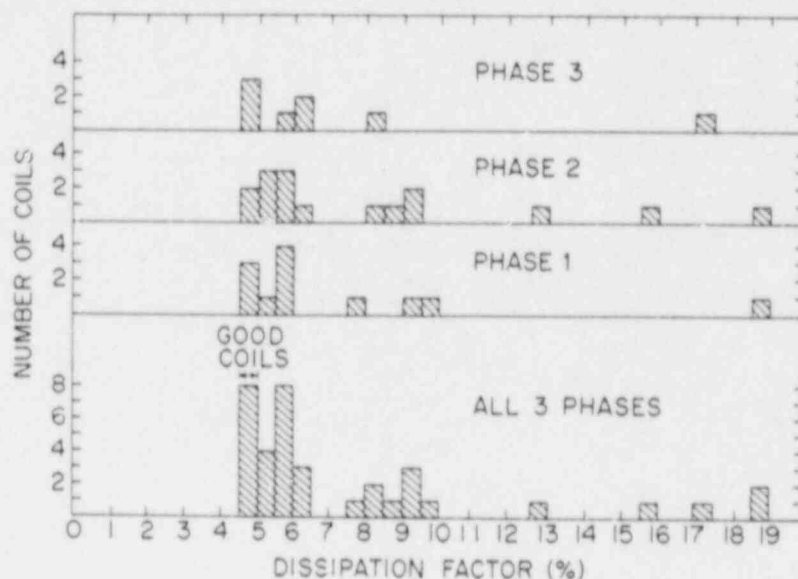
Figure 4.3 shows the distribution of the 36 coils tested at 2000 volts. Eight (8) coils were found to be good coils with dissipation factors less than 5%. Another fifteen (15) coils were found to have a dissipation factor of less than 7% and were considered to be in acceptable condition. The remaining thirteen (13) coils exhibited aging in their insulating materials. These coils (70-79, 84, 87, and 88) are presumed to have developed cracks and voids in their insulation resulting in the higher dissipation factors.

Figure 4.3 - Dissipation factor at 2000 volts.

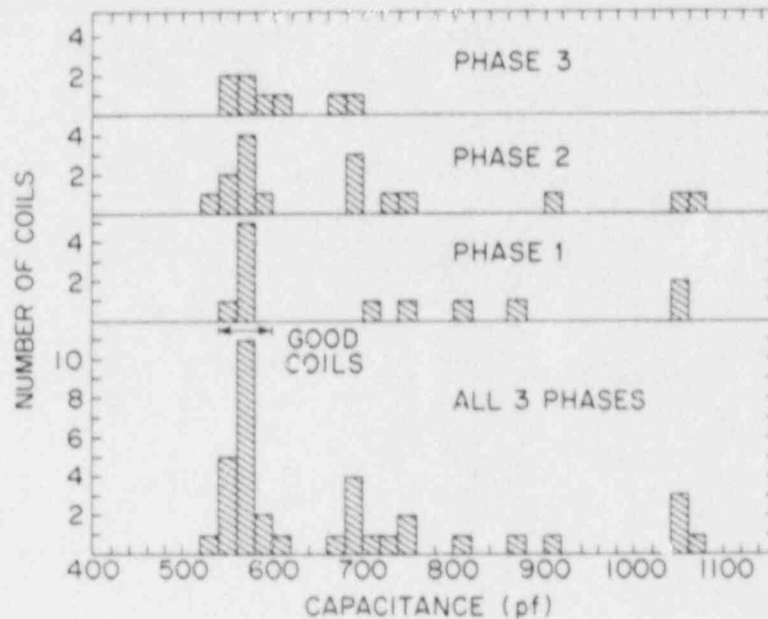
The distribution of capacitance values among the 36 tested coils is shown in Figure 4.4. As shown, twenty (20) of the coils indicated normal values while the remaining sixteen (16) coils exhibited higher capacitance in their insulating materials. From the above discussion, it can be concluded that

these 16 coils have probably experienced thinning in their insulation materials due to their age and environmental conditions. Of the 16 coils with high capacitance, coils 46, 47, 70-79, 84, 87, 88, and 89 are definitely showing signs of insulation thinning.

Figure 4.4 - Capacitance at 2000 volts.

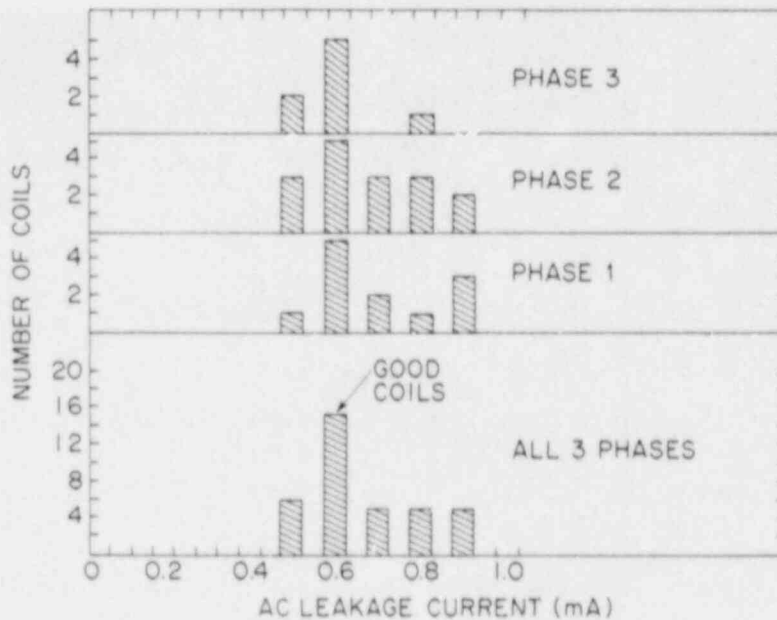
Figure 4.5 shows the distribution of leakage current for the 36 coils tested. As shown, fifteen (15) of the coils indicated a higher leakage current at an impressed voltage of 2,000 volts than the baseline data presented in Table 4.3 (0.6 mA @ 2000 v). Comparing the data from Table 4.1 with Table 4.2, it is seen that all of these coils have also indicated higher dissipation factors and/or capacitance values. This is consistent with expected results since increased dissipation factor or capacitance would indicate the insulation is in a degraded condition. The degraded insulation should show an increased leakage current. The ac leakage current test, therefore, verified the findings of the dissipation factor and capacitance tests.

Figure 4.5 - Ac leakage current at 2000 volts.

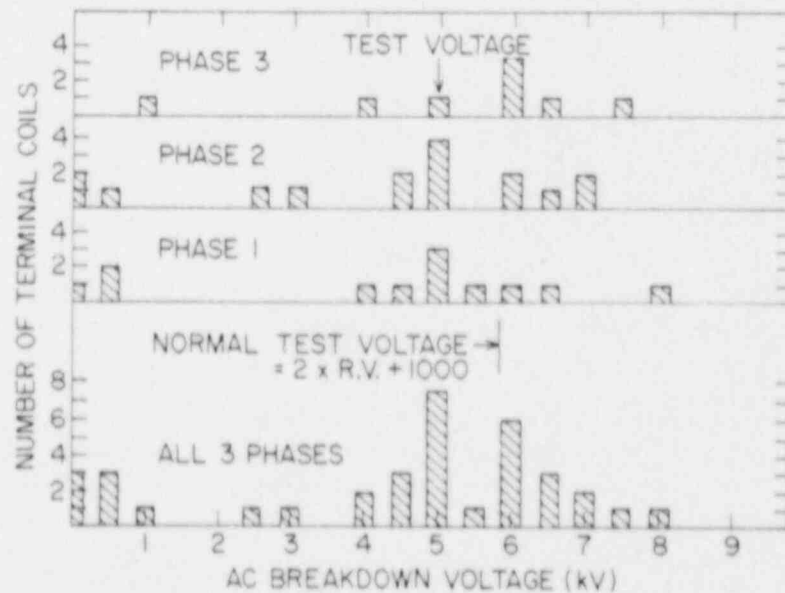
The remaining coils (71-79, 87-88) in Table 4.4 showed a significant increase above baseline for all three test parameters. This indicates coils have experienced degradation by thinning as well as by an increase in cracks and voids.

Figure 4.6 - Ac high potential test.

From the above results it is concluded that both the ac dissipation factor and capacitance tests are useful to determine and trend insulation degradation. It is recommended that one of these tests be considered for inclusion in a maintenance program. The ac leakage current test is also useful in determining insulation integrity, although it does not provide information as to the mechanism for degradation. It should be noted that coils with increased leakage current will develop larger I^2R heating effects which could accelerate the aging process and contribute to early failure. Leakage current could, therefore, be an important parameter to monitor.
