Vicinity Property Completion Report

Vicinity Property No. **DUR 003**

DU-003

12TH STREET - 13TH STREET

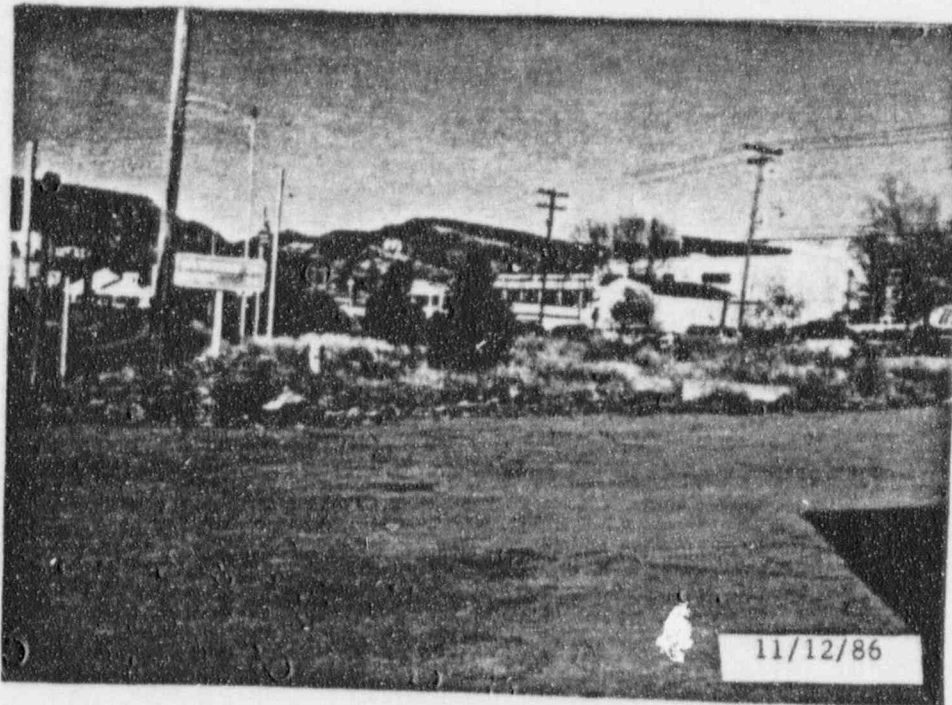
Prior to Remedial Action Looking North from Station 0+00

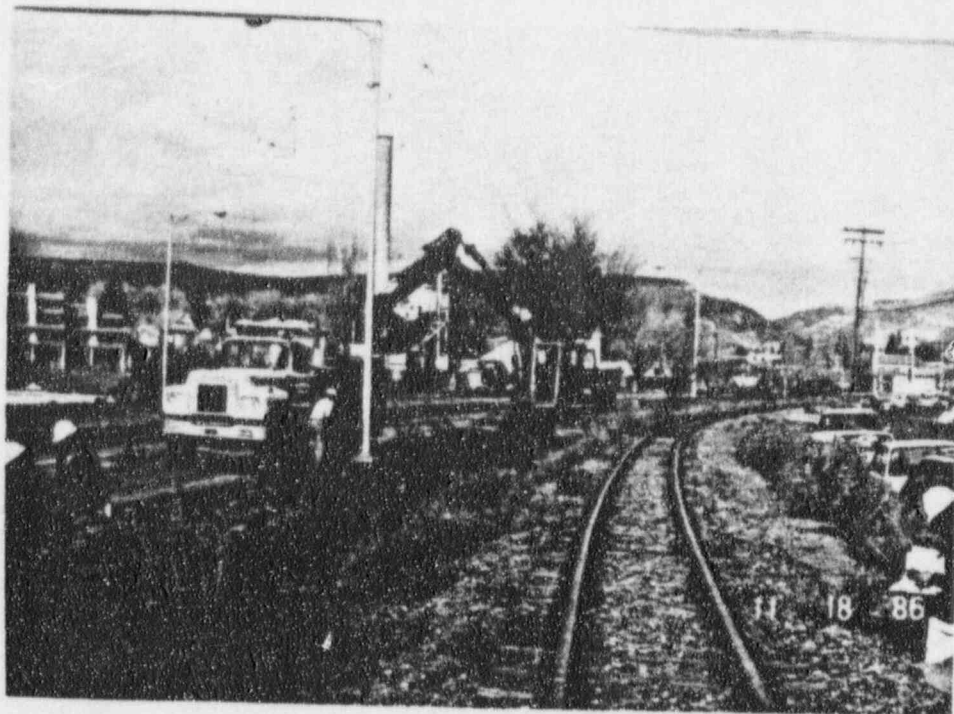
During Excavation Looking North from Station 2+50

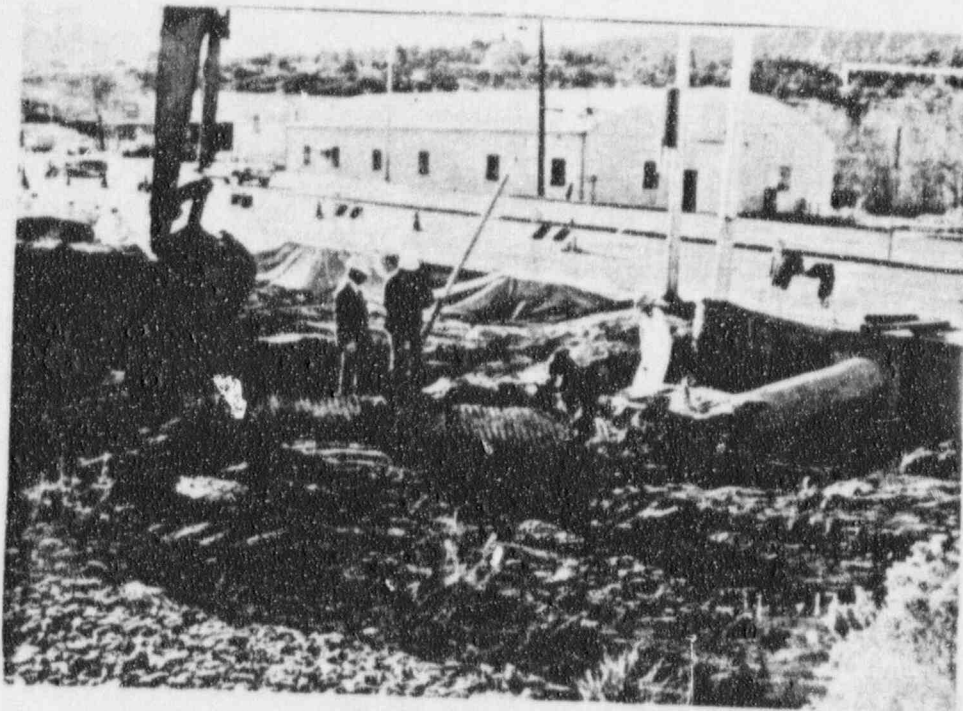
Looking West at Excavation and Culvert at Station 1+10,30L

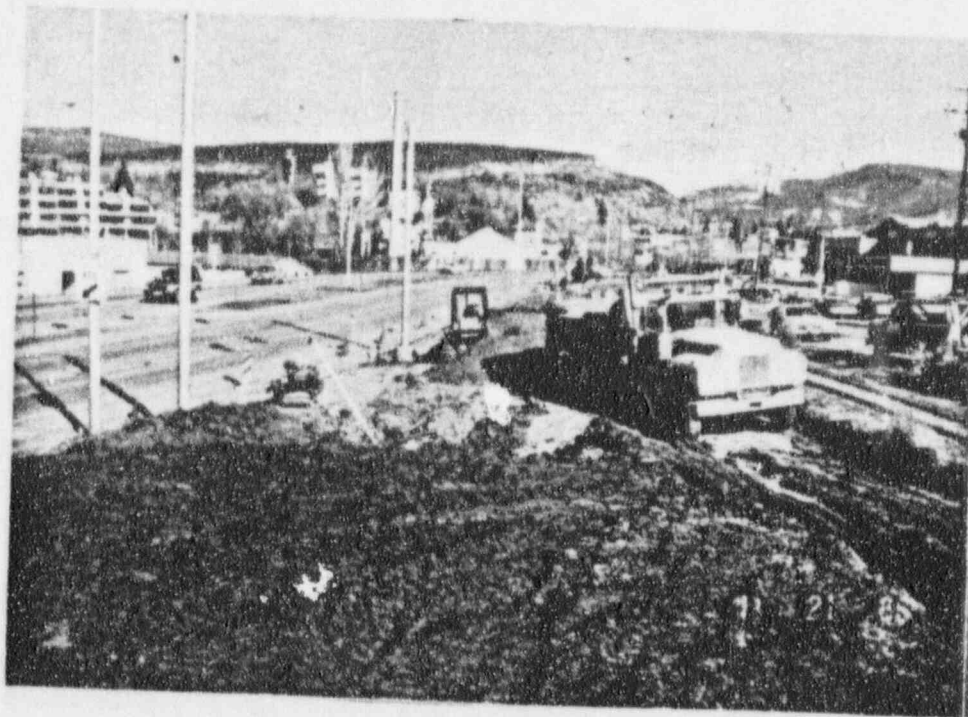
Looking North at Backfill Station 1+00 to 2+00

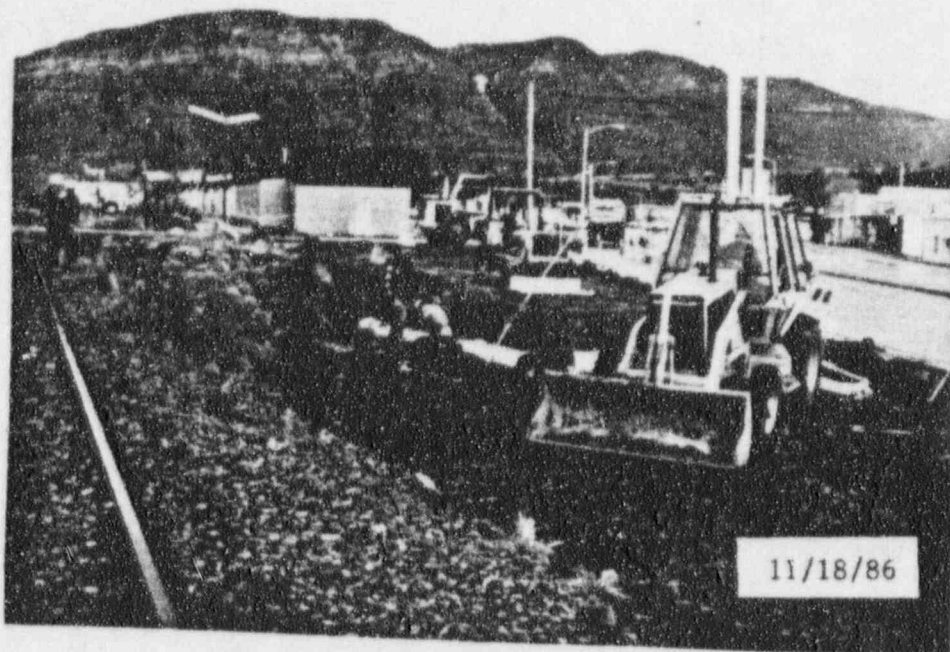
Looking South at Backfill Station 0+00 to 1+00

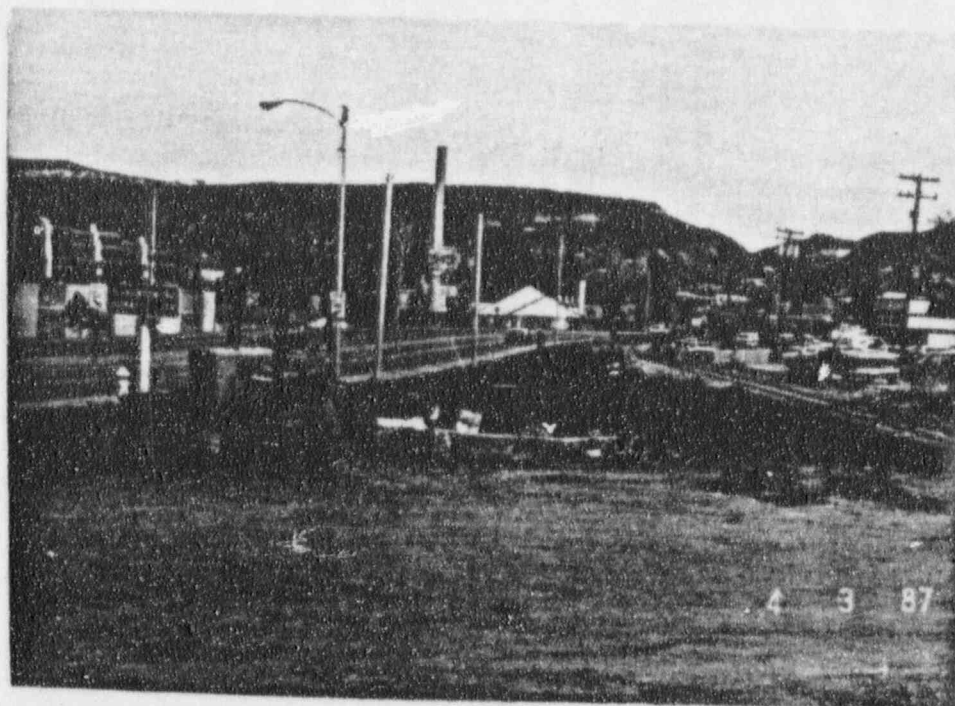
Looking North at Seed, Mulch and Fertilizer in Place

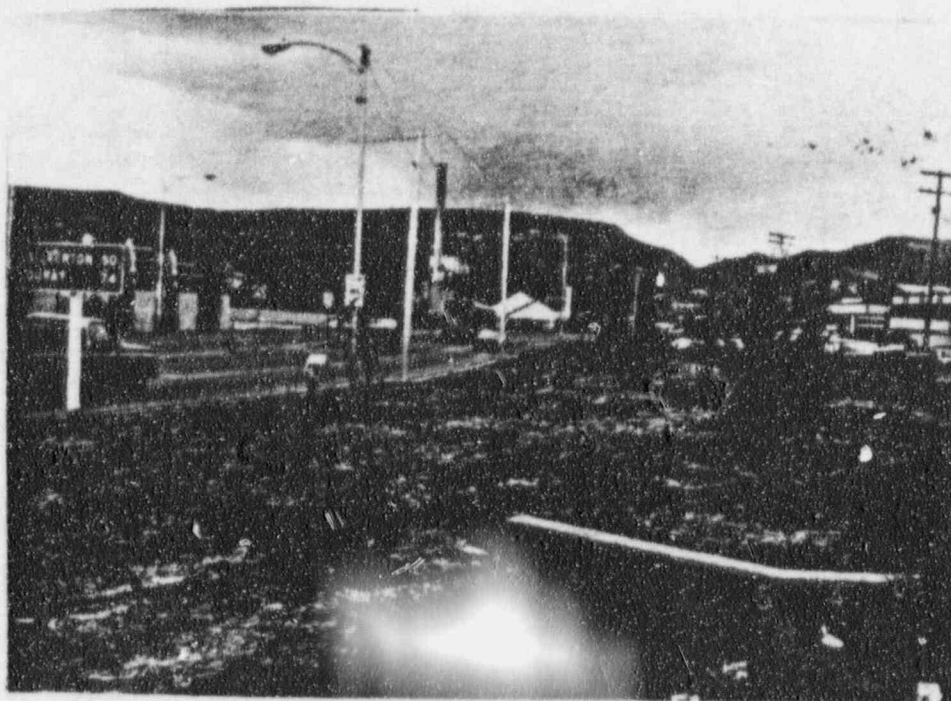
Looking North After Restoration

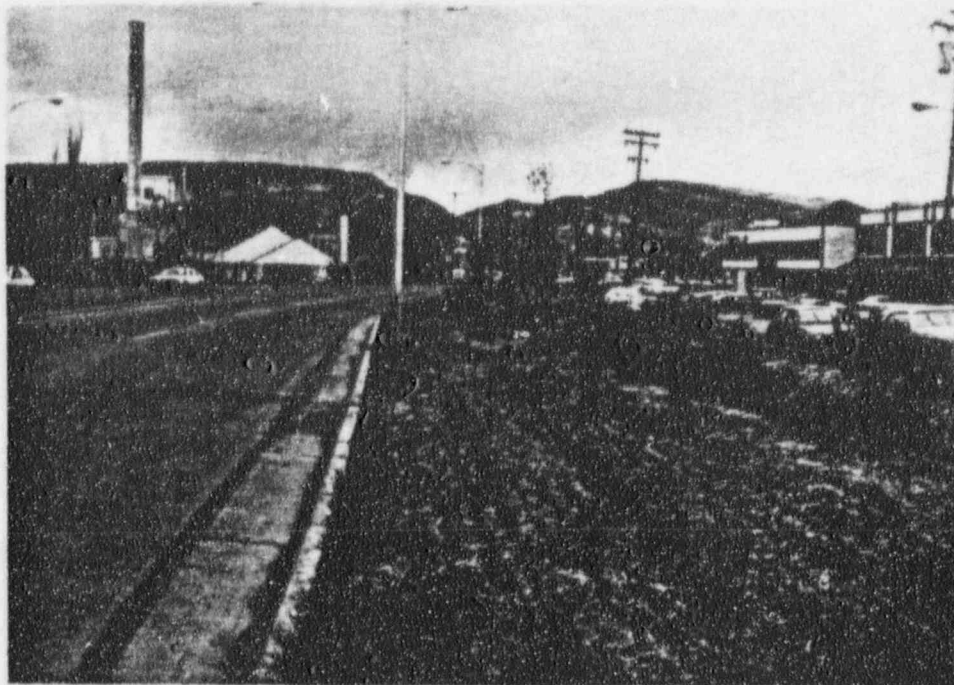
Looking North After Restoration

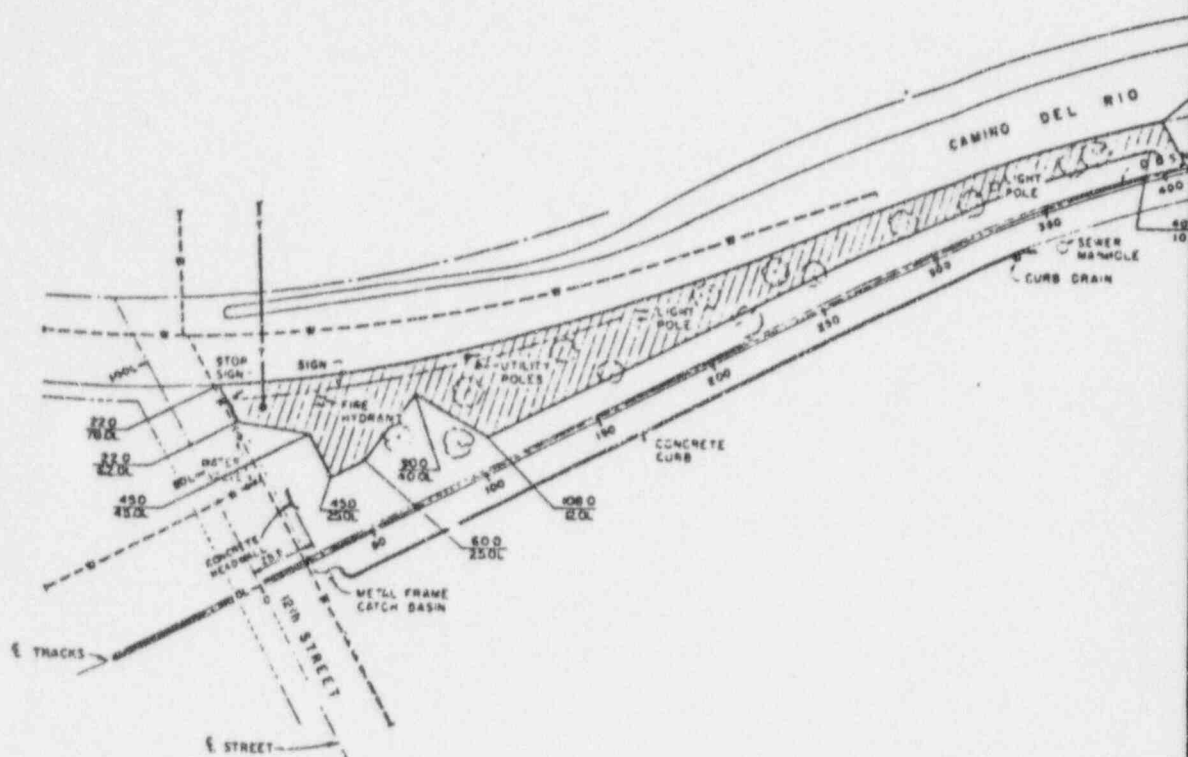
The results of the survey defining the contaminated area requiring remedial action are presented on Drawing DU-003-016.

ESTIMATED DEPTH OF CONTAMINATION

1-6"

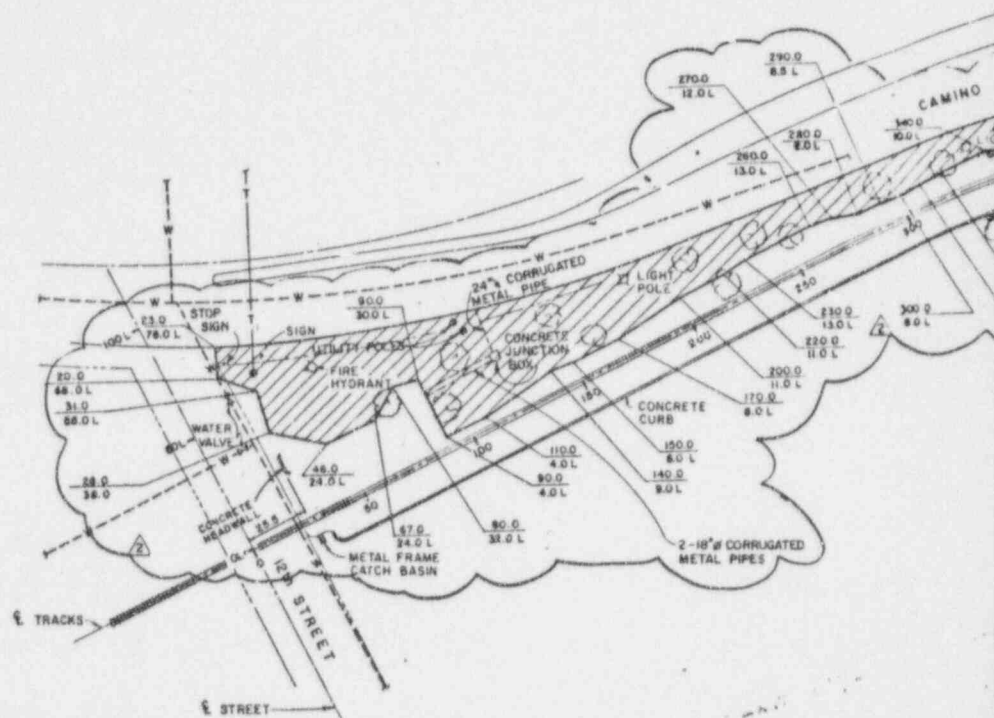
Drawing DU-003-020 shows the actual areas of excavation.

5. EXCAVATED AREAS TO BE FILL WITH COMPACTED CORNER FILL AND 6 INCHES TOP SOIL. TOP WITH SEED AND MULCH.
6. PROVIDE TEMPORARY RISE SIGN AT STREET DURING CONSTRUCTION
7. INSTALL NEW CONCRETE STORM DRAIN

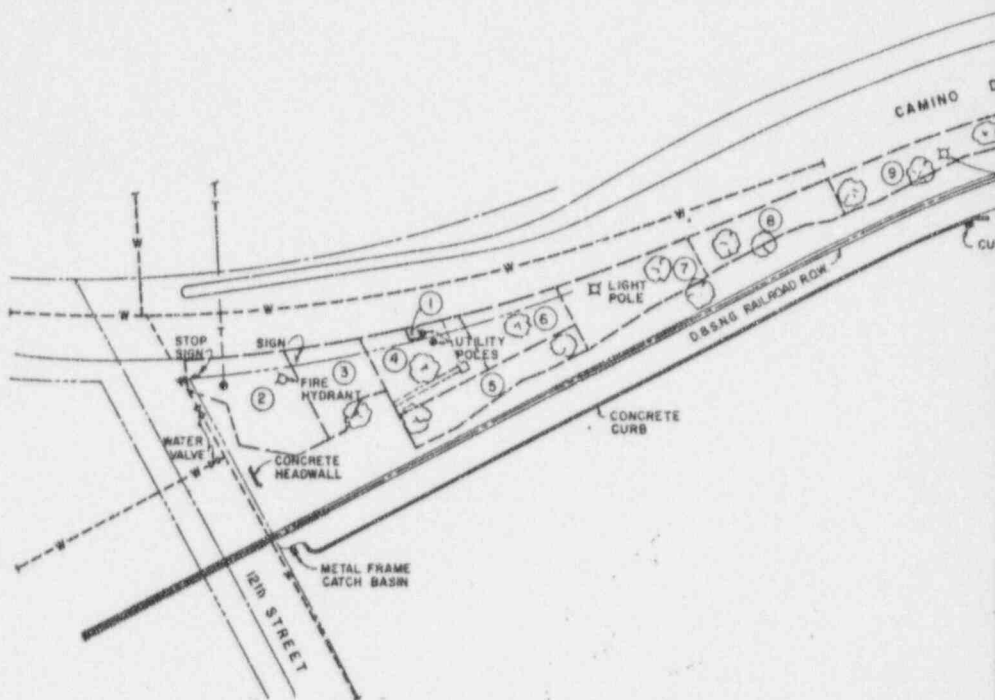
Approximately six cubic yards of material with a concentration of 18 pCi/g remain under the railroad tracks on this vicinity property. The gamma level in the contaminated area is 14 micro R/hr, approaching the Durango background value of 16 micro R/hr. The track is used daily by the Durango and Silverton Narrow Gauge Railroad.

1. SUPPLEMENTAL STANDARDS IN ACCORDANCE WITH 40 CFR 192.22
SUPPORT C SHALL APPLY TO THE PORTION OF PROPERTY DU-003
INDICATED ON THIS DRAWING. AN ESTIMATED VOLUME OF 6 CUBIC
YARDS OF LOW LEVEL RADIOLOGICALLY CONTAMINATED MATERIAL
REMAIN IN PLACE AT THE LOCATION INDICATED.
