Prairie Island Nuclear Generating Plant

LER 1-97-07, Rev 1

**Both Trains of Spent Fuel Pool Special Ventilation
Inoperable While Handling Load over Spent Fuel**

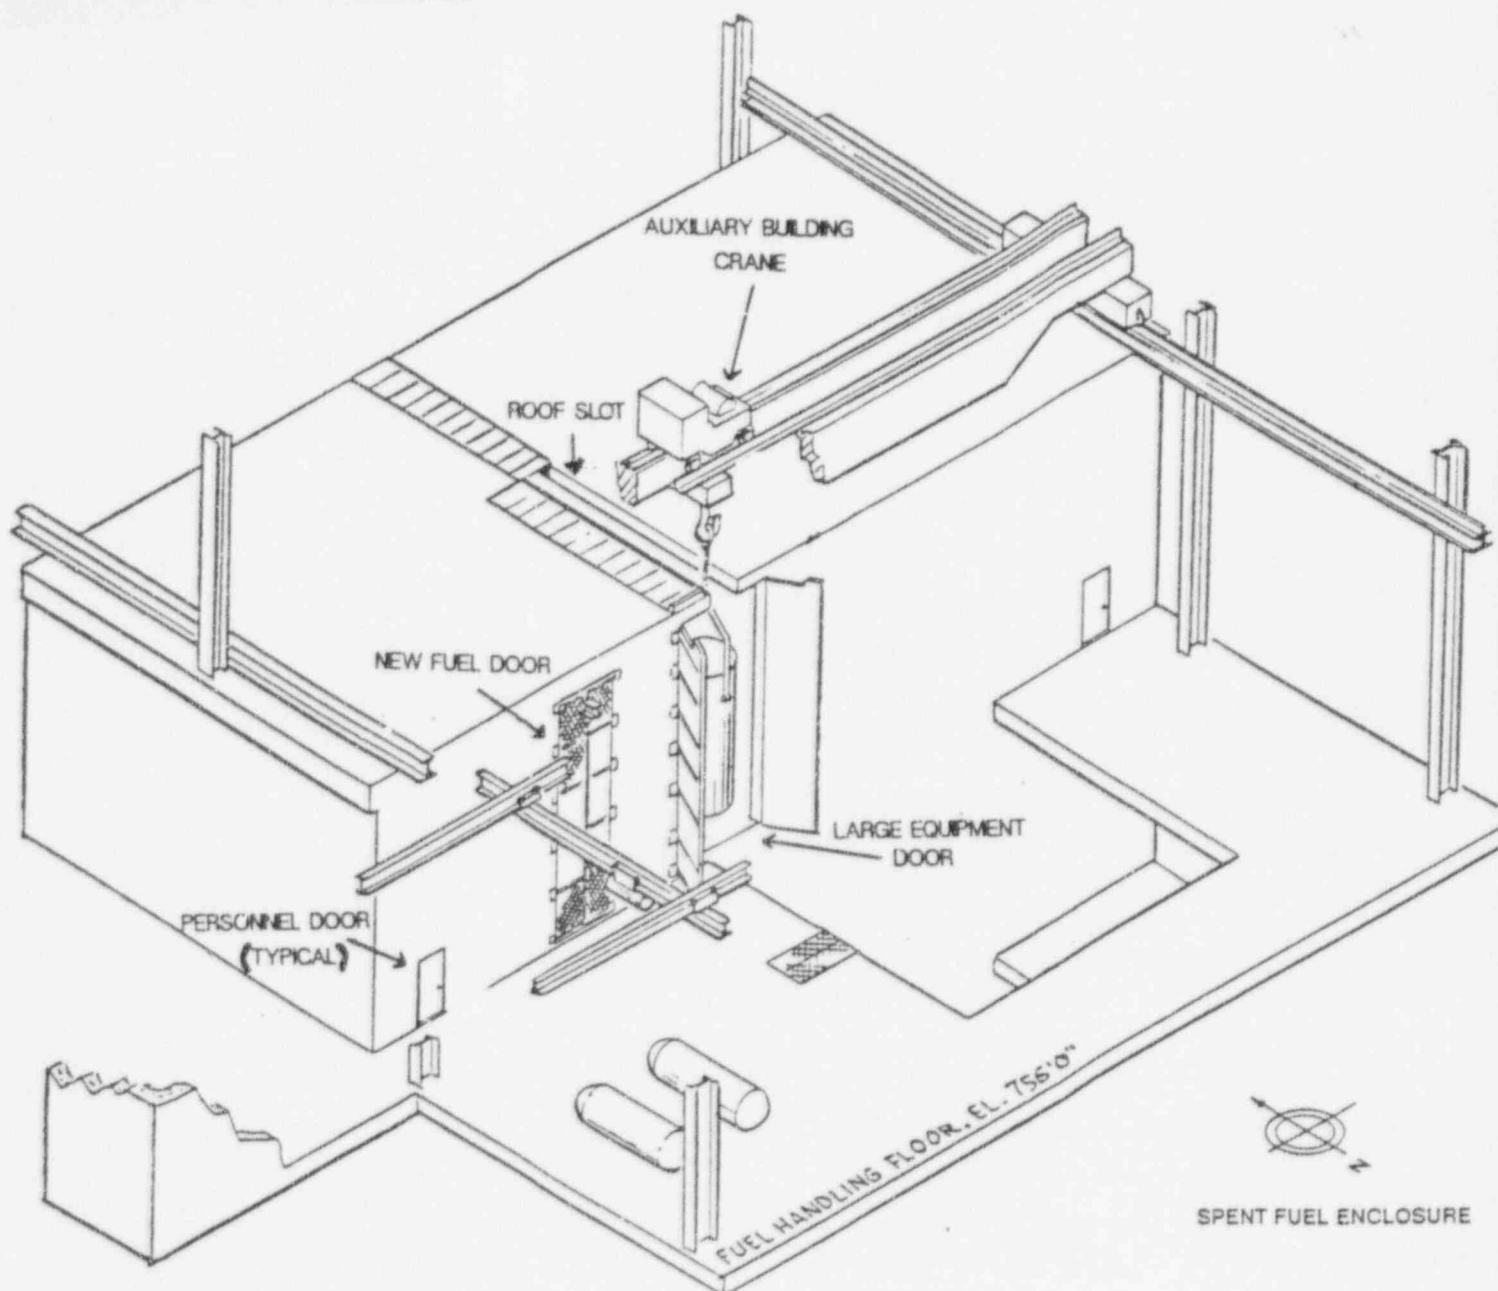
FIGURE 1

The enclosure completely encloses both spent fuel pools, the new fuel storage pit, and spent fuel pool handling crane³. The auxiliary building crane, a large overhead crane, passes over the top of the enclosure. The structure contains seven door openings and a roof slot (see Figure 1). At the four corners of the structure are personnel access doors which are of normal size. At approximately the center of the enclosure, on either side, are 2 full enclosure height openings with double doors which

serve as access for large equipment such as casks. On one side is a third large single-door opening that is used to transfer new fuel into the enclosure for storage in the new fuel pit. Finally in between the double-doored openings is a roof slot with moveable panels. This opening, along with the large double-doored openings, provide for passage for large equipment through the structure, suspended by the auxiliary building crane.

The Spent Fuel Pool Special Ventilation system contains 2 independent 100% ventilation trains. The system removes air from the spent fuel pool enclosure, passes it through PAC and charcoal filters and exhaust it to the atmosphere. The trains of the system are automatically started on a high radiation signal from detectors in the ducting of the normal ventilation exhaust. In order for the Spent Fuel Pool Special Ventilation System to be able to create a negative pressure in the enclosure structure all the openings must be closed. Prairie Island's Technical Specifications state in paragraph 3.8.D that when both trains of Spent Fuel Pool Ventilation System are out-of-service: "suspend all fuel handling operations and crane operations with loads over spent fuel (inside the spent fuel pool enclosure)." Thus by simply opening a personnel door both ventilation trains are out-of-service for the time that the door is open and TS 3.8.D applies.

Other corrective actions associated with this event are two-fold, interim and long term. As an interim action, procedure changes will be put in place that will require that all (except personnel) doors be closed when handling fuel or crane operations with loads over spent fuel -- this action completely eliminates the use of the auxiliary building crane with loads directly over spent fuel. In support of the procedure changes will be special training to those plant personnel who could be involved in work in the enclosure. The procedural changes and training will be completed prior to the next movement of loads or fuel in the enclosure.
