Subject: Duane Arnold Energy Center  
Docket No: 50-331  
Op. License No: DPR-49  
Licensee Event Report #97-06  
File: A-118a

Duane Arnold Energy Center

Inadequate Functional Test of the High Pressure Coolant Injection System Steam Leak Detection Time Delay

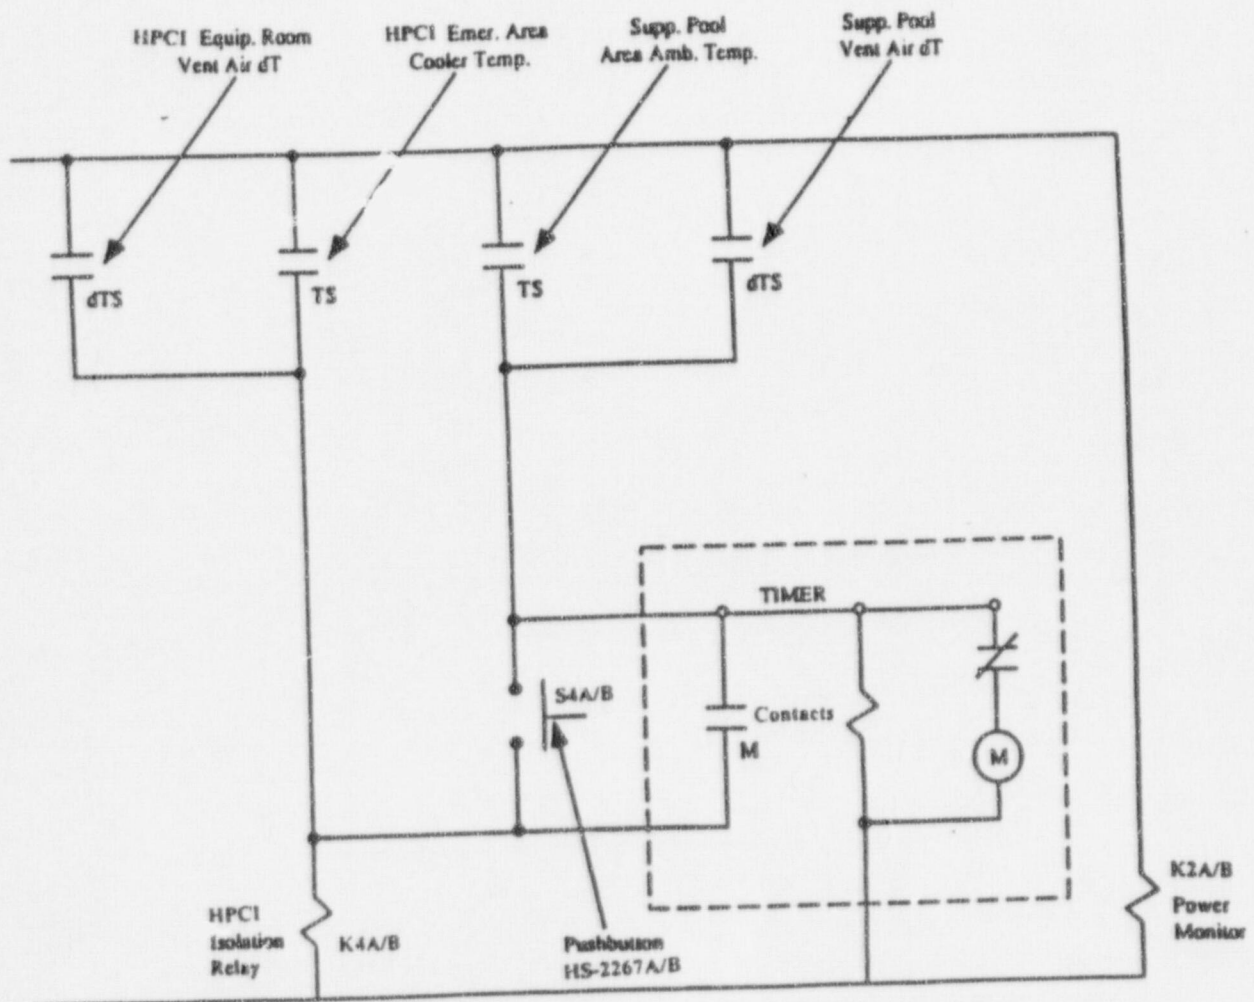
Figure 1. Simplified HPCI Timer Circuit, Channel 'A/B'

The cause of this event was the functional test procedure for testing the HPCI SLD time delay which contained an incorrect instruction. The procedure directed personnel to depress the "HPCI Auto Isolation Time Delay Override" switch (HS-2267A) on Panel 1C21 after the "HPCI Auto Isolation Timer" started but before it timed out. In this condition, the contacts were not allowed to activate to energize the time delay relay (B21B-K4A), instead, the relay was energized by the hand switch which bypassed the time delay relay contacts.

The quarterly test procedure was revised upon the discovery and re-performed satisfactorily without complications by 1022 hours on both channels of the HPCI SLD Time Delay logic. In addition, the logic channels had been tested and calibrated satisfactorily on December 16, 1996 during the annual channel test and calibration. The procedure for the annual channel test and calibration was reviewed and confirmed to not contain the incorrect instruction.
