CORPORATION
Crystal River Unit 3
Docket No. 50-302

Subject: Licensee Event Report (LER) 97-011-00

Potential design basis Condition from Pressure Locking of Emergency Feedwater Isolation Valves Caused by
Insufficient Oversight/Review of Calculations

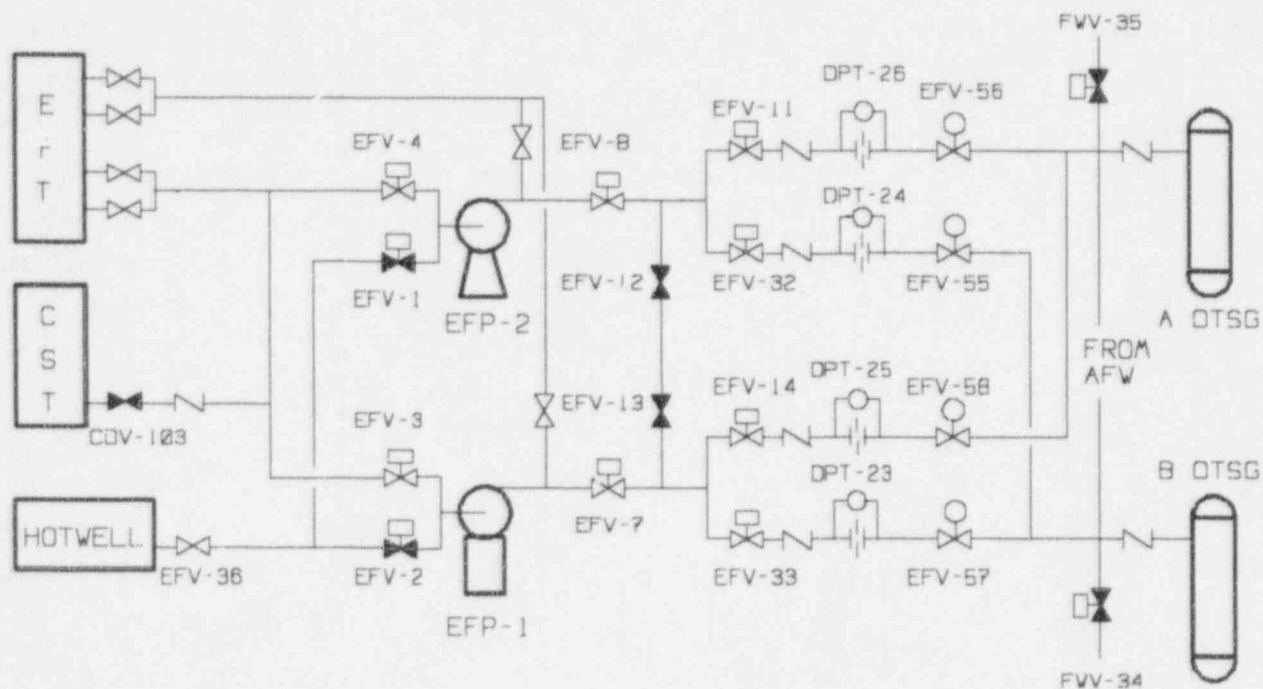
Figure 1, Emergency Feedwater System

The conditions for an event which could cause the postulated pressure locking are as follows. Refer to Figure 1.

1. A pipe rupture occurs in a steam line or main feedwater pipe associated with the 'A' steam generator. The pipe rupture must take place in the Intermediate Building [VK] and create a high temperature environment in the emergency feedwater pump room in excess of 400 degrees Fahrenheit (F). Depending on the break size, the steam generator will either isolate quickly (large breaks) with the temperature in the building returning to below 150 degrees F in approximately 15 minutes, or cause the steam generator to blow down for up to 20 minutes (small breaks) until operator action is implemented to isolate the break.

2. Main feedwater [SJ](FW) is isolated and emergency feedwater actuates on low steam generator pressure (less than 600 pounds per square inch gauge).
3. The 'A' steam generator is isolated by a feed-only-good-generator (FOGG) signal or by manual operator action.

4. One of the two emergency feedwater control valves [BA,FCV] (EFV-55 or EFV-57) to the 'B' steam generator fails open. The control valve failure is the single failure in this scenario;

5. The flow path with the failed control valve continues to fill the 'B' steam generator to the overflow setpoint which causes both isolation valves EFV-32 and EFV-33 to close.
6. Boil-off in the 'B' steam generator to the overflow reset point takes greater than five minutes and both isolation valves are assumed to pressure lock due to the high temperature environment created by the line break.
7. After boil-off in the steam generator to the overflow reset point, the isolation valves attempt to reopen but can not due to the actuator being incapable of overcoming the additional thrust requirements resulting from pressurized fluid in the valve bonnet caused by thermal expansion of the confined fluid.

EFV-32 and EFV-33 will be modified or replaced by October 26, 1997, to preclude the possibility of pressure locking.
