Vicinity Property Completion Report

VICINITY PROPERTY COMPLETION REPORT

DU-144A S
TRUCK BY-PASS (CAMINO DEL RIO)
DURANGO, COLORADO

May 16, 1991

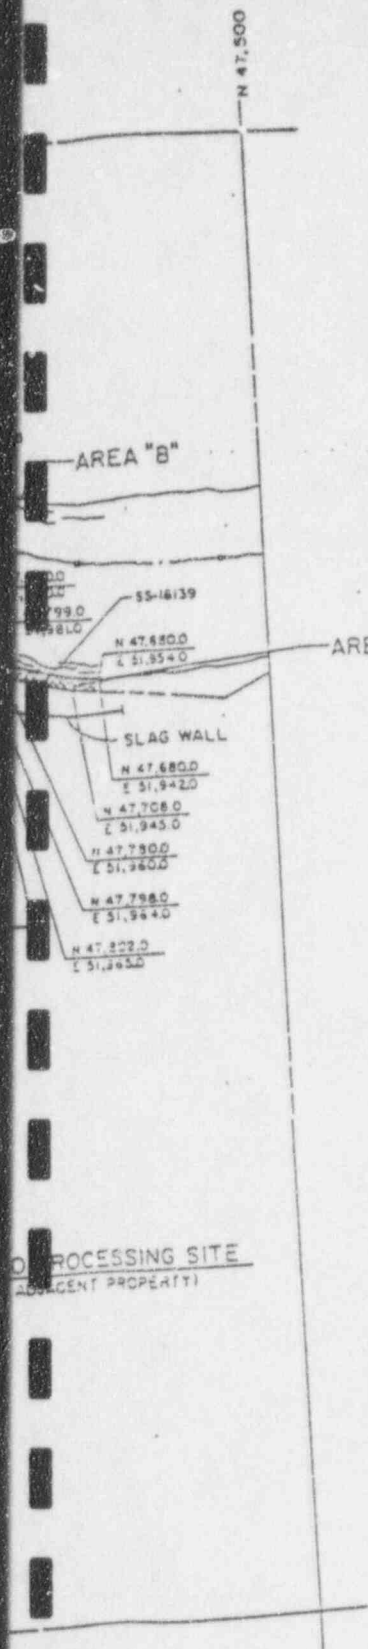
Areas A, B and C have been excavated down to the water table and Ra-226 concentration in these Areas range from 40 pCi/g to 114 pCi/g. Further excavation in Areas A and C would require Z-pile along the rivers edge, pumping operations and water treatment. Continued excavation of Area B would require excavation of a 30 vertical cliff of radiological clean slag. As agreed upon by the RAC, TSC, CDH, DOE and NRC further excavation in these areas was not warranted due to the high cost relative to the long term benefits. These areas are covered with a minimum of two feet of backfill and riprap per the Durango Site Restoration Plan. With this cover in place general area exposure rates are near background levels. Background for the Durango Site is 14 micro R/hr. The estimated volume of contaminated material that remains in these areas is 125 cy.

Area D is presently covered with 3 feet of riprap. Contamination is sporadically distributed throughout the 2.5 foot layer of soil beneath the riprap. Ra-226 concentrations in soil in this area range from <1.5 to 35 pCi/g. General area exposure rates are near background. The estimated volume of contaminated material that remains in this area is 120 cy.

Area F is presently covered with 3 feet of riprap. Contamination is sporadically distributed throughout the 2 foot layer of soil beneath the riprap. Ra-226 concentrations in soil in this area range from <1.5 to 166.0 pCi/g. General area gamma exposure rates range from 16 to 25 micro R/hr. The estimated volume of contaminated material that remains in this area is a 600 cy.

Contamination in Area G does not exceed EPA standards for Ra-226; however, a lens of uranium was exposed at the high water mark on the bank of the Animas River. This lens varies from 1 to 6 inches in thickness. The extent to which the lens extends on to the property is undetermined due to an over burden of radiologically clean material that varies in thickness from 2 to 25 feet. This overburden consists mostly of slag generated by a lead smelter that operated from the 1880's to 1930. Ra-226 concentration in soil in the Uranium Lens Area range from <1.5 to 12.1 pCi/g. The exposed portions of the uranium lens was covered with 2 feet backfill and riprap per the Durango Site Restoration Plan. With 2 feet of backfill and riprap over the exposed portion of the lens, exposure rates are near background levels.

All the Supplemental Standards areas are covered with a minimum of 2 feet of backfill and riprap.
