SUBJECT: REVIEW OF PRELIMINARY ACCIDENT SEQUENCE PRECURSOR ANALYSIS OF  
OPERATIONAL EVENT AT LASALLE COUNTY STATION, UNITS 1 AND 2

**LER No. 373/96-007, -008**

Event Description: Concrete sealant fouls cooling water systems

Plant: LaSalle 1 and 2

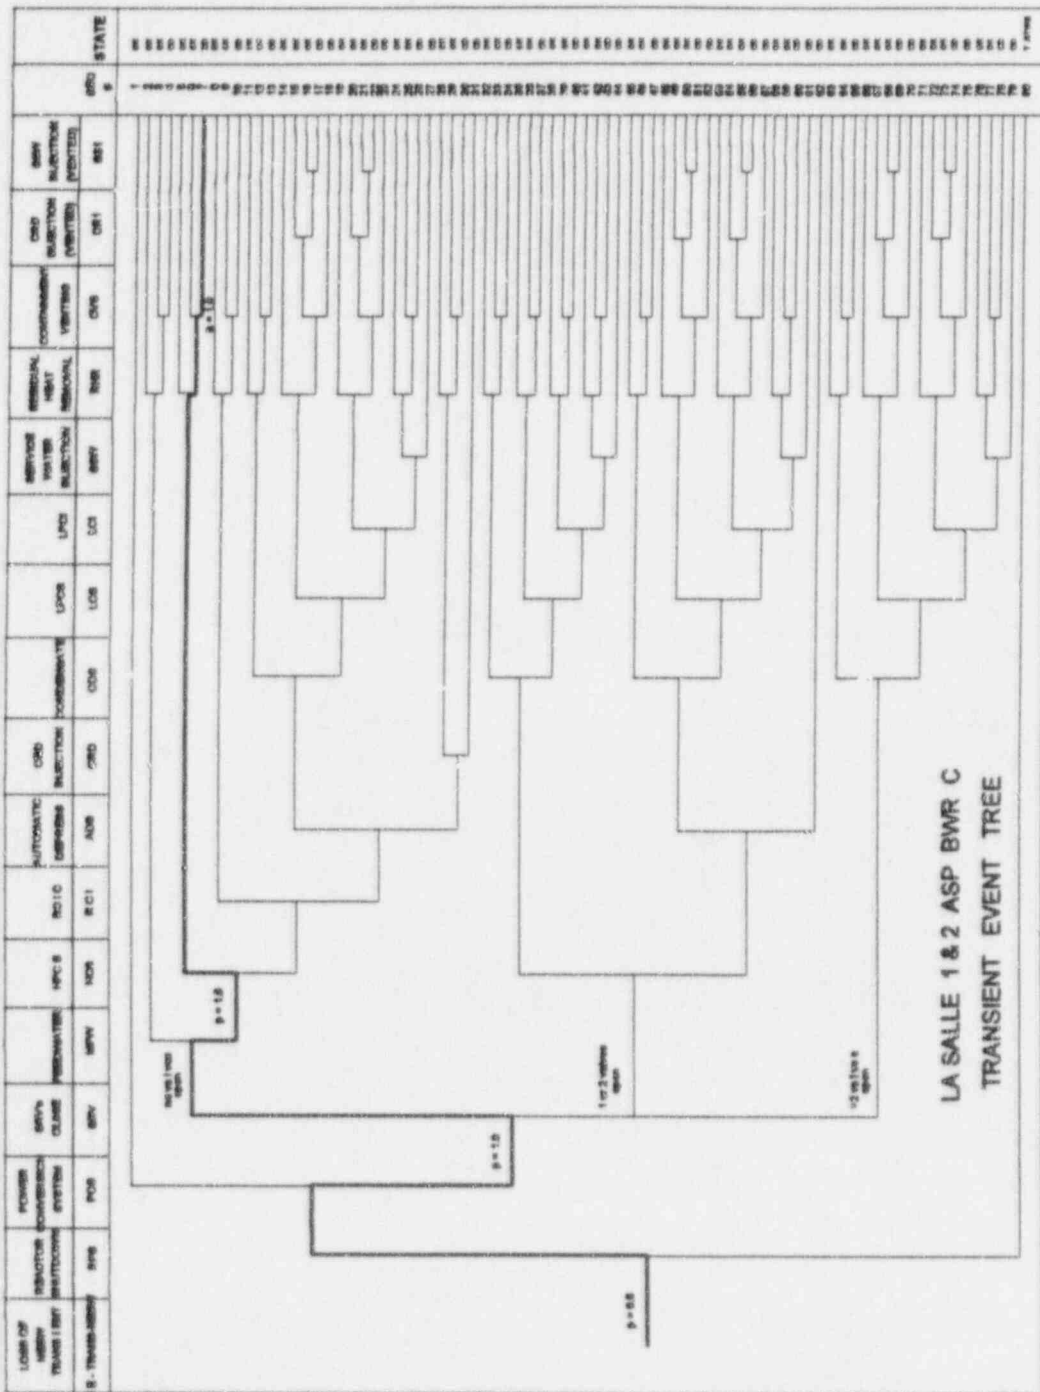
The CCDP estimated for this event is  $2.3 \times 10^{-5}$ . The dominant sequence highlighted on the event tree in Figure 1 involves

- the postulated scram with unavailability of PCS and main feedwater,
- failure of RHR, and
- unavailability of containment venting.

Figure 1. Dominant core damage sequence for LER Nos. 373/96-007, -008. (The loss of NESW fails the following systems: CDS, MFW, PCS, CRD, and CVS.)

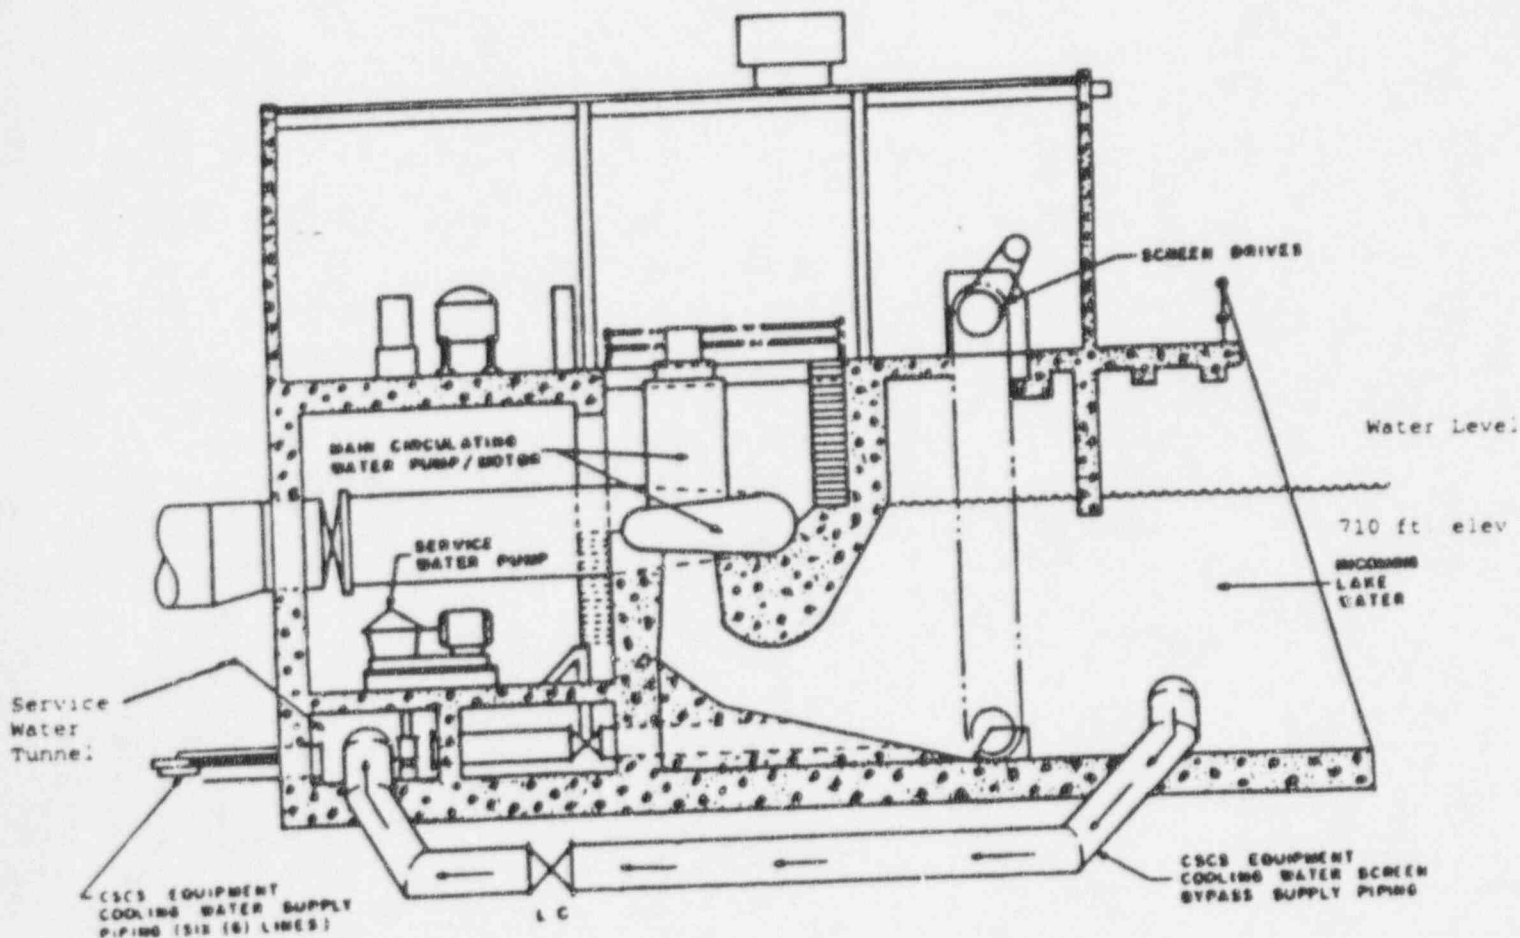
Lake Screen House Cross-section View

While doing floor repairs, the workers started fixing cracks on the top or ceiling of a service water tunnel which runs the length of the building approximately 20 feet below lake level (see sketch). This tunnel supplies cooling water to both the non-essential and essential (safety-related) cooling water pumps at the plant. As they repaired these cracks, the large amount of water at pressure indicated to the workers that a large void was present. The workers believed that they were working on a concrete floor laid over soil. They proceeded to drill five holes through the ceiling of the service water tunnel and inject sealant. Instead of being injected into a void under the building floor, the material was injected into the tunnel accumulating on the ceiling and floor or dispersing into the cooling water.

The root cause of this event is that work affecting plant safety related structures was assigned and performed outside the controls of the Nuclear Work Request Process. This occurred when the work was approved without identifying a potential impact on the Seismic Category 1 Service Water Tunnel or the Service Water System from the sealant injection process used in concrete crack repairs and resulted in the work not being reviewed by Engineering. The sealant work being performed was considered "Material Condition" repair and incorrectly assumed to be non-intrusive. The workers were using "craft capability" to perform the sealant work, no Work Package was generated for the work. Two Action Requests (ARs) were used as the authorization for the repairs. Crack repair work was performed on walls as well as the floor at the Lake Screen House but also on the Seismic Category 1 Service Water Tunnel.

1. Floor and wall repair work in the Lake Screen House was stopped.
2. The service water tunnel was cleaned and inspected.
3. Essential Service Water Systems and balance of plant equipment that could have been impacted by the intrusion of sealant were inspected, cleaned and tested to ensure that the systems and equipment would function as designed.

4. The structural integrity of the seismic-class I service water tunnel was evaluated to ensure that repair activities had not degraded the structure.
5. An Engineering Policy was published which outlined repair and controls associated with building structural repairs and use of sealants as a temporary or permanent repair requiring engineering review and approval.
