Subject: Zion Nuclear Power Station Units 1 and 2
Amendment Nos. 98 and 88 to
DPR-39 and DPR-48
NRC Docket Nos. 50-295 and 50-304

RESULTS OF DETECTABILITY THRESHOLD INVESTIGATION

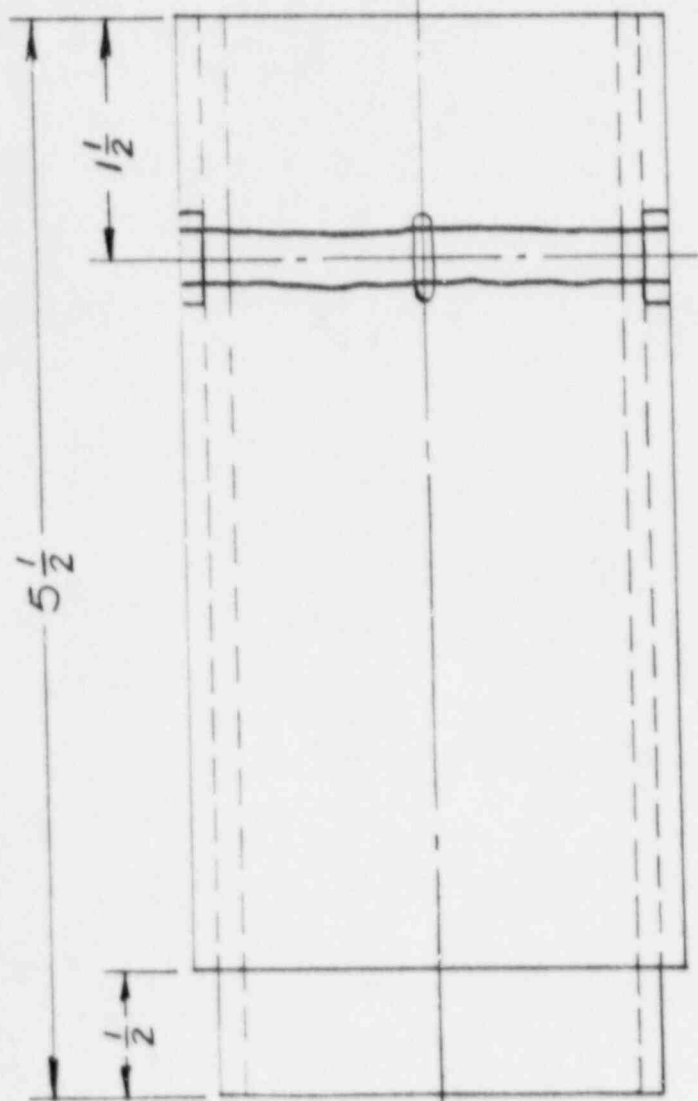
UT SAMPLE #4
AXIAL NOTCH IN EXPANSION
WITH WELD

1. (4) Milled notches
2. Width: .030", .050", .070", .090"
3. Length: completely across weld
4. Depth: .050" (through outer tube)
5. Spacing: 90 degree intervals

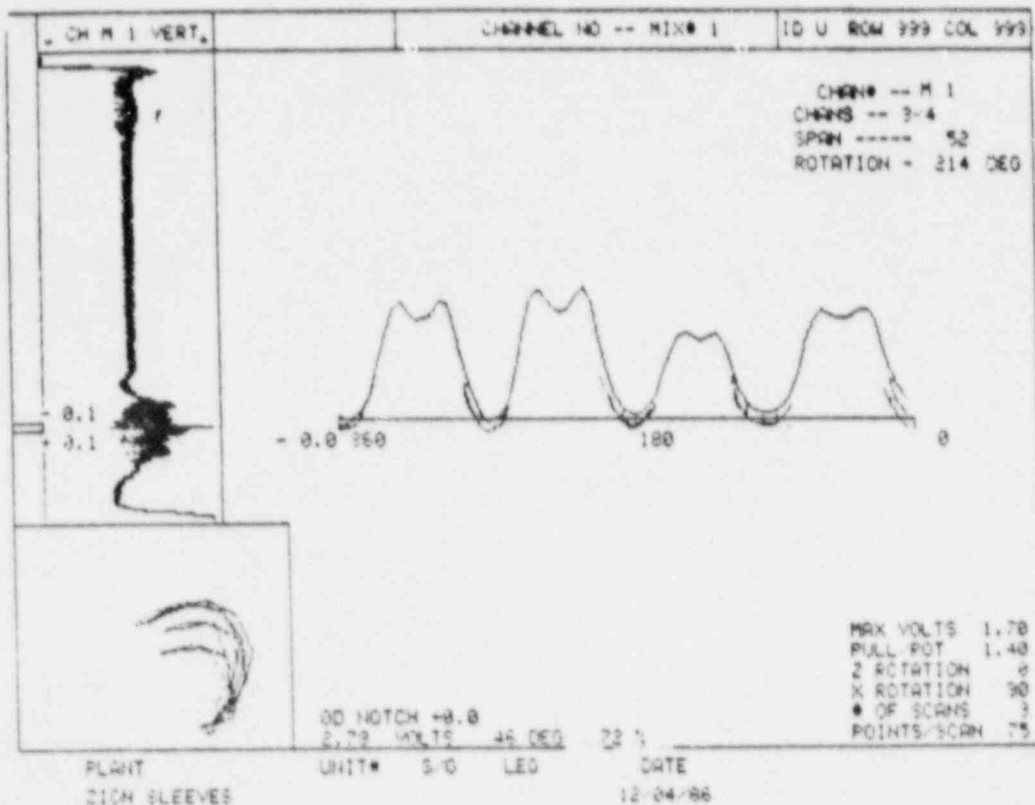
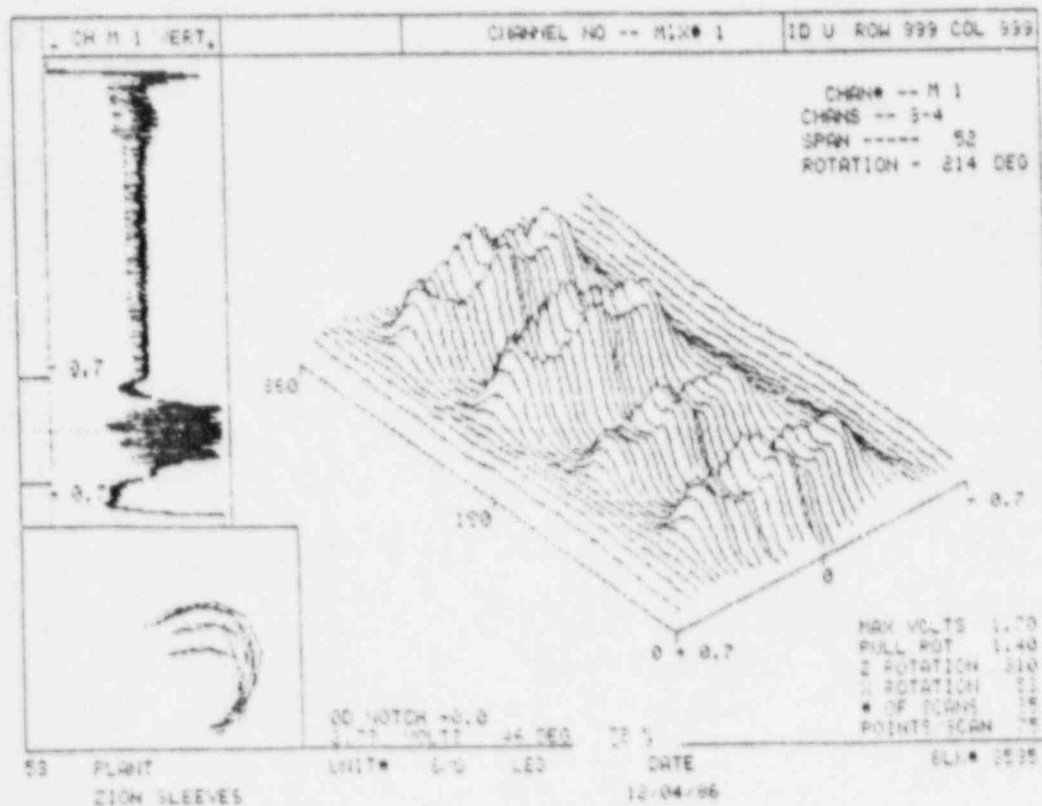
ROTOPROBE

AXIAL NOTCH IN EXPANSION WITH WELD

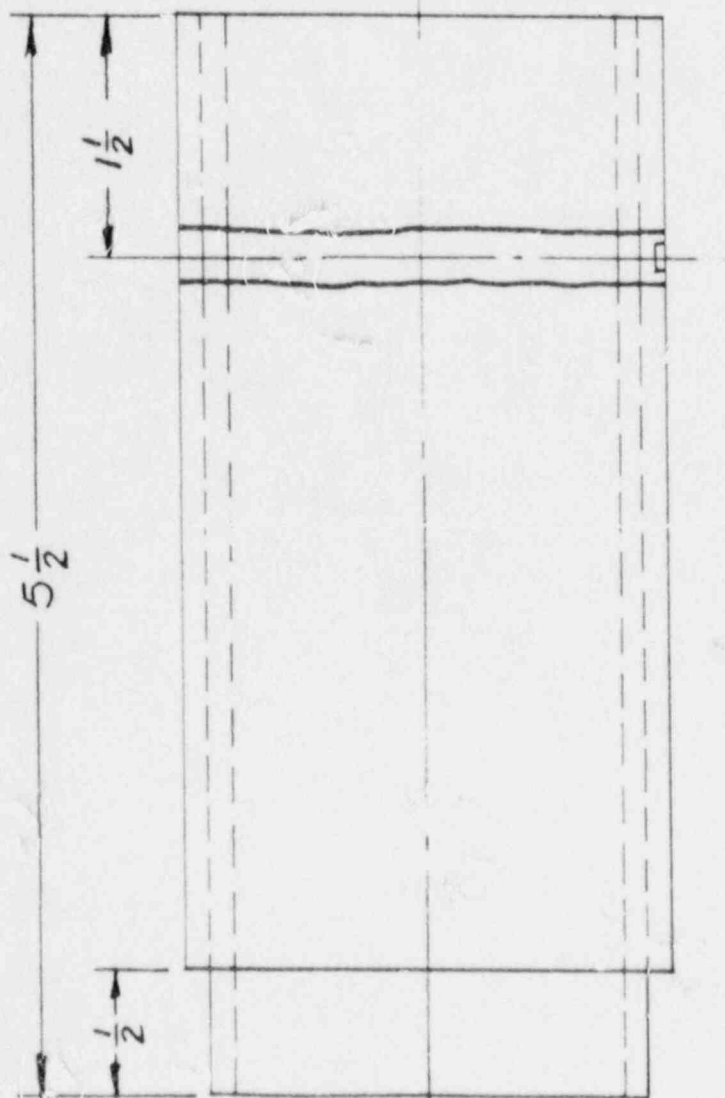
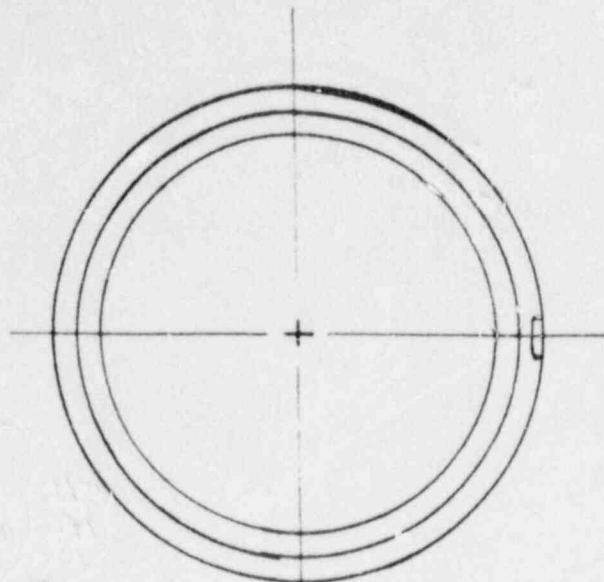
TEST SAMPLE #4

40% THROUGH-WALL HOLE
IN PARENT TUBE OUTSIDE DIA

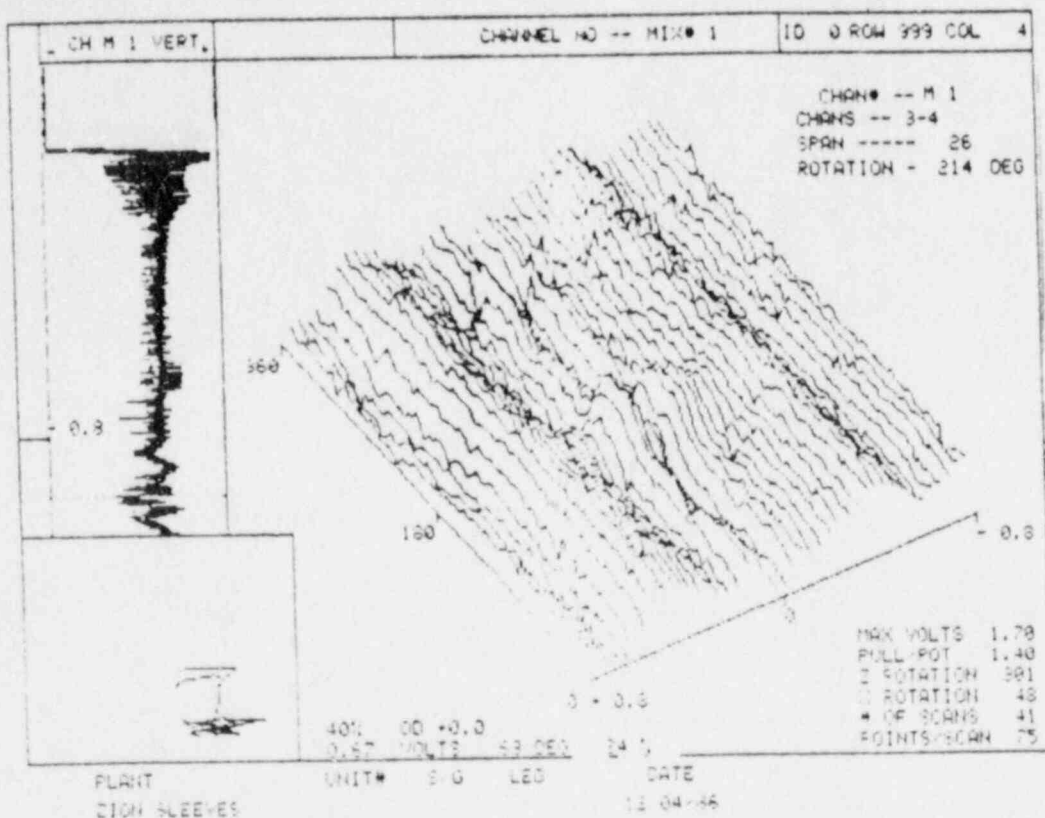
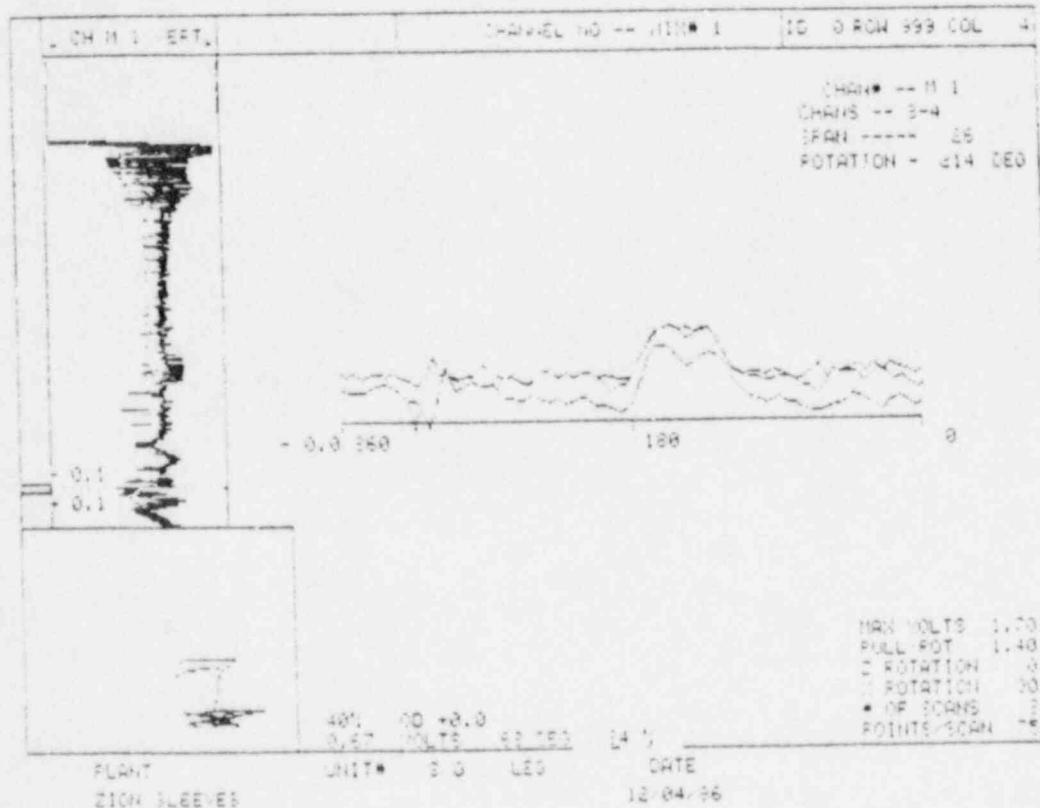
ROTOPROBE

IN EXPANSION WITH WELD

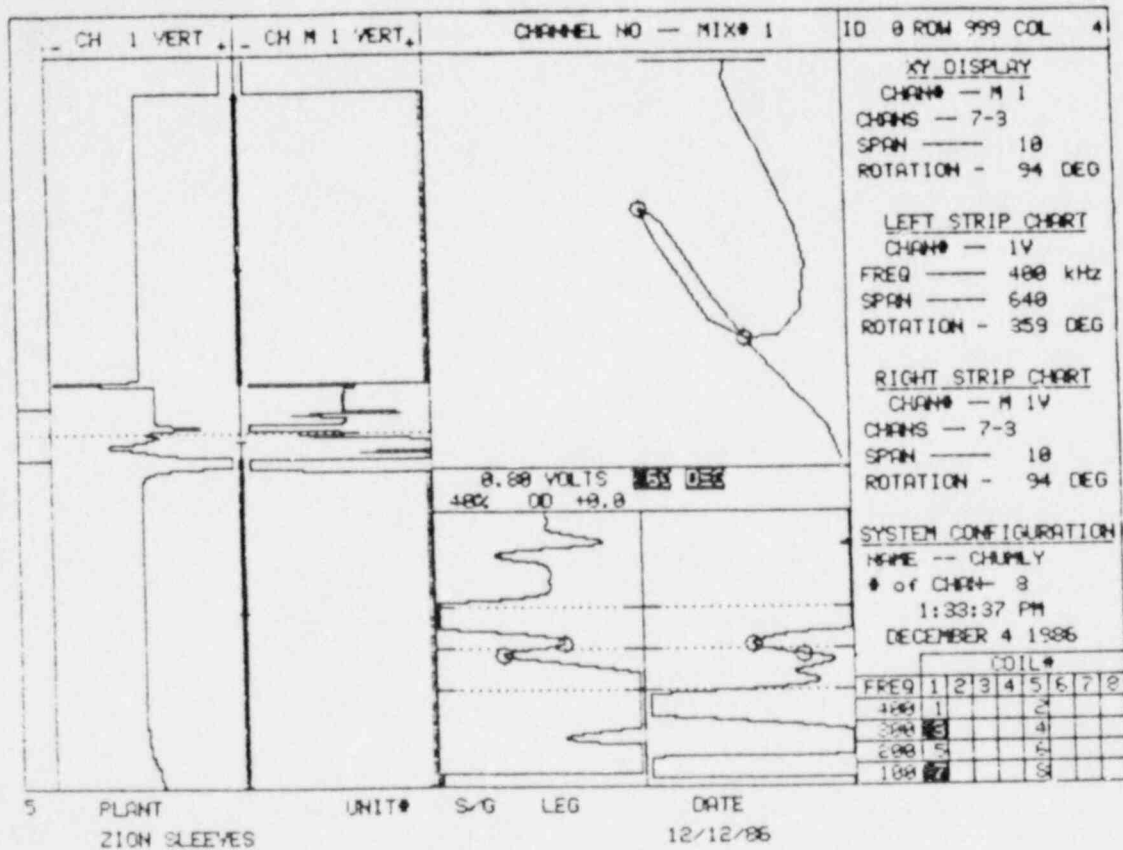
BOBBIN COIL

IN EXPANSION WITH WELD

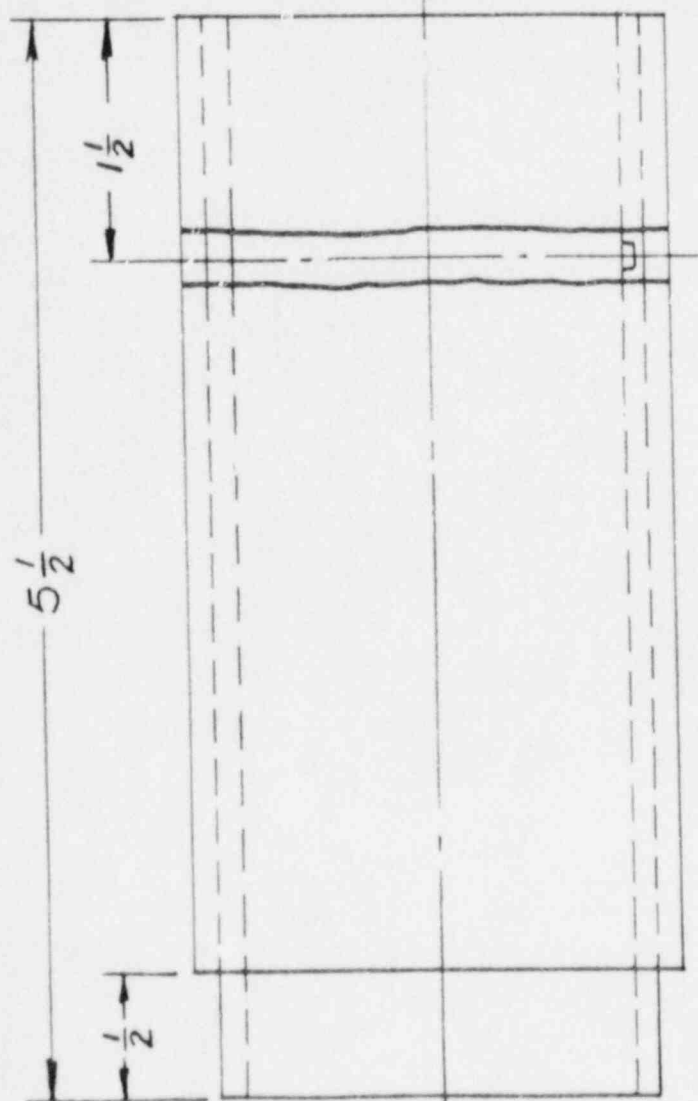
TEST SAMPLE #2

40% FLAW IN SLEEVE
INNER DIAMETER

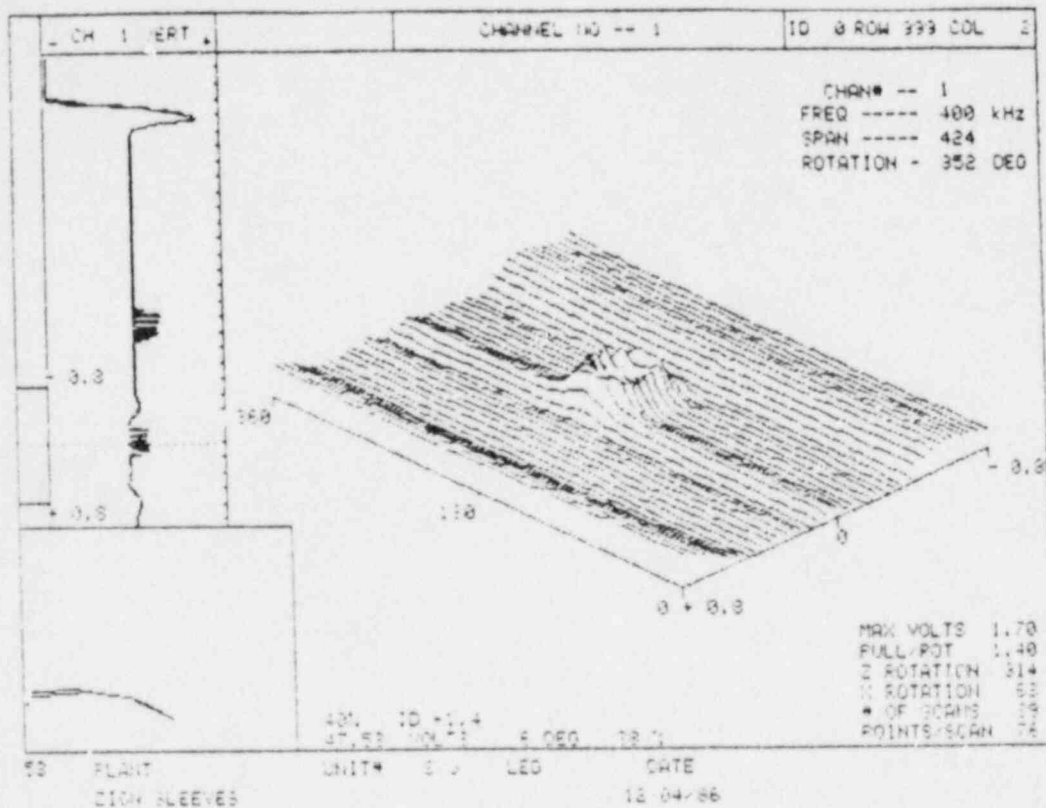
ROTOPROBE

IN EXPANSION WITH WELD

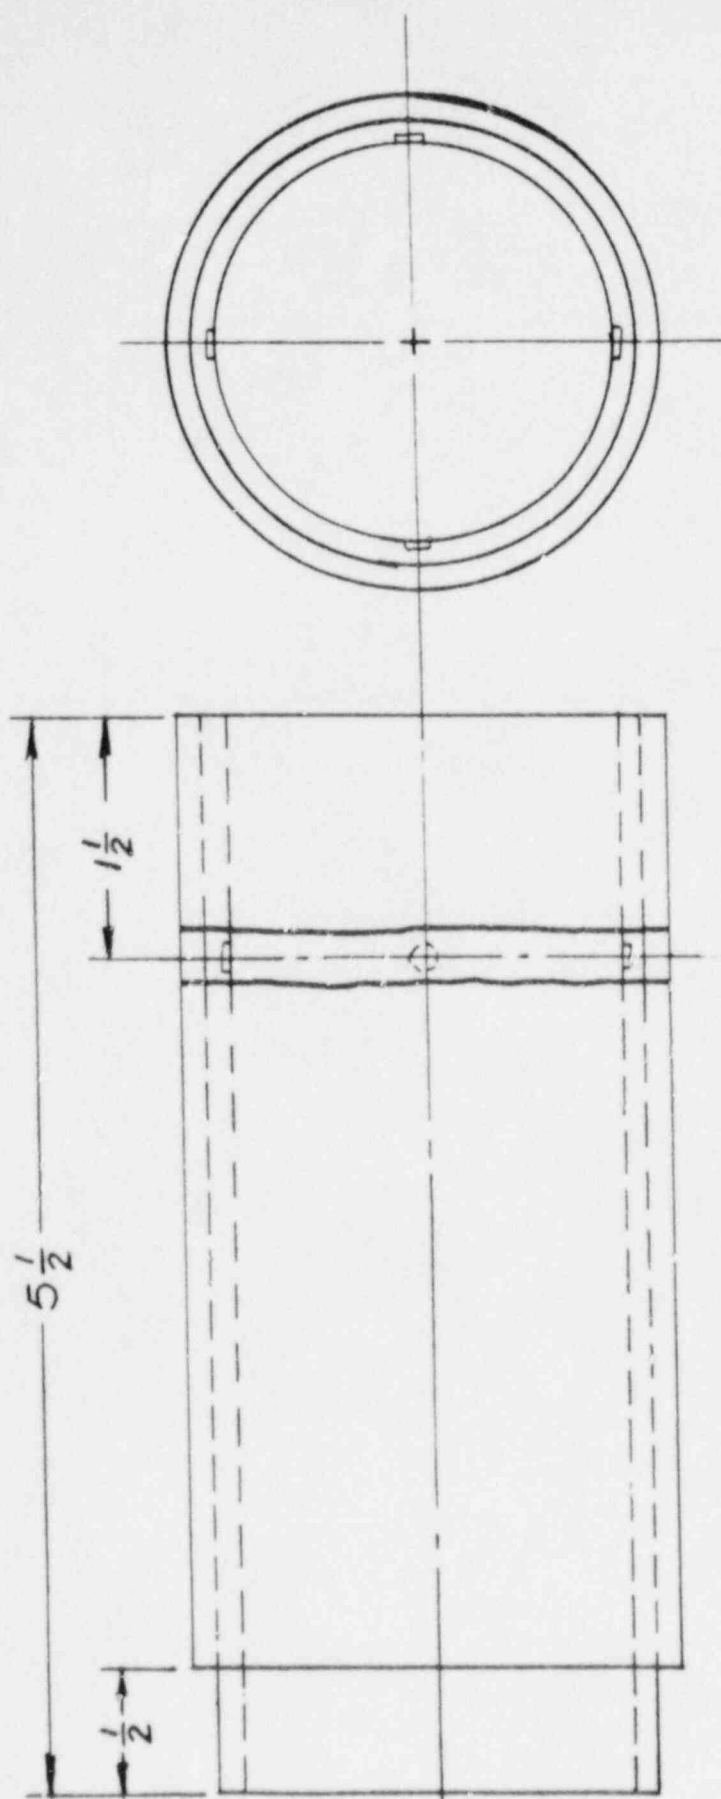
TEST SAMPLE #3

20 % THROUGH-WALL HOLE
IN SLEEVE INNER DIA

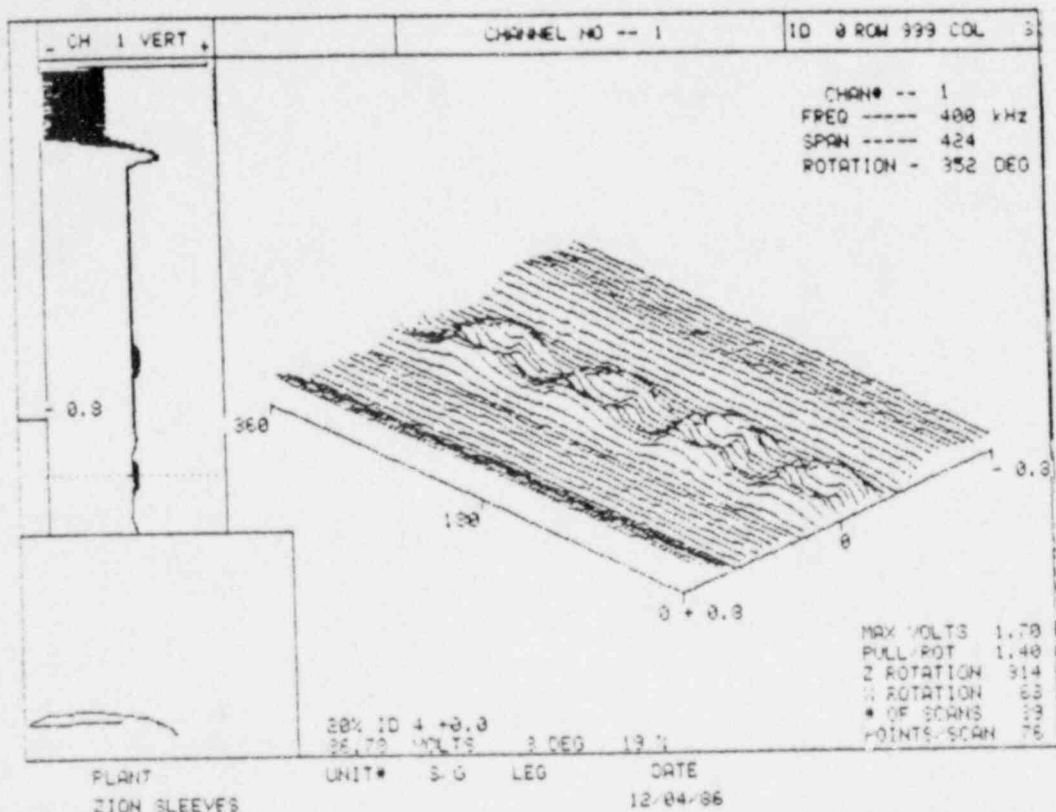
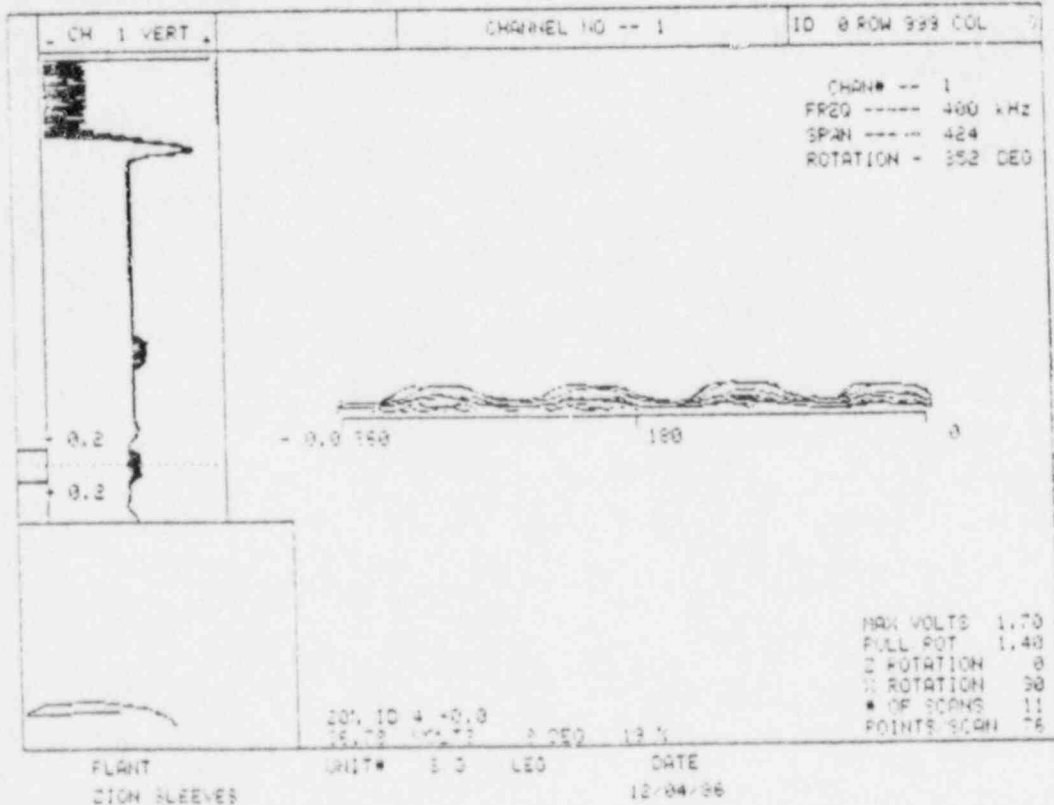
**IN EXPANSION WITH WELD
 ROTOPROBE**

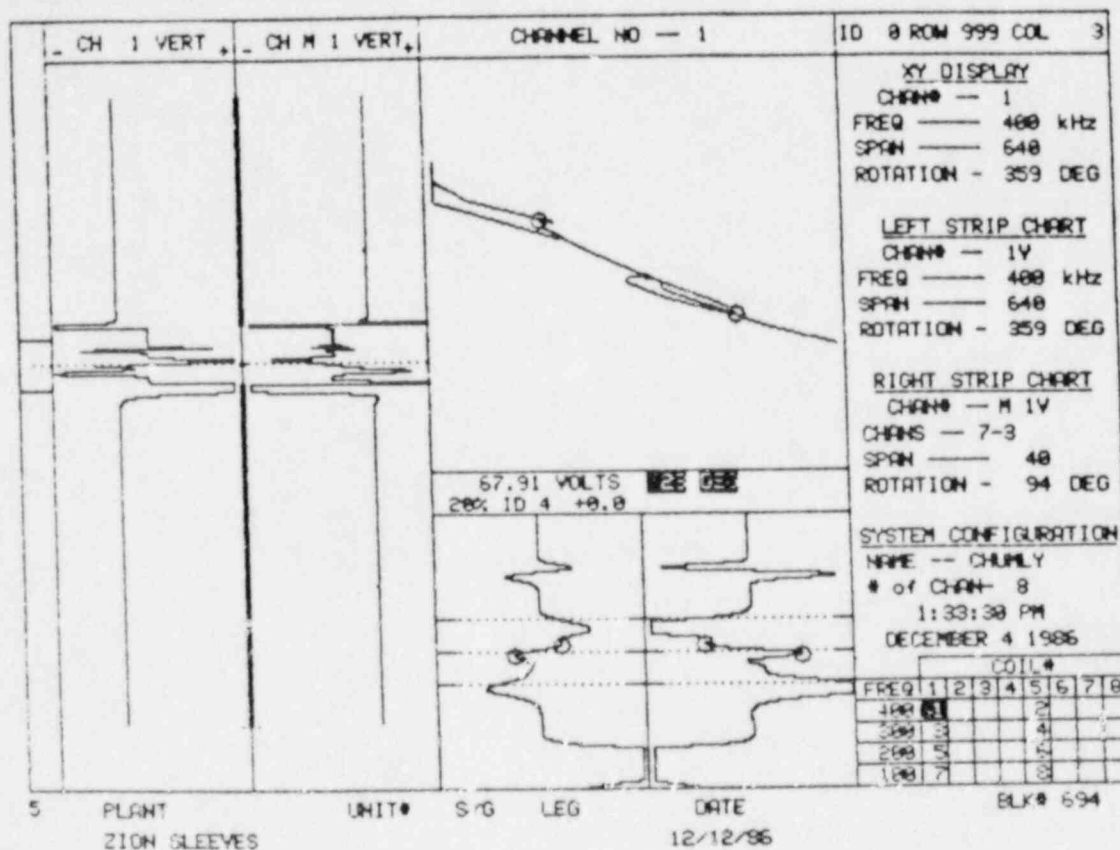
BOBBIN COIL

IN EXPANSION WITH WELD
