ACTION MANUFACTURING CO.
MANUFACTURING • ORDNANCE • ENGINEERING

Subject: Report of Incident, 18 December 1980

Reference: NRC License No. 37-19104-01
Attachment: Failure Analysis Report 2-010208

QDF NO. 2-010208	Analysis by: J.L. Gross		Date of Analysis 12-22-90
Part Name Scale Assembly	Lab or Location AMC - Plant #2		Address 2829 Cedar St.
Dwg. No. 11733751	Item No. # 18	Serial No. N/A	Manufacturer: AMC

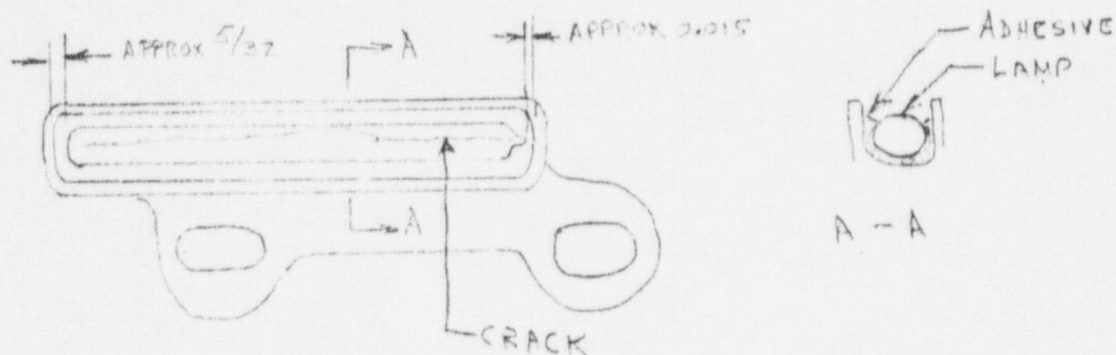
- 1.- Lamp not properly centered, end to end, in the holder. Since one end had only 0.015 inch clearance (versus 0.090 inch on the other end), it is possible that differential contraction/expansion rates of the aluminum holder versus the glass may have resulted in compression of the glass at low temperature.

The scale was carefully removed from the "leaker", and the holder and lamp visually examined. See sketch.

Three possibly significant observations were made.

- 1.- The lamp had a longitudinal crack, running the length of the lamp.
- 2.- The lamp was not carefully centered in the holder, with the clearance at the pointed end being approximately 0.015 inch, and 5/32 inch at the other end.
- 3.- The RTV adhesive covered approximately 230° around the circumference of the lamp.

- 2.- Greater than 180° circumferential coverage of the lamp, coupled with loss of some flexibility at low temperature, would have also contributed to the failure, if the premise of interference is correct.

- 3.- Testing at -90°F rather than -80°F could also be a contributing cause. This additional 10° would further reduce the flexibility of the RTV adhesive, increasing the probability of failure when coupled with premises 1 and 2 above. If the RTV became sufficiently hard, the greater than 180° circumferential coverage might also produce circumferential compression of the glass tube.
- 4.- A last possibility is that a latent defect existed in the glass. If this were true, then this defect coupled with any or all of the previously discussed potential causes would have resulted in the failure.

- 1.- Both assemblers and inspectors have been cautioned to:
 - a.- Assure the lamps are carefully centered in the holders, and NOT limit acceptable clearance to the 0.005 in. requirement of the drawing.
 - b.- Maintain circumferential RTV coverage of the lamp to 180° or less.
- 2.- New cams have been cut for low temperature cycle to assure that temperature does not go below -80° F.
- 3.- In addition to the plastic boxes, the test items will be placed in "Zip-Lok" type plastic bags to minimize probability of chamber contamination in case of future failure.
