PRECURSOR DESCRIPTION AND DATA

NSIC Accession Number: 169587

Title: Safety Injection Path to RCS Obstructed at Turkey Point 4

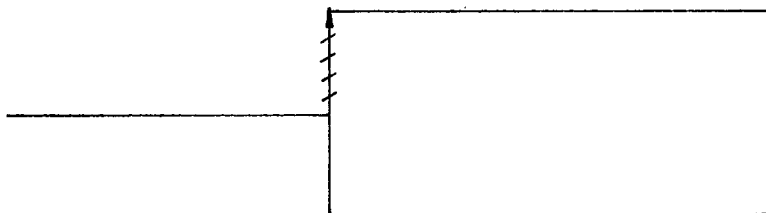
NSIC 169587 - Actual Occurrence for Safety Injection Path to RCS Obstructed at Turkey Point 4

Reactor beginning refueling outage	Safety injection system blocked by boric acid solidification
---------------------------------------	--

No - no requirement for safety injection

No

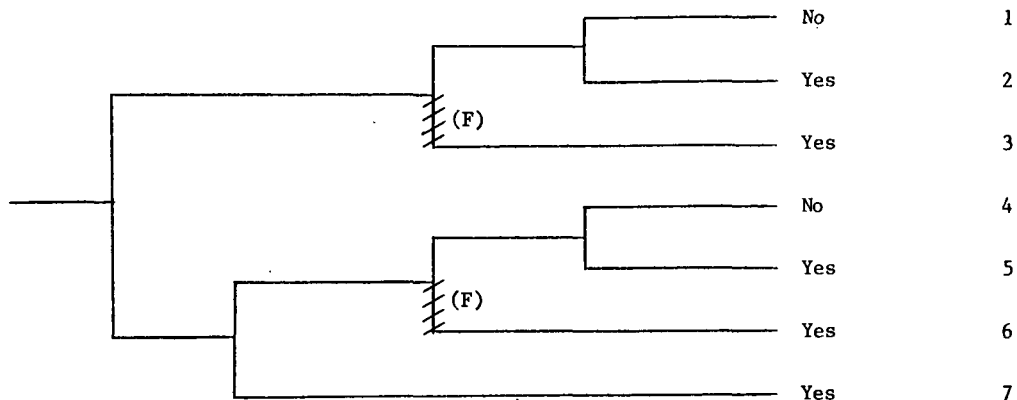
NSIC 169587 - Sequence of Interest for Safety Injection Path to RCS Obstructed
at Turkey Point 4

Small LOCA	Reactor Trip	Auxiliary Feedwater and Secondary Heat Removal	High Pressure Injection	Low Pressure Recirculation and LPR/HPI Cross-Connect	Potential Severe Core Damage	Sequence No.
---------------	-----------------	---	-------------------------------	---	---------------------------------------	-----------------
