## PRECURSOR DESCRIPTION AND DATA

NSIC Accession Number: 171733

Title: Unavailability of Three Auxiliary Feedwater Pumps at Zion 2

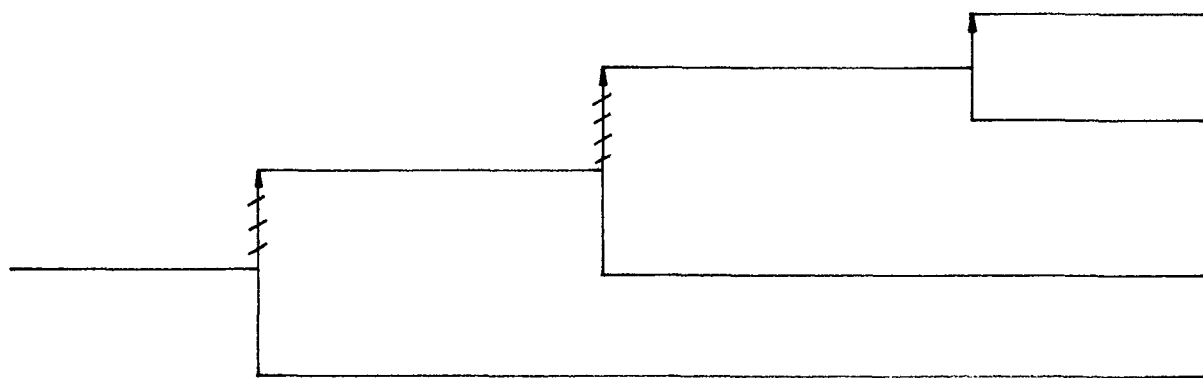
Reactor at 90% power and 2A turbine-driven AFW pump out of service for maintenance	Water leaks from two hydrogen coolers in the unit generator result in generator trip and subsequent reactor trip	Motor-driven AFW pumps fail to auto-start and run on low-low steam generator level due to low suction pressure trip caused by improperly sensed suction pressure	Motor-driven AFW pumps manually started
--	--	--	---

Potential  
Severe  
Core  
Damage

No

No - bleed and feed  
plus main feed-  
water recovery  
available
