PRECURSOR DESCRIPTION AND DATA

NSIC Accession Number: 148764

Title: Steam Dump Valves Fail to Close Following Load Rejection at Beaver Valley 1

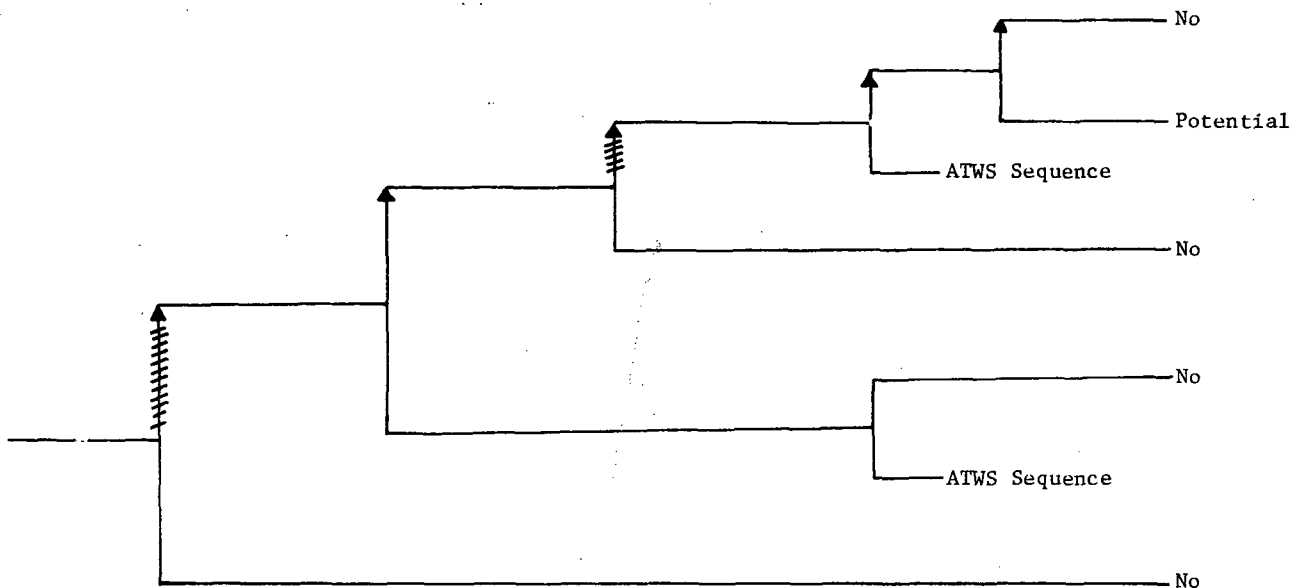
1. With the reactor at 92% power, the 1B heater drain pump tripped due to low heater drain tank level.
2. During the subsequent load rejection, the condenser steam dump valves opened as required, but failed to close because the valve operators were exposed to cold temperatures due to improperly positioned air dampers in the turbine building.
3. Low steam line pressure resulted in a reactor trip and safety injection.

NSIC 148764 - Actual Sequence for Steam Dump Valves Fail to Close Following Load Rejection at Beaver Valley

CAUSE: Valves failed to close due to exposure to abnormally low temperatures resulting from improper damper position, human error

The air dampers were properly positioned.

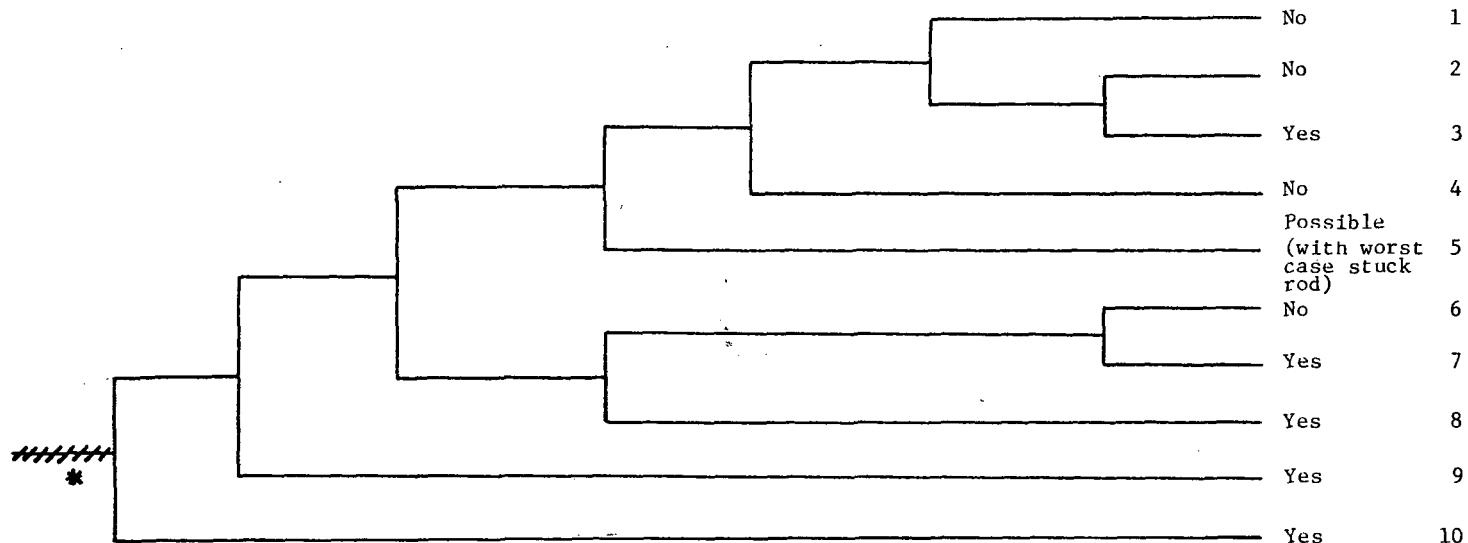
NSIC 148764 — Sequence of Interest for Steam Dump Valves Fail to Close Following Load Rejection at Beaver Valley 1

COMMENT: The LER does not specify how many of these valves stuck open. However, the FSAR (section 10.3) states that all the steam dump valves open on a step load decrease and the failure of 9 remaining open is equivalent to a steam line break.
