PRECURSOR DESCRIPTION AND DATA

NSIC Accession Number: 39024

Title: Loss of Off Site Power and Other Failures At Big Rock Point.

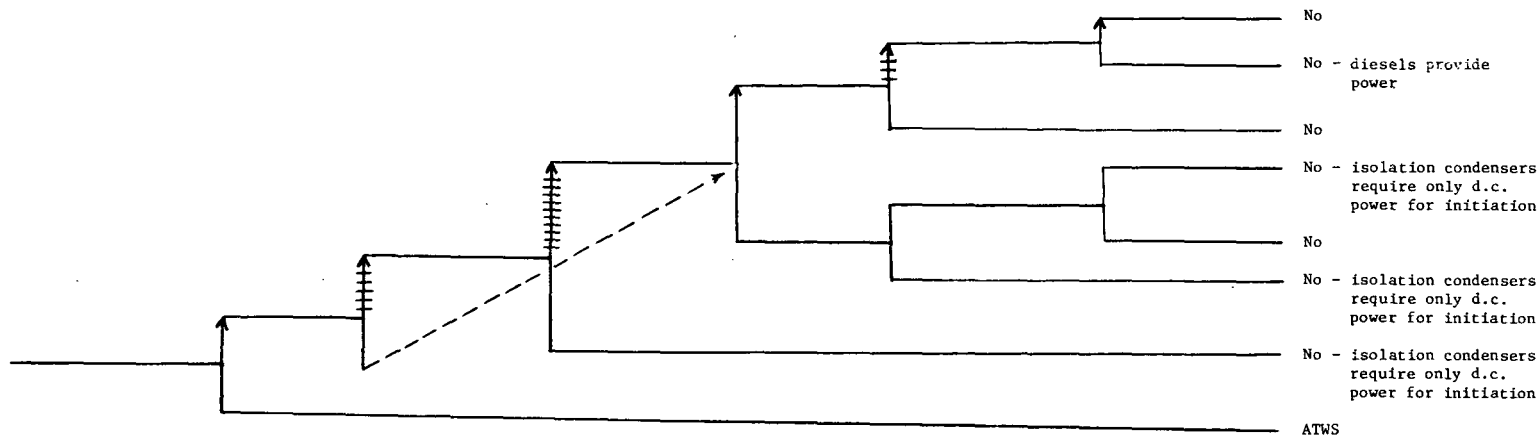
NSIC 39024 - Actual Occurrence of Loss of Offsite Power and Other Failures at Big Rock Point

Line faults induced by "galloping conductors" resulted in 388 OCB trip. Substation CB cleared the fault, but momentarily isolated the plant from the grid. This resulted in a turbine trip on overspeed.	Reactor trip on high neutron flux	199 OCB manually opened because 138kv line intermittently de-energized. Automatic transfer to the back-up 46kv line occurs	A faulty trip coil (380 OCB) and a faulty overcurrent relay (1288 OCB) caused the 46kv line to de-energize	Diesel starts and loads emergency bus	Voltage restored to 138kv line within 20 minutes, but broken trips on false signal from audio tone relay equipment	Audio tone relay overridden and power is restored to the 138kv line
--	-----------------------------------	--	--	---------------------------------------	--	---

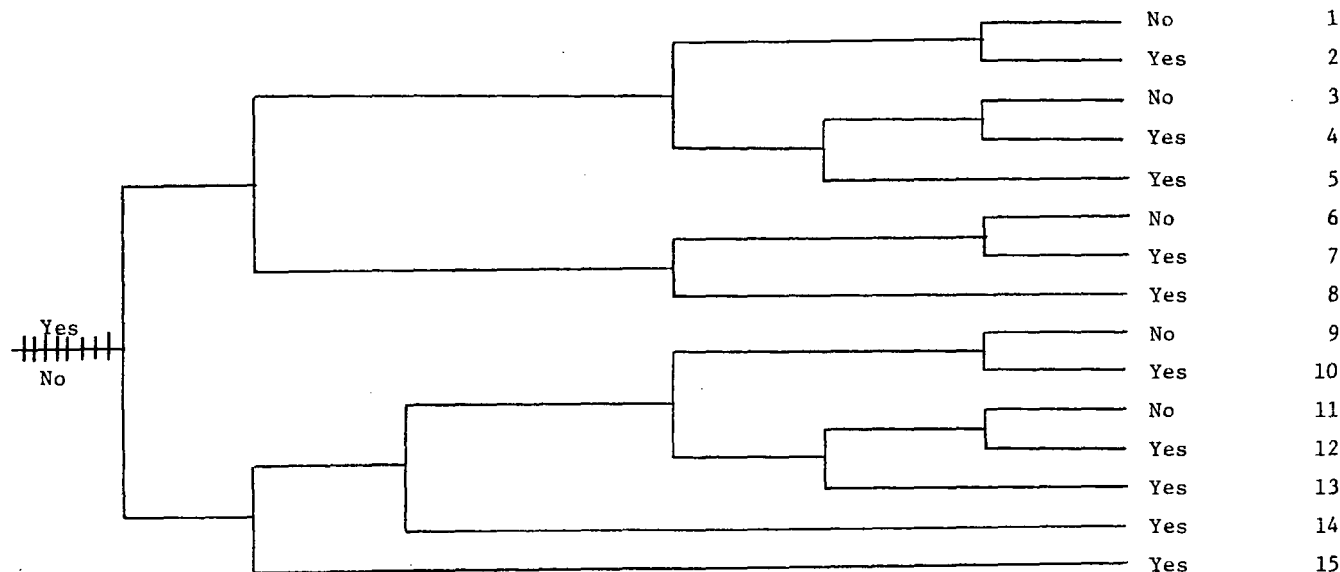
NSIC 39024 — Sequence of Interest of Loss of Offsite Power and Other Failures at Big Rock Point

¹ Big Rock Point utilizes isolation condenser instead of RCIC

² Success requires return of A.C. power within a day.
