NSIC Accession Number: 101444

Date: March 22, 1975

Title: Cable Tray Fire Causes Extensive Damage at Browns Ferry

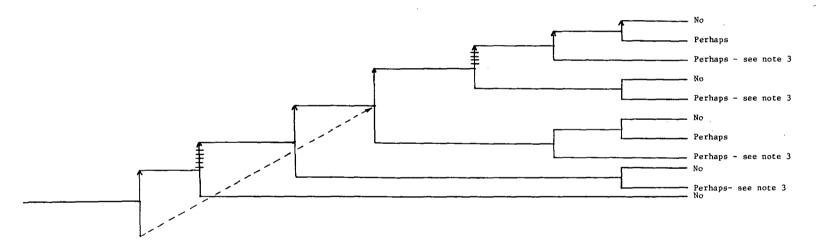
NSIC 101444 - Actual Occurrence of Cable Tray Fire at Browns Ferry 1

Reactor at power Opera and a cable spreading scram room fire resulted in anomalous behavior of ECCS controls 6 instrumentation	the supplying systems	automatically closes	Pressure relief valves manually opened allowing condensate booster pumps to supply water	Relief valves fail closed eliminating C.B. pump cooling	Valves repaired & booster pump returned to service	Shutdown ² cooling establishes	Potential Severe Core Damage
---	-----------------------	----------------------	---	---	---	---	---------------------------------------

- 1. Closure of the MSIV had two immediate consequences.
 - (a) The steam generated by decay heat could not be passed to the main condenser, but instead remained in the reactor.
 - (b) The steam supply to the feedwater pump turbine was lost thus eliminating the remaining source of high pressure cooling water.

The MSIV is designed to fail closed.

- 2. The MSIV closed shortly after 1:00 pm. Shutdown cooling wasn't restored until 4:30 am the next morning. Without adequate cooling over this period of time the core would have been severely damaged.
- 3. See the attached sheet. This information was obtained from *Nuclear Safety*, Vol. 17, No. 5, September-October 1976, p. 607.

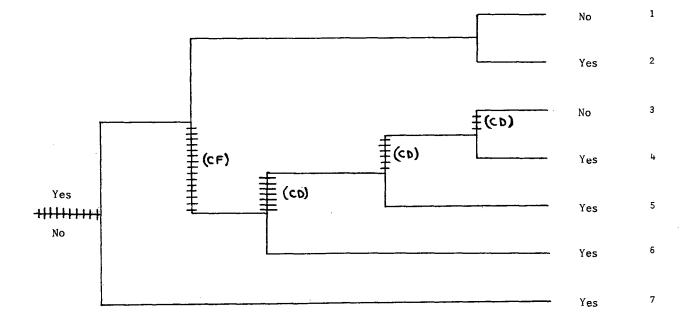
NSIC 101444 - Sequence of Interest of Cable Tray Fire at Browns Ferry 1

Loss of Feedwater Flow	Reactor Subcritical	RCIC/HPCI Response Adequate	Automatic ² Depressurization System Operates	LPCI or CS Response Adequate	Long Term Core Cooling	Potential Severe Core Damage	Sequence No.
------------------------------	------------------------	-----------------------------------	---	------------------------------------	---------------------------------	---------------------------------------	-----------------

1

Nonstandard techniques could have been used to make RCIC operable.

2

The depressurization was manually initiated.
