PRECURSOR DESCRIPTION AND DATA

NSIC Accession Number: 95040

Title: HPCI Injection Valves and RCIC Fail at Browns Ferry 2

NSIC 95040 — Actual Occurrence of HPCI Injection Valves and RCIC Fail at Browns Ferry 2

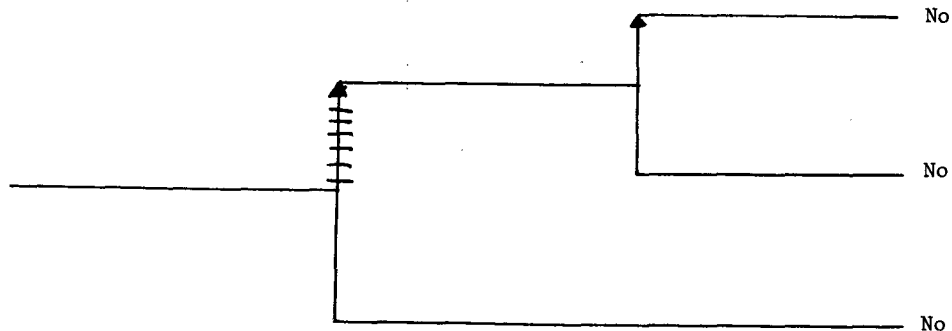
1. The HPCI injection valve failed to open during post-maintenance testing of this valve.
2. RCIC was then initiated, however, it failed to show any speed indication. The seat holding the valve operative was broken and a printed circuit board in the tachometer was damaged.

HPCI Test Underway With The Reactor At 5% Power	HPCI Injection Valve Fails To Open	RCIC Initiates But Turbine Fails To Develop Speed	Potential Severe Core Damage
--	---------------------------------------	---	---------------------------------------

1. The broken valve operator seats were replaced.
2. A new circuit board was installed in the RCIC tachometer.
