PRECURSOR DESCRIPTION AND DATA

NSIC Accession Number: 128569

Title: Safety Relief Valve Fails to Reset at Brunswick 2

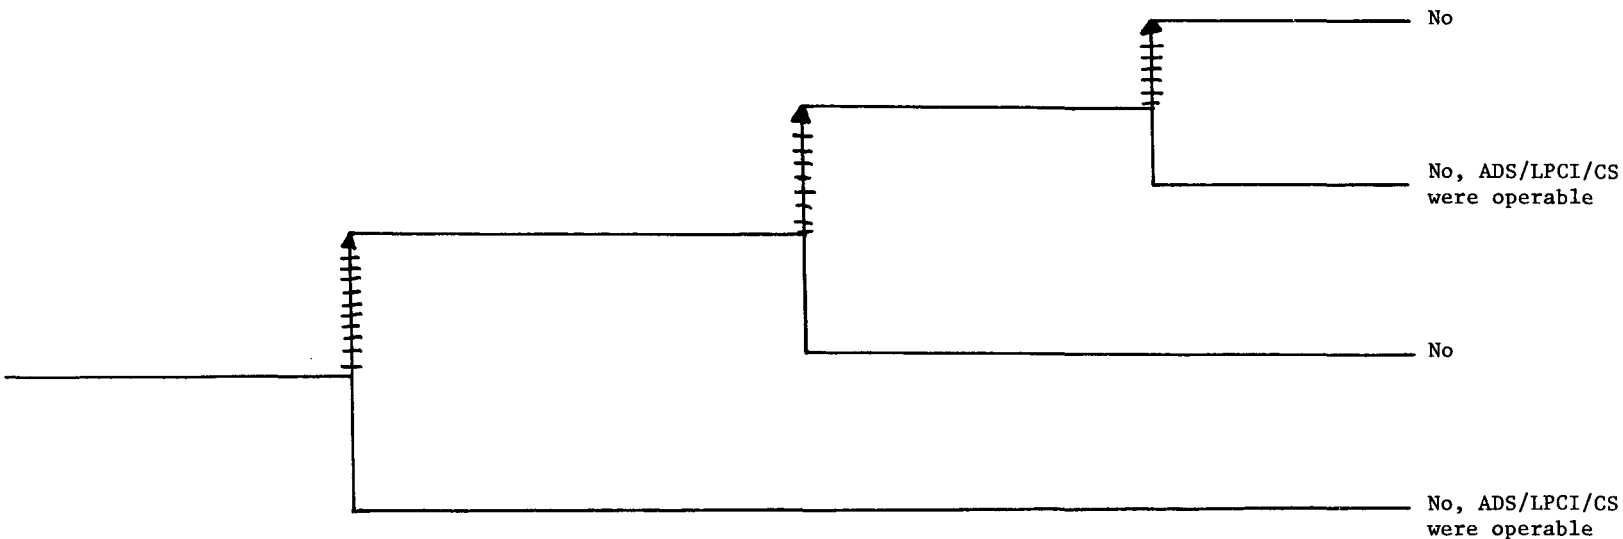
A Reactor Scram Occurred
Following A Turbine Trip

HPCI/RCIC Initiated And Injected
Into The Core, They Tripped Once
Water Level Was Recovered

Safety Relief Valves Were
Used To Control Pressure.
The "B" Safety Relief
Valve Stuck Open On The
Third Opening

RCIC Was Manually
Initiated But Was
Insufficient To
Maintain Water
Level. HPCI Was
Then Initiated
And Water Level
Was Again Re-
stored

Potential
Severe
Core
Damage

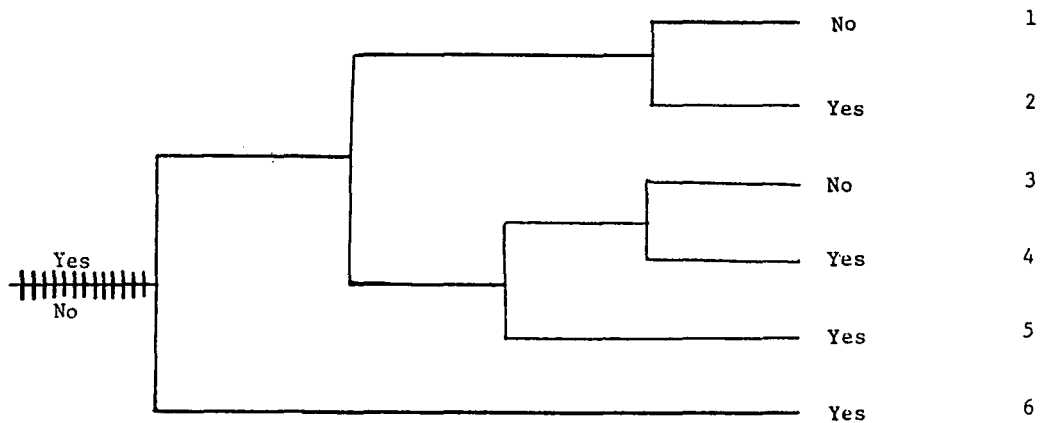
NSIC 128569 - Sequence of Interest for Safety Relief Valve Fails to Reset at Brunswick 2

Loss of Coolant Accident	Reactor Maintained Subcritical	HPCI/RCIC Response Adequate	ADS/LPCI CS Response Adequate	Long Term Core Cooling	Potential Severe Core Damage	Sequence No.
--------------------------------	--------------------------------------	-----------------------------------	--	---------------------------------	---------------------------------------	-----------------
