PRECURSOR DESCRIPTION AND DATA

NSIC Accession Number: 150271

Title: Both RHR Service Water Pumps Inoperable at Brunswick 2

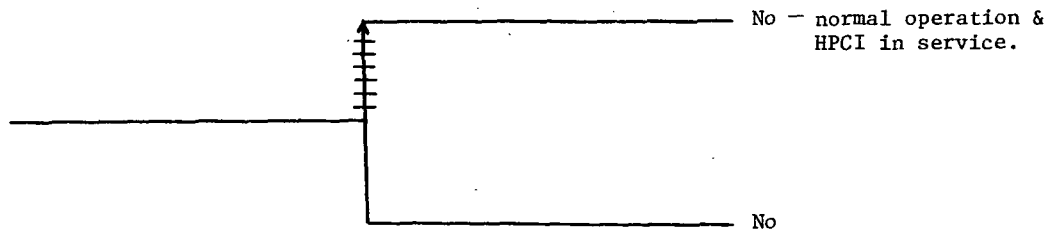
With the reactor at 88% power, the operator gives clearance to uncouple RHR pump 2B for alignment check	Mechanic uncouples pump 2A by mistake, leaving both pumps out of service for 7 days	Potential Severe Core Damage
---	---	---------------------------------------

NSIC 150271 - Actual Occurrence of Both RHR Service Water Pumps Inoperable at Brunswick 2

Seven hours later the error was discovered and pump 2A was recoupled and tested to ensure operability.

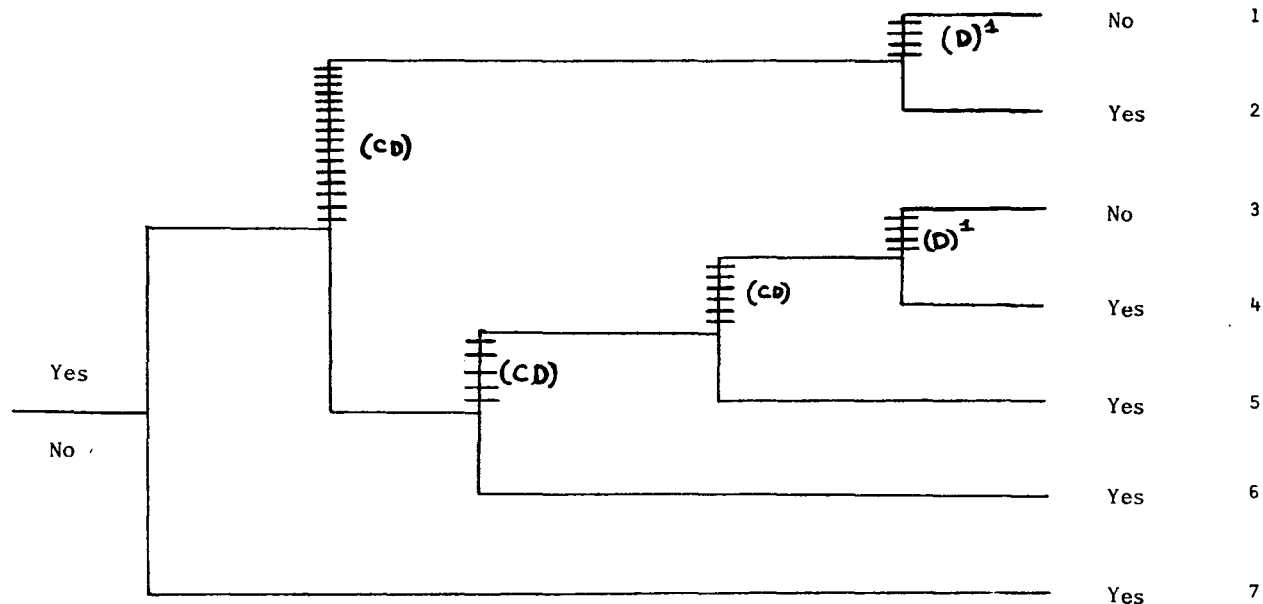
Loss of Feedwater Flow	Reactor Subcritical	RCIC/HPCI Response Adequate	Automatic Depressurization System Operates	LPCI or CS Response Adequate	Long Term Core Cooling	Potential Severe Core Damage	Sequence No.
------------------------	---------------------	-----------------------------	--	------------------------------	------------------------	------------------------------	--------------

NSIC 150271 — Sequence of Interest of Both RHR Service Water Pumps Inoperable at Brunswick 2

¹For success the operator must rack the pumps backin within 2-24 hours.
