PRECURSOR DESCRIPTION AND DATA

NSIC Accession Number: 137543

Title: Diesel Generator Fails to Start Following a Loss of All Offsite Power at Calvert Cliffs 1

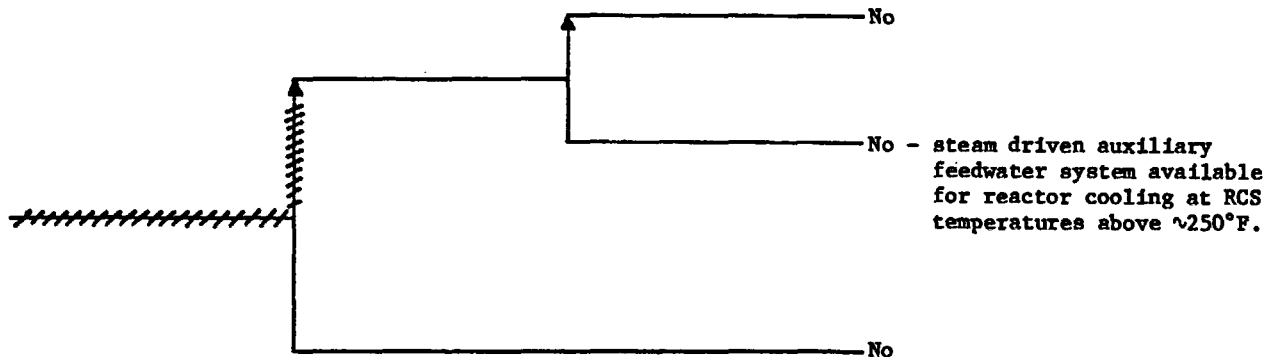
NSIC 137543 - Actual Occurrence for Diesel Generator Fails to Start Following a Loss of All Offsite Power at Calvert Cliffs 1

1. With the plant shutdown, switchyard breaker protective relaying automatically opened the switchyard breakers, resulting in a loss of offsite power.
2. Diesel generator 11 failed to start.
3. Diesel generator 12 started and provided power to safety-related loads.

None - the cause of the diesel-generator failing to start was not determined.

| With the Reactor Shutdown, Switchyard Breaker Protection Relaying Automatically Opened Breakers, Resulting in a Loss of Offsite Power | Diesel-Generator 11 Fails to Start | Diesel-Generator 12 Starts and Provides Power to Safety-Related Loads | Potential Severe Core Damage |

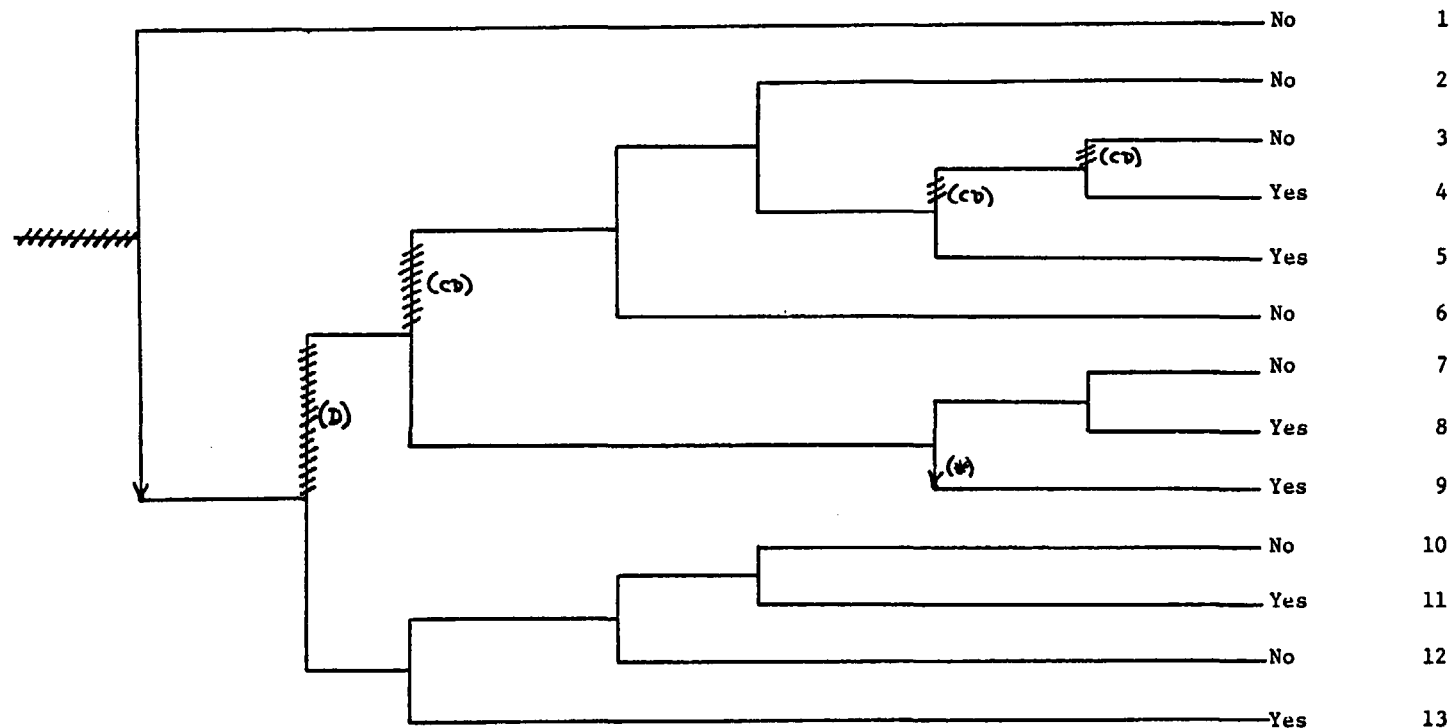
NSIC 137543 — Sequence of Interest for Diesel Generator Fails to Start Following a Loss of All Offsite Power at Calvert Cliffs 1

| Loss of Offsite Power | Turbine Generator Runs Back and Assumes House Loads | Emergency Power | Auxiliary Feedwater and Secondary Heat Removal | PORV Demanded | PORV or PORV Isolation Valve Closure | High Pressure Injection | Long Term Core Cooling | Potential Severe Core Damage | Sequence No. |

* Not included in mitigation procedures.
