PRECURSOR DESCRIPTION AND DATA

NSIC Accession Number: 128906

Title: No Break Power Panel De-energized at Cooper

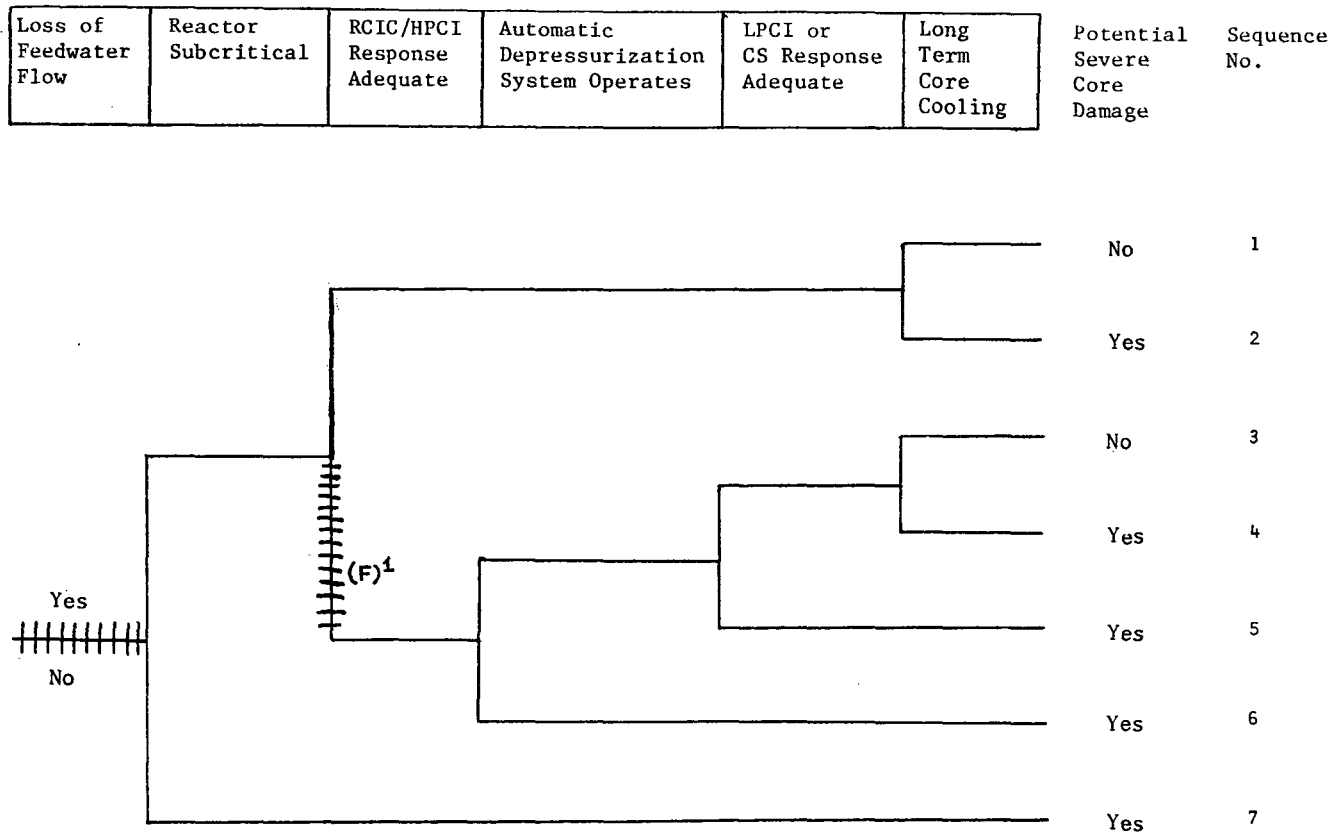
1. A blown fuse in the no break power panel (NBPP) caused it to de-energize. The automatic power backup source was out of service (due to a failed K10 contactor).
2. The NBPP supplies both the feedwater controller and the RCIC, thus a partial loss of feedwater flow and degraded operation of the RCIC resulted.
3. The reactor tripped on low water level.
4. The MSIVs closed and the HPCI and RCIC systems initiated on low-low water level.
5. Neither the RCIC nor the HPCI responded adequately. The RCIC did not go to full speed because of the loss of the NBPP. The HPCI, however, did not accelerate to full speed because the governor actuator was not functioning.

6. A relief valve opened at 1080 psig for pressure control.
7. At -110" the operator opened another relief valve in order to increase HPCI flow. At that point power was restored and the RCIC pump ramped up to power and provided proper water level control.

NSIC 128906— Sequence of Interest for No Break Power Panel De-energized at Cooper

¹Success requires restoration of power to the NBPP.

1. The blown fuse was replaced.
2. The contactor for the auxiliary power source was replaced and reconnected.
