PRECURSOR DESCRIPTION AND DATA

NSIC Accession Number: 150882

Title: Both Diesel Generators Trip During Testing at Crystal River 3

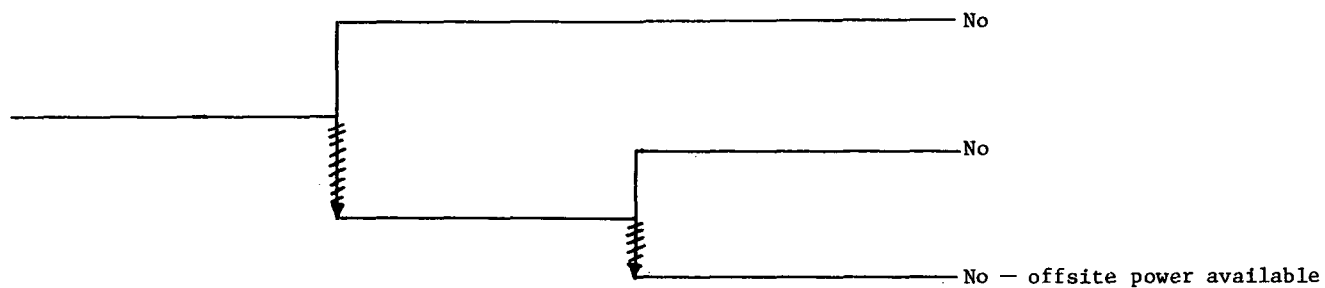
1. During performance of Engineered Safeguards Time Response Test, both diesel generators tripped when loaded on the emergency buses due to an imbalance in reactive load.

NSIC 150882 — Actual Occurrence for Failure of Both Diesel Generators During Testing at Crystal River 3

CAUSE: Imbalance in reactive load, both DGs tripped, (human error)

1. A procedure revision was implemented to eliminate the high MVAR and reduce the reactive load imbalance.
2. The diesel generators were surveilled daily from June 9 - June 15 and performed satisfactorily.

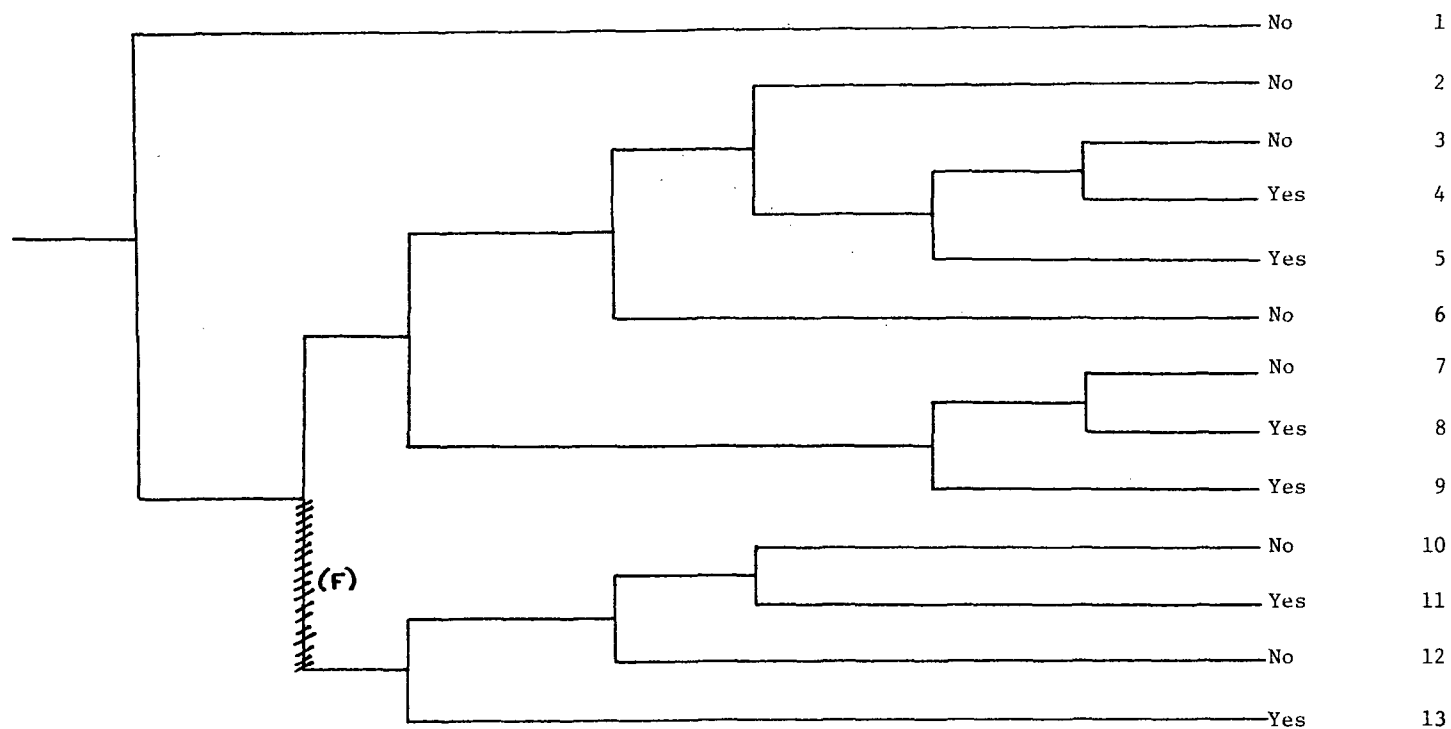
NSIC 150882 - Sequence of Interest for Failure of Both Diesel Generators During Testing at Crystal River 3

SEQUENCE OF INTEREST: Loss of off-site power
