PRECURSOR DESCRIPTION AND DATA

NSIC Accession Number: 153333

Title: Flowpath from AFW Pump to Two Steam Generators Made Inoperable at Cook 1

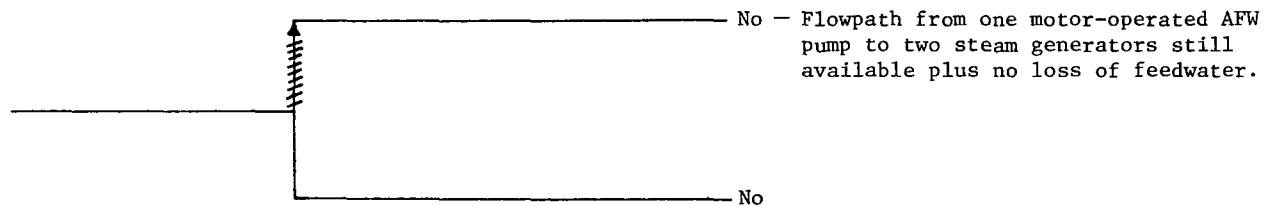
Reactor at 100% Power with Turbine- Driven AFW Pump Out of Service	Power Supply for Valves from Motor-Operated AFW Pump to Two of Four Steam Generators Removed from Service for Inspection
---	--

NSIC 153333 - Actual Occurrence for Flowpath from AFW Pump to Two Steam Generators Made Inoperable at Cook 1

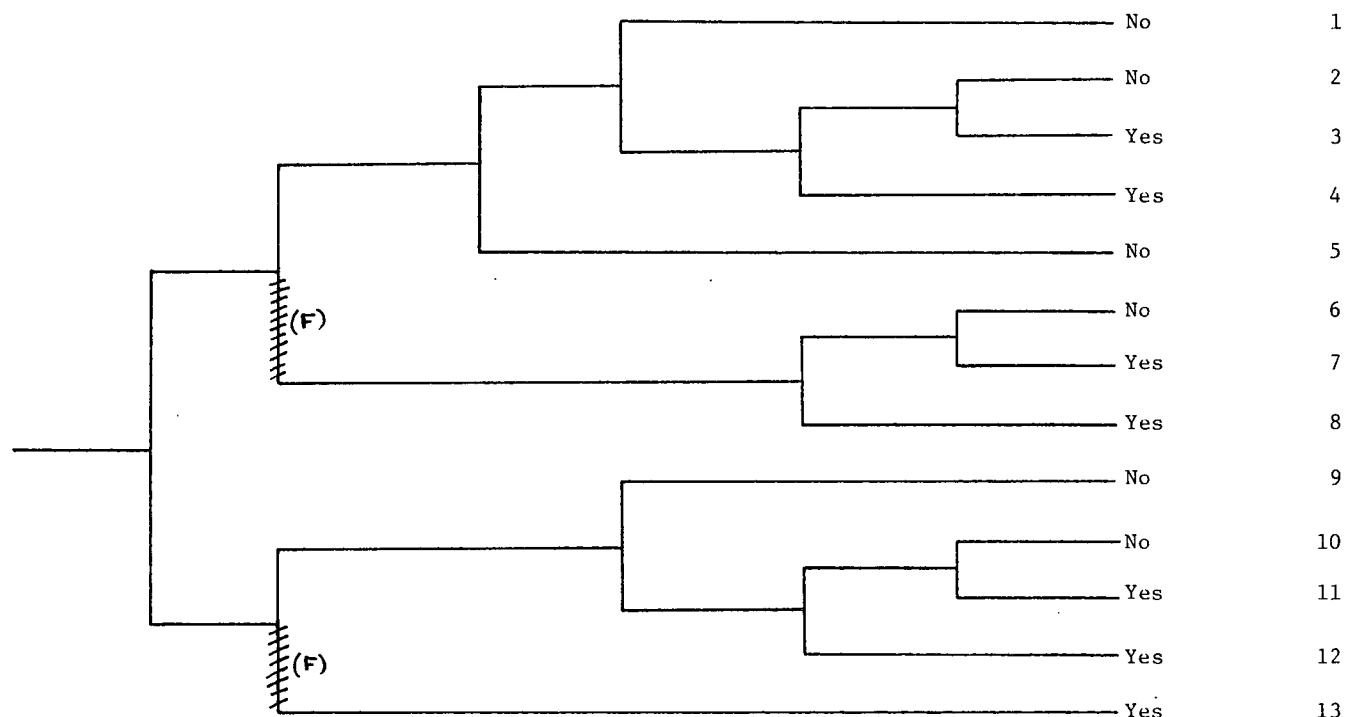
NSIC 153333 - Sequence of Interest for Flowpath from AFW Pump to Two Steam Generators Made Inoperable at Cook 1
