# PRECURSOR DESCRIPTION AND DATA

NSIC Accession Number: 130788

Title: Half-trip of SFRCS Causes RCS Pressure Rise at Davis-Besse 1

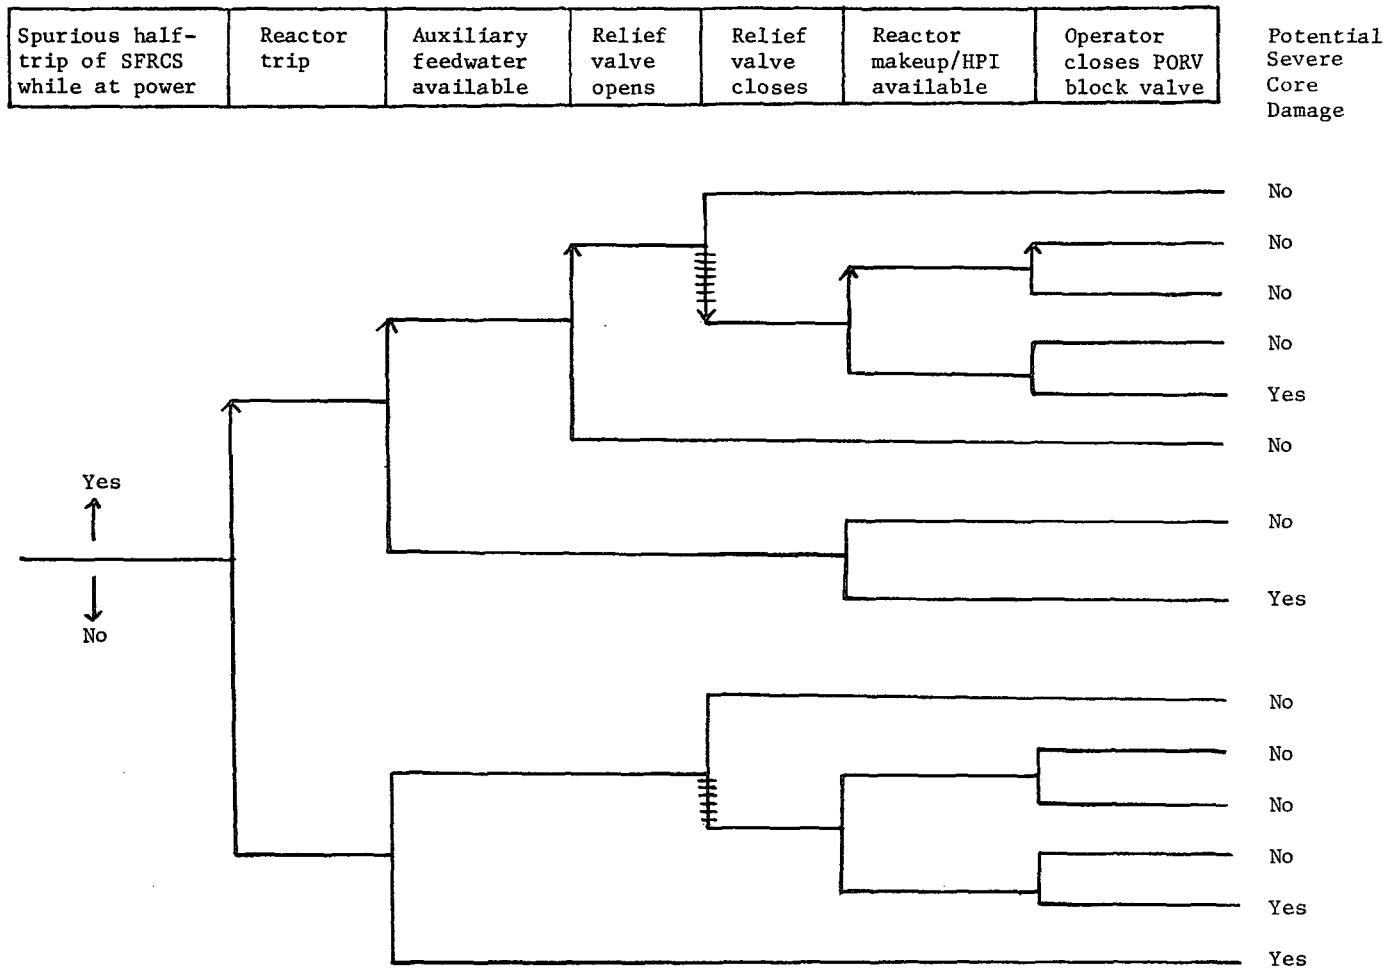
NSIC 130788 — Actual Occurrence for Spurious Half-Trip fo SFRCS Causes RCS Pressure Rise at Davis-Besse 1

1. A spurious half-trip of the SFRCS occurred, which initiated closure of a feedwater valve, resulting in loss of water to one steam generator.
2. The reduction in heat removal resulted in operation of the pressurizer relief valve, which failed open after 9 open/close cycles.
3. The operator manually tripped the reactor; within six minutes the RCS was at saturation pressure/temperature.
4. The pressurizer level went to maximum.
5. Approximately 25 minutes later the operator realized the relief valve was stuck open and closed the block valve, terminating the transient.

CAUSE: Close relay missing from relief valve control circuit (PORV failure).

1. The SFRCS was monitored to detect spurious signals.
2. Plans were also being developed to add additional SFRCS alarm windows and seal in alarm conditions.
3. A missing PORV control circuit relay was installed.

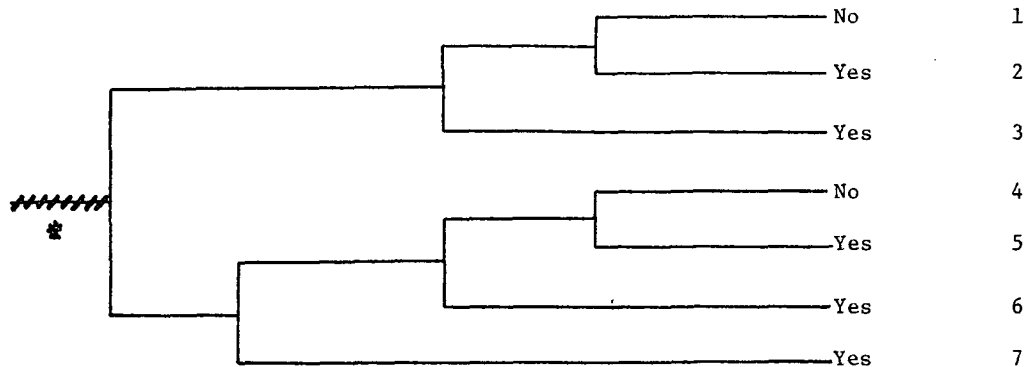
NSIC 130788 -- Sequence of Interest for Spurious Half-Trip of SFRCS Causes RCS Pressure Rise at Davis-Besse 1

\* failure requires operator error in failing to close PORV block valve.

SEQUENCE OF INTEREST: Stuck open PORV — small LOCA.
