# PRECURSOR DESCRIPTION AND DATA

NSIC Accession Number: 132927

Title: Both 13.8 kV Buses De-energized at Davis-Besse 1

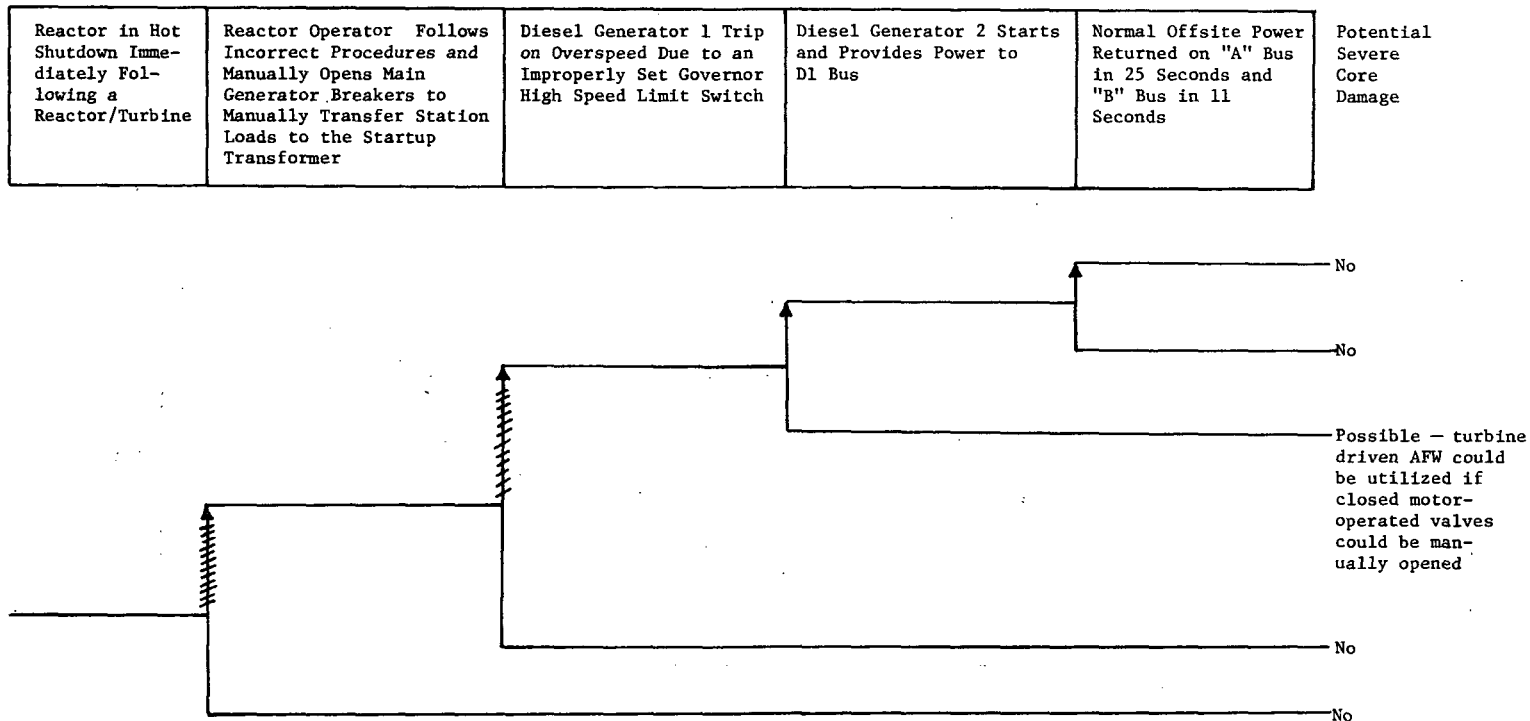
NSIC 132927 - Actual Occurrence for Both 13.8 kv Buses De-Energized at Davis-Besse 1

1. Immediately following a reactor/turbine trip, the operator opened the main generator breakers and attempted a manual transfer to the two station start-up transformers. The applicable emergency procedure incorrectly called for manually tripping the turbine generator output breaker after trip, which did not allow for auto transfer to the startup transformer.
2. The diesel generators started and DG 2 supplied power to the D1 bus.
3. Diesel generator DG 1 tripped on overspeed due to the improper setting of the governor high speed limit switch.
4. Normal off-site power was returned within 11 seconds on the "B" bus and 25 seconds on the "A" bus.

CAUSE: Operator incorrectly attempted manual transfer to startup transformers,  
incorrect setting of diesel generator governor high speed limit switch.

ACTUAL OCCURRENCE: Operator error induced loss of offsite power with subsequent  
diesel generator overspeed trip.

The applicable emergency procedure was revised to preclude manual tripping of the turbine generator breakers after a turbine trip.

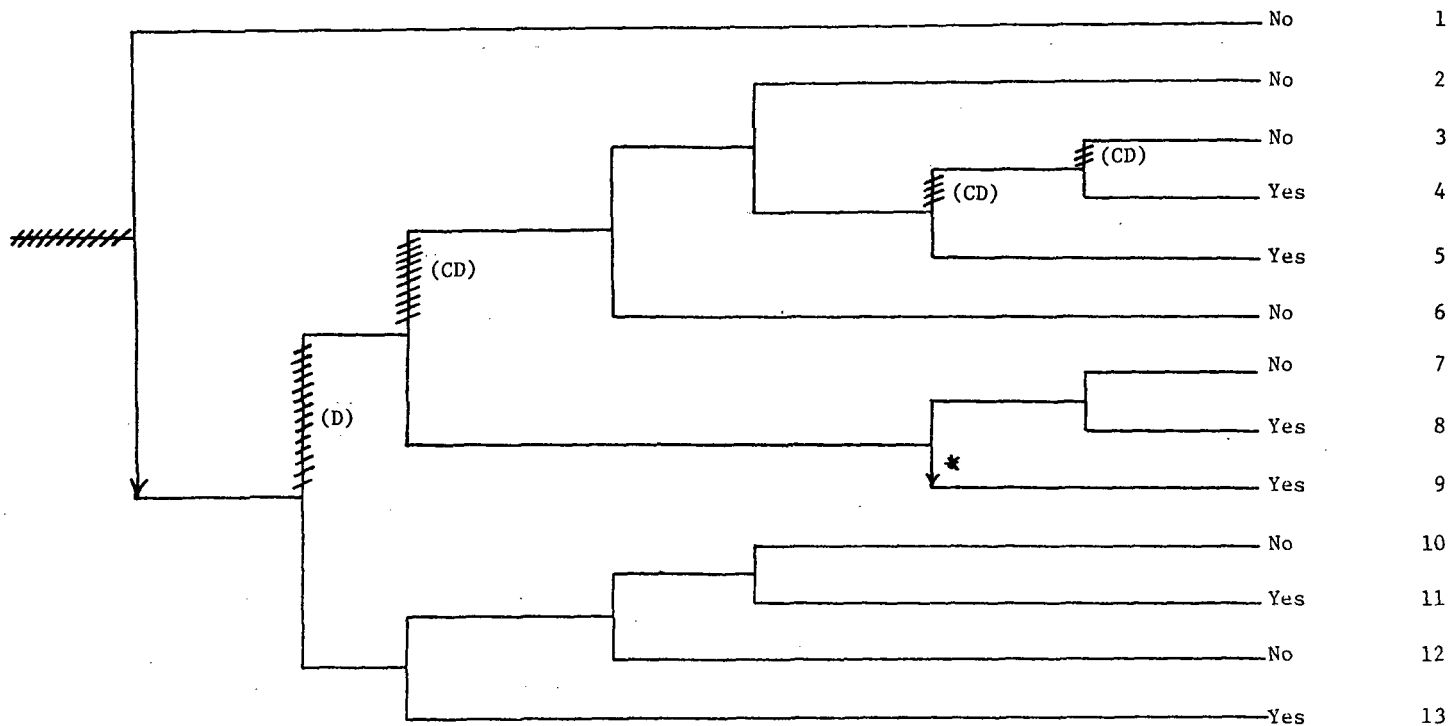
NSIC 132927 — Sequence of Interest for Both 13.8 kv Buses De-Energized at Davis-Besse 1

SEQUENCE OF INTEREST: Loss of offsite power
