PRECURSOR DESCRIPTION AND DATA

NSIC Accession Number: 133706

Date: December 11, 1977

Title: Control of Both Auxiliary Feed Pump Turbines Lost at Davis-Besse 1

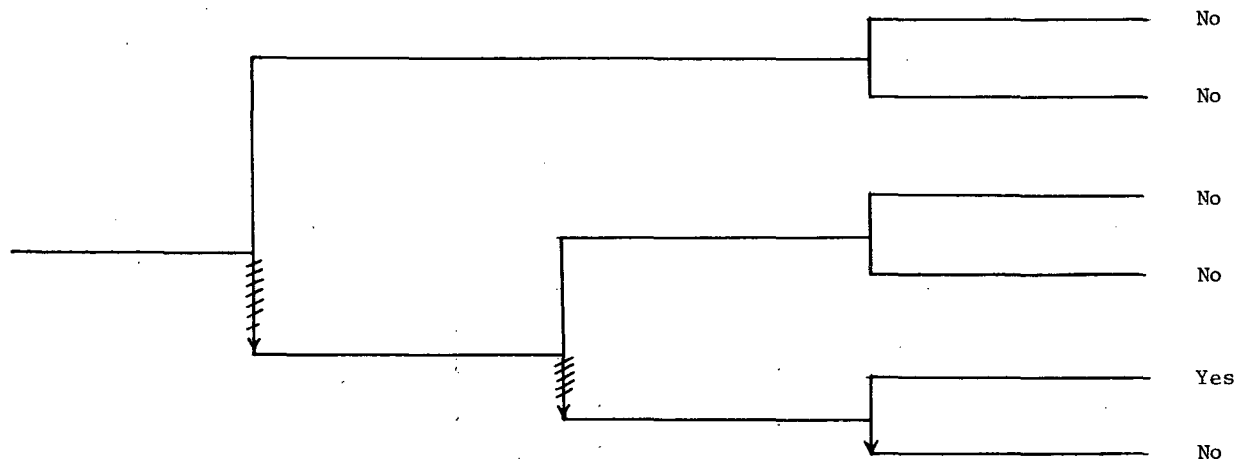
NSIC 133706 — Actual Occurrence for Control of Both Auxiliary Feed Pump Turbines Lost at Davis-Besse 1

1. During testing, control over both auxiliary feedwater pump turbines was lost, rendering the pumps inoperable.
2. Control of the turbine for pump 1-1 was lost due to mechanical binding in the governor.
3. Control of the turbine for pump 1-2 was lost due to blown control power supply fuses for the speed changer motor.

Reactor in hot standby during "Reactor/Turbine Trip Test"	Auxiliary feedwater pump 1-1 operable	Auxiliary feedwater pump 1-2 operable	Auxiliary feedwater pump required	Potential Severe Core Damage
---	---------------------------------------	---------------------------------------	-----------------------------------	------------------------------

1. On pump 1-1, the roll pin which was binding was repositioned, cleaned, and lubricated.
2. On pump 1-2, the blown fuses were replaced, as were two relays suspected of sticking and causing the blown fuses.

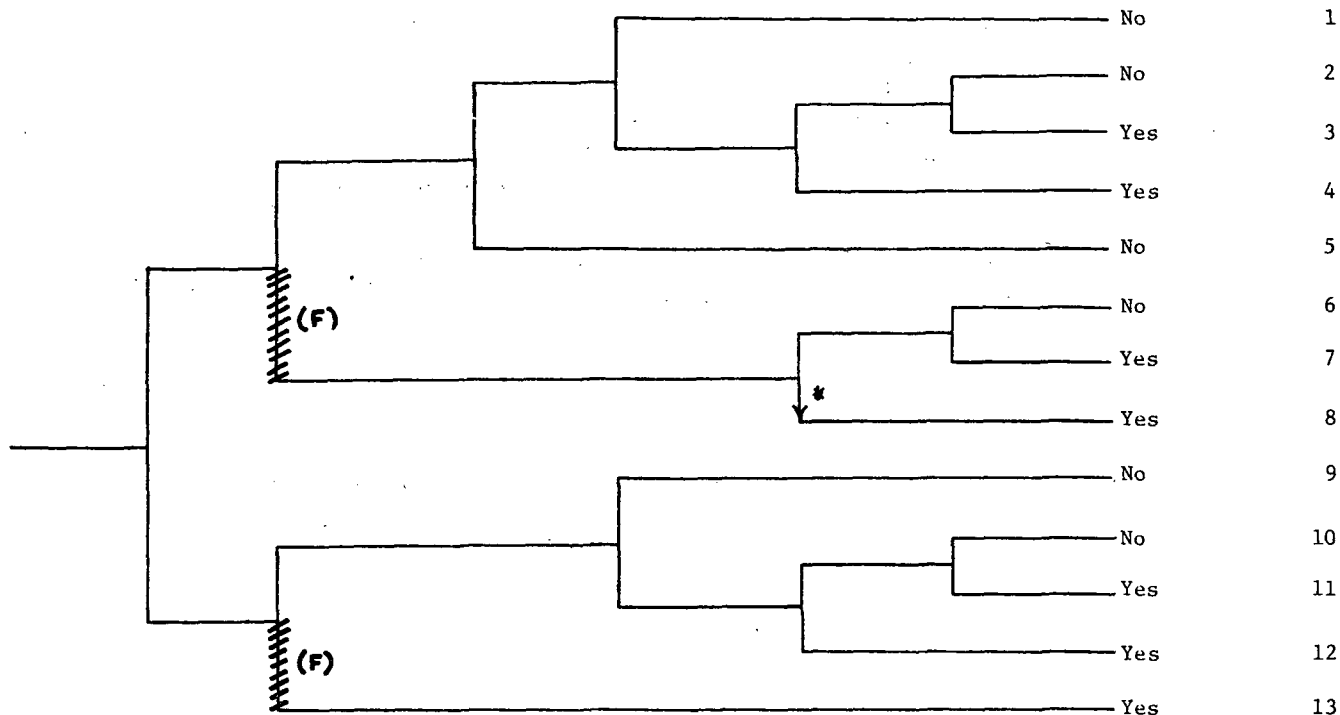
NSIC 133706 — Sequence of Interest for Control of Both Auxiliary Feed Pump Turbines Lost at Davis-Besse 1

Loss of Main Feedwater	Reactor Trip	Auxiliary Feedwater and Secondary Heat Removal	PORV Demanded	PORV or PORV Isolation Valve Closure	High Pressure Injection	Long Term Core Cooling	Potential Severe Core Damage	Sequence No.
------------------------	--------------	--	---------------	--------------------------------------	-------------------------	------------------------	------------------------------	--------------

*not included in mitigation procedures
