# PRECURSOR DESCRIPTION AND DATA

NSIC Accession Number: 152951

Date: October 15, 1979

Title: Offsite Power Lost at Davis-Besse 1

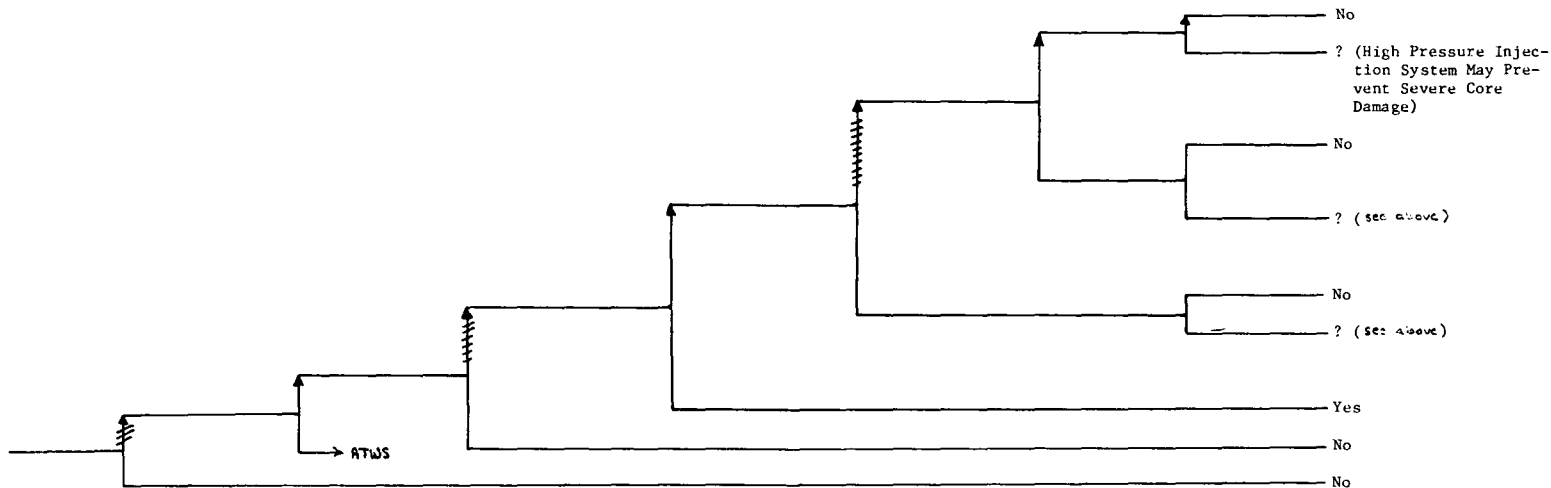
Reactor at ~69% Power	ICS Capacitor Failure Opens Turbine Control Valves, Resulting in Increased Reactor Power and Increased Feed-water Flow	Reactor Trip at Reduced High Flux Set Point of ~69% Power	Fault in Generator Output Breaker 35460 Due to Failed Muffler Results in Trip of 345 kv "J" Bus and Loss of Offsite Power	Diesel Generators No. 1 & 2 Start and Load Their Safety-Related Buses	Linkage Rod Assembly Failure in Diesel Generator No. 2 Output Breaker Results in Failure of Train No. 2 Component Cooling Water and Service Water Pumps to Start	Operator Manually Starts Train No. 2 Component Cooling Water and Service Water Pumps	Steam Driven AFW Pumps Provide SG/RCS Cooling	Potential Severe Core Damage
-----------------------	--	---	---	---	--	--	---	------------------------------

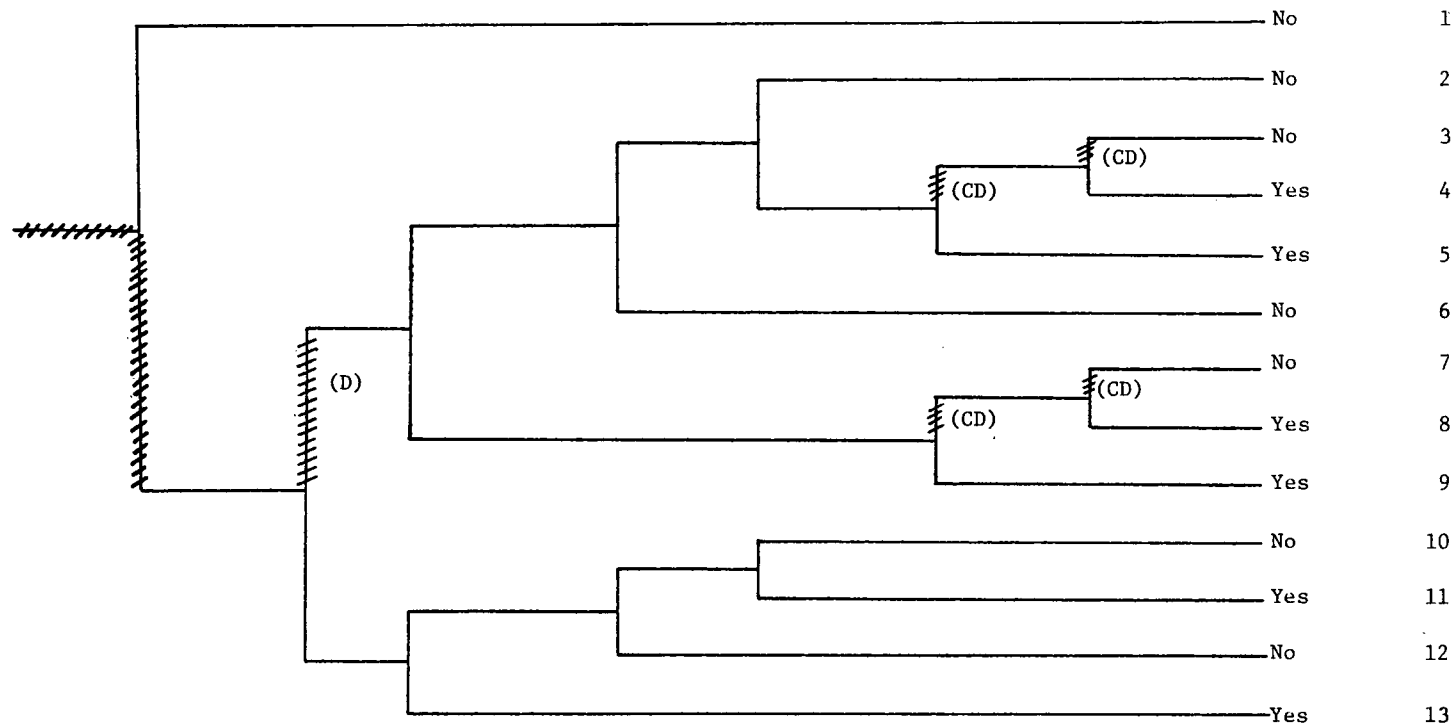
Loss of Offsite Power	Turbine Generator Runs Back and Assumes House Loads	Emergency Power	Auxiliary Feedwater and Secondary Heat Removal	PORV Demanded	PORV or PORV Isolation Valve Closure	High Pressure Injection	Long Term Core Cooling	Potential Severe Core Damage	Sequence No.
-----------------------	---	-----------------	--	---------------	--------------------------------------	-------------------------	------------------------	------------------------------	--------------
