NSIC Accession Number: 44751

Date: April 27, 1970

Title: Failure of Three of Four Safety System Sensors for Primary Drum Low Level Scram at Dresden 1

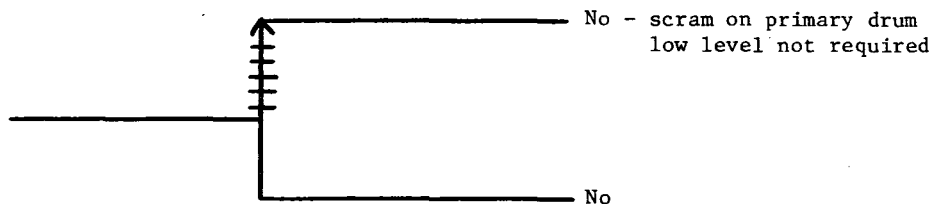
NSIC 44751 — Actual Occurrence for Failure of Three of Four
Safety System Sensors for Primary Drum Level Scram at Dresden 1

During a routine test, three of four primary drum low level scram system sensors were found failed due to crud build-up in the switches. These failures would cause a failure to scram on low drum level if that were required.

(Reactor condition unknown) testing in progress	Three of four primary drum low level scram switches found failed	Potential Severe Core Damage
---	--	---------------------------------------

CAUSE: Crud buildup in the float chambers

The switches were flushed and their proper operation was demonstrated. The switches were to be replaced with differential-type switches at the up-coming refueling.

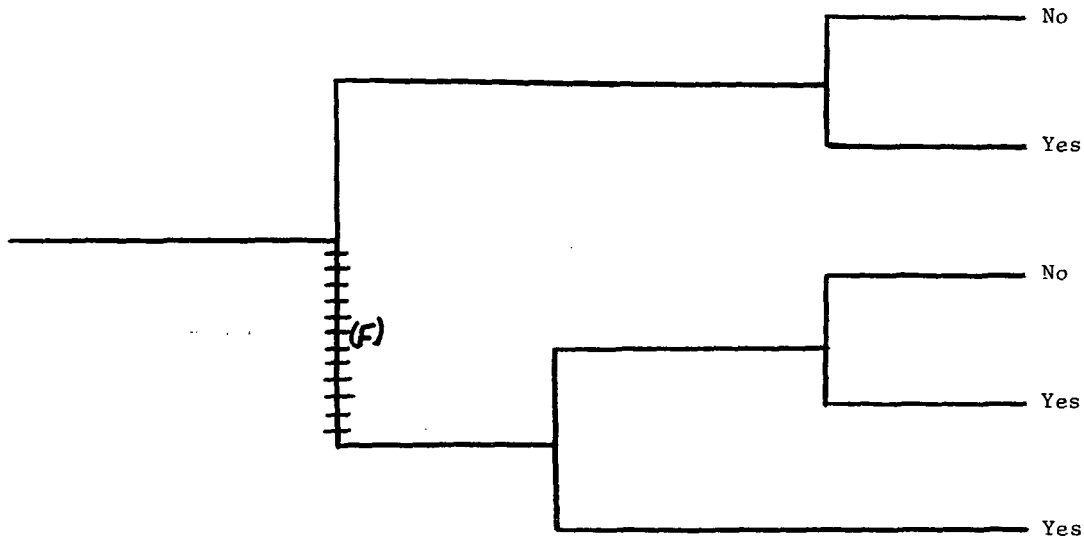
NSIC 44751 — Sequence of Interest for Failure of Three of Four Safety System Sensors for Primary Drum Level Scram at Dresden 1

Loss of feedwater due to inadvertent valve closure, etc. (feed system still pressurized normal loss of feedwater trip unavailable)	Reactor scram on low primary drum level	Operator detects low primary drum level and manually scrams reactor (or initiates secondary shutdown system)	Emergency condenser provides core cooling	Potential Severe Core Damage
--	---	--	---	------------------------------
