PRECURSOR DESCRIPTION AND DATA

NSIC Accession Number: 47814

Title: Depressurization Incident at Dresden 2

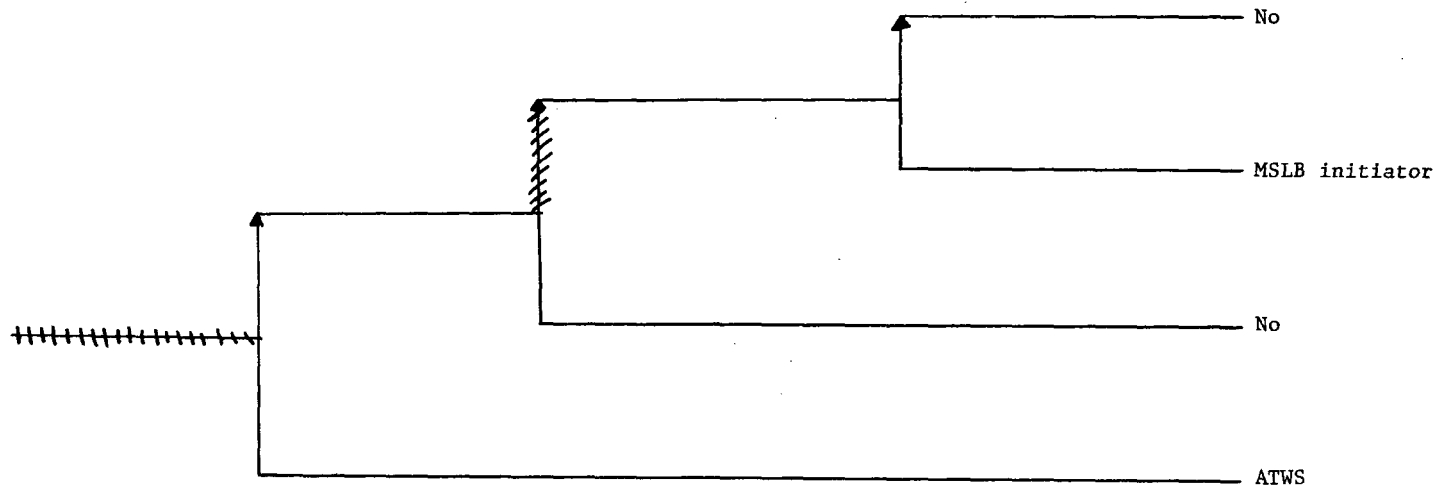
A Spurious Signal Initiates a Feed-water Transient	The Reactor Tripped	Due to an Erroneous Signal the Operator Took Control of the Feedwater Controls and Overfilled the Vessel	Feedwater Was Throttled Back and the Reactor Placed in Cold Shutdown	Potential Severe Core Damage
--	---------------------	--	--	------------------------------

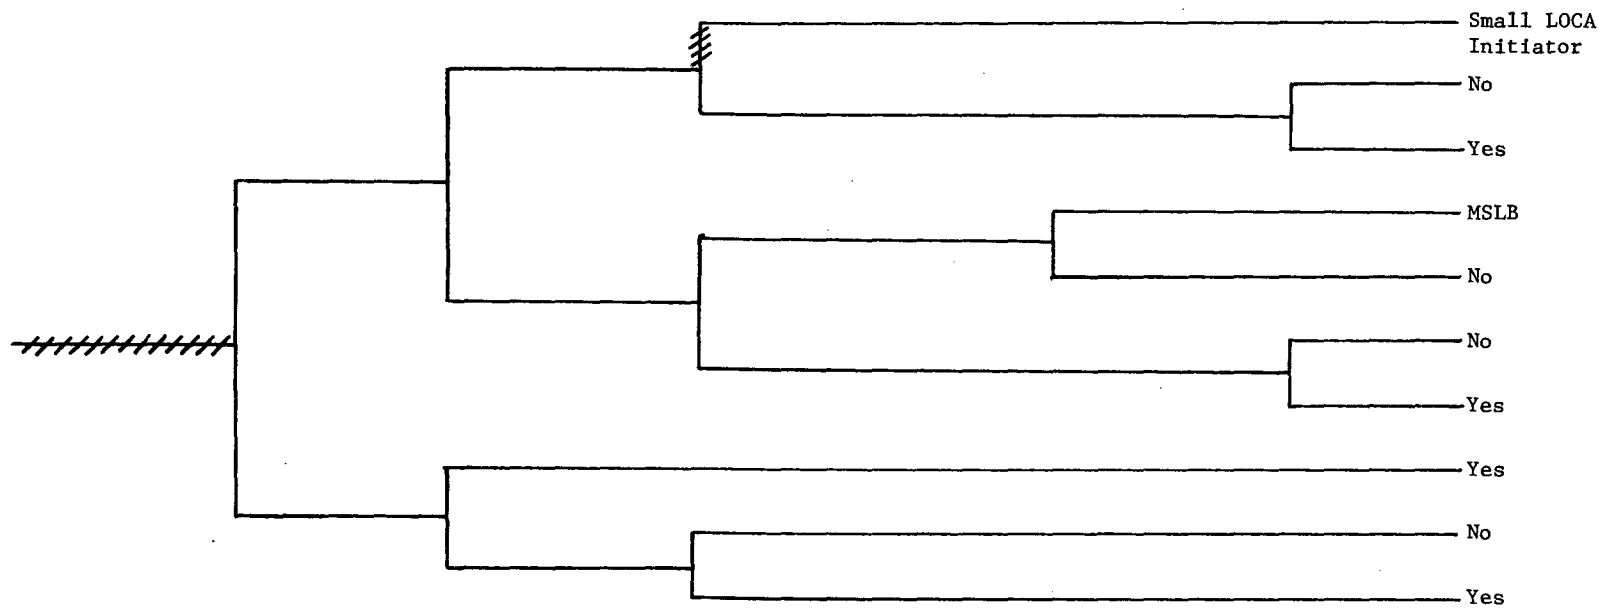
NSIC 47814 — Sequence of Interest for the Depressurization Incident at Dresden 2

Excessive Coolant Inventory	Reactor Scram	Reactor Vessel Or Turbine Isolate	Reactor Coolant Overflows Into Steam Lines, Is Discharged Through Relief Valves, Which Stick Open	Steam Line Break Due To Turbine Missiles, etc.	Long Term Core Cooling Success	Potential Severe Core Damage
-----------------------------	---------------	-----------------------------------	---	--	--------------------------------	------------------------------
