PRECURSOR DESCRIPTION AND DATA

NSIC Accession Number: 39380

Title: Safety Valve Operation After Feedwater Transient at Dresden 3

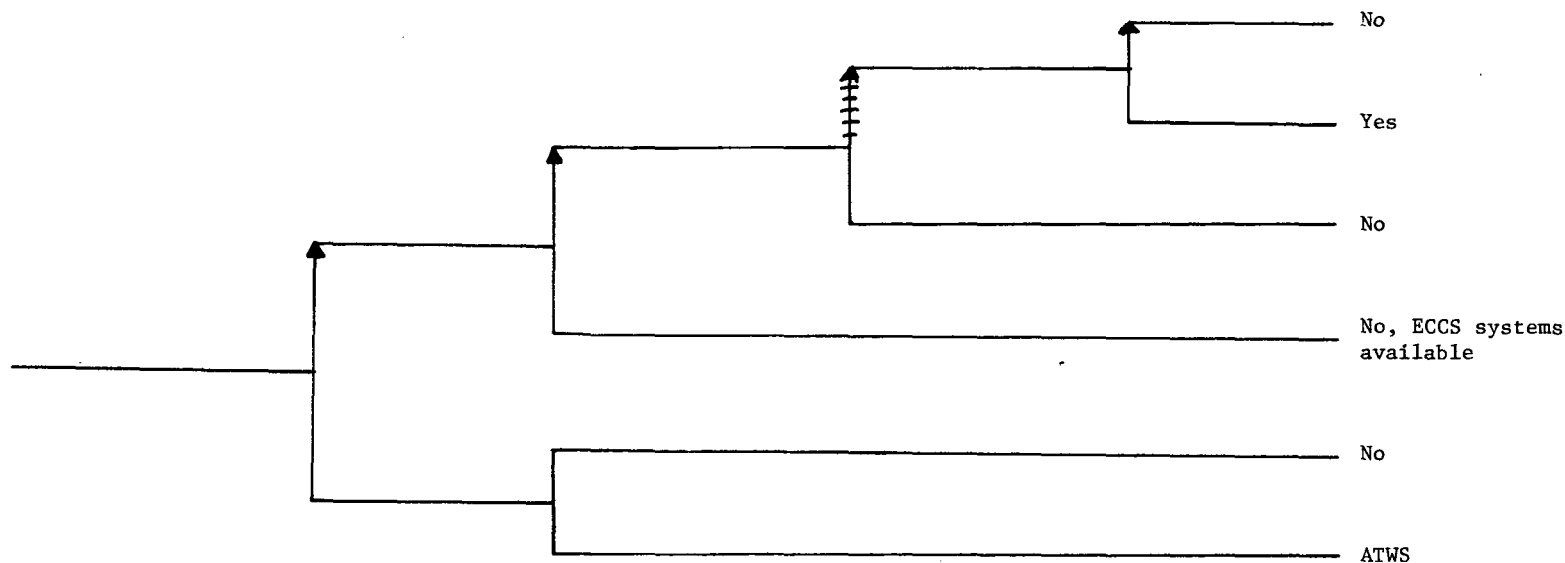
1. Loss of the 3C condensate booster pump initiated a feedwater transient.
2. The 3B feedwater pump auto-started and was used to recover water level.
3. The 3B feedwater regulating valve locked out in the open position and the flow on light failed to indicate this situation.
4. Within 2 minutes and 45 seconds the water level had reached the main steam-line causing a safety valve to actuate which resulted in pressurizing the drywell.
5. During the transient low power range monitor cabling, one electromatic relief valve solenoid operator and piping insulation were damaged.

| Condensate Booster Pump Trip Causes Of Feed-water Transient | A Turbine Trip/ Reactor Trip Occurs | The B Feedwater Pump Auto Starts And Supplies Coolant To The Reactor | The Regulator Valve Sticks Open And Overfills The Reactor Vessel. Water Blows Out The Relief Valve | The Plant Was Brought To A Safe Shutdown | Potential Severe Core Damage |

1. All damaged equipment was repaired or replaced.
2. The feedwater control system was recalibrated and the signals verified.
3. The air system was modified by installing a 10 ft³ accumulator.

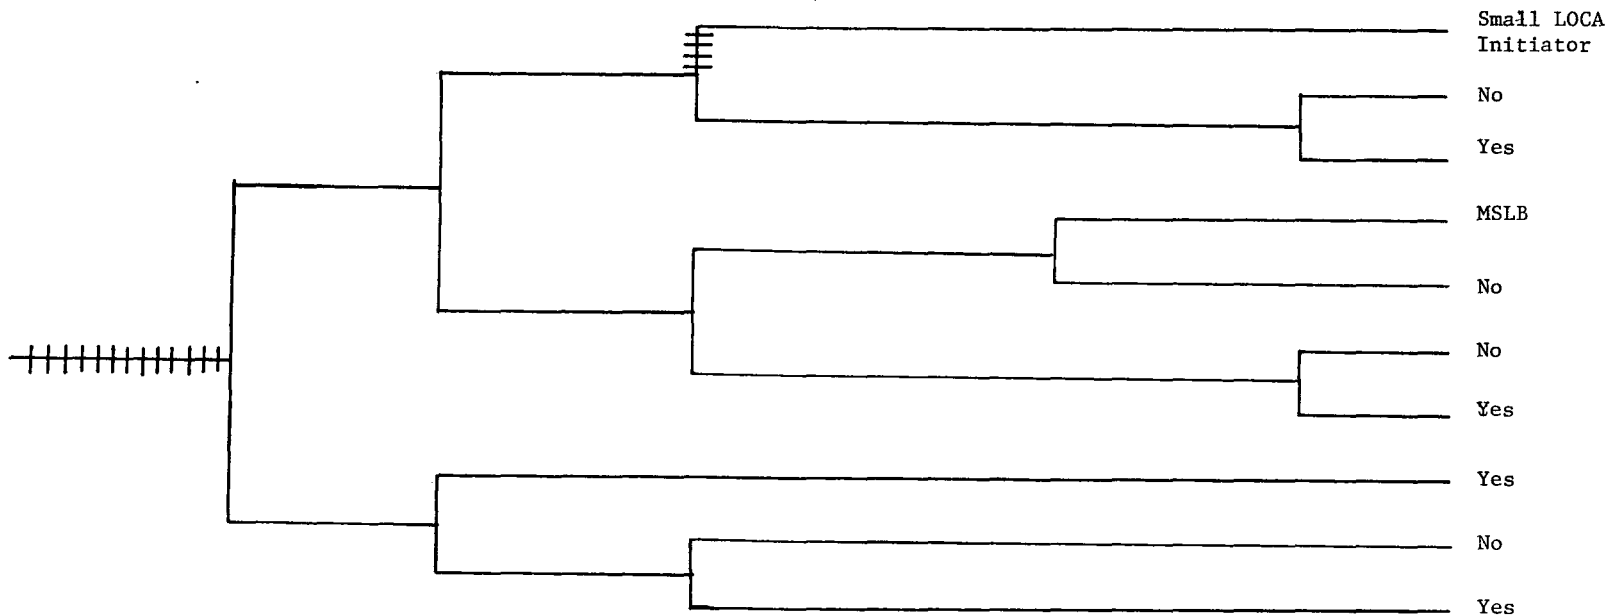
| Excessive Coolant Inventory | Reactor Scram | Reactor Vessel Or Turbine Isolate | Reactor Coolant Overflows Into Steam Lines, Is Discharged Through Relief Valves, Which Stick Open | Steam Line Break Due To Turbine Missiles, etc. | Long Term Core Cooling Success | Potential Severe Core Damage |
