PRECURSOR DESCRIPTION AND DATA

NSIC Accession Number: 149230

Title: Both Emergency Service Water Systems Inoperable at Arnold

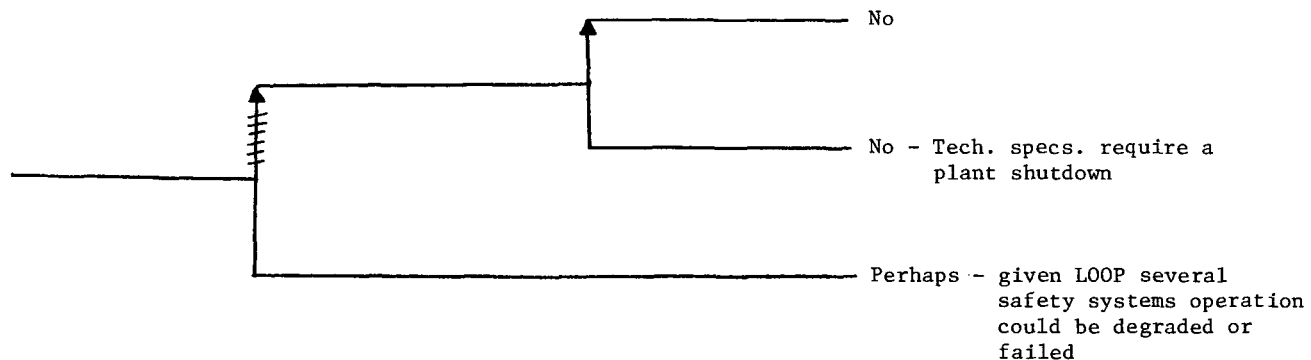
1. The reactor was operating at 70% power and surveillance testing of the emergency service water system was underway.
2. Strainer in both emergency service water systems were found to be plugged.

NSIC 149230 — Actual Occurrence of Both Emergency Service Water Systems Inoperable at Arnold

CAUSE: the strainers were not cleaned often enough

1. The strainers were cleaned within 2.5 hours.
2. Self-cleaning strainers are to be installed during the 1980 refuel.

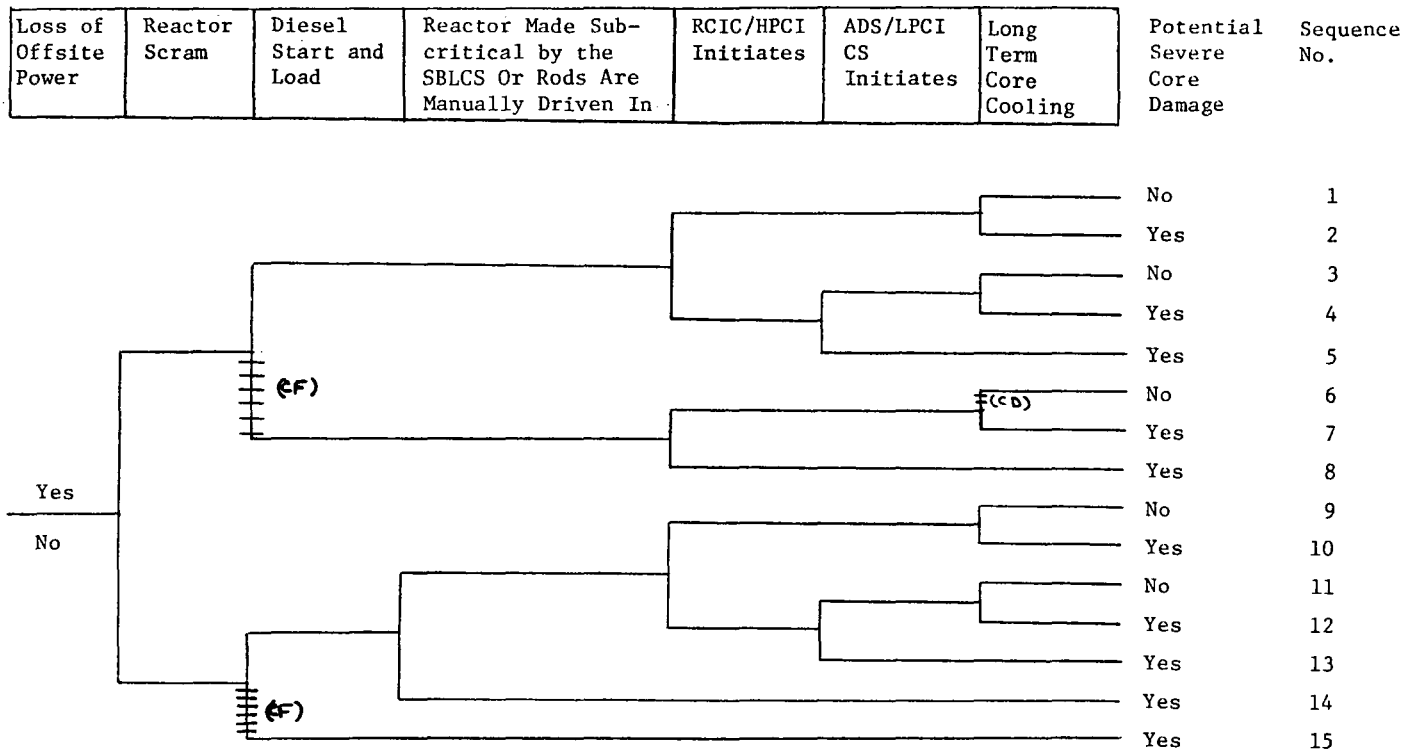
NSIC 149230 — Sequence of Interest of Both Emergency Service Water Systems Inoperable at Arnold

SEQUENCE OF INTEREST: loss of offsite power
