# PRECURSOR DESCRIPTION AND DATA

NSIC Accession Number: 100415

Title: All Drywell High Pressure Switches Found Isolated at Fitzpatrick

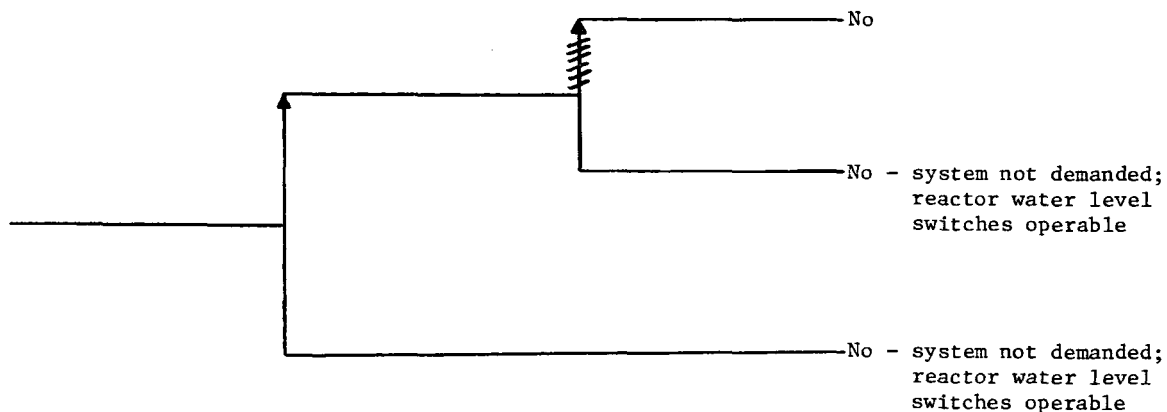
During routine surveillance testing, an instrumentation technician discovered the rack isolation valves for drywell high pressure instruments in both trains closed. Further investigation revealed the associated root valves at the drywell penetrations were also closed. It is presumed the valves were left closed since August 1974 when the valves were supposed to be reopened following the completion of surveillance testing.

NSIC 100415 - Actual Occurrence of All High Pressure Switches Found Isolated at FitzPatrick

1. The valves were immediately opened and locked to prevent reoccurrence of this event.
2. The root valves and other isolation valves are being added to appropriate operational and maintenance check lists.

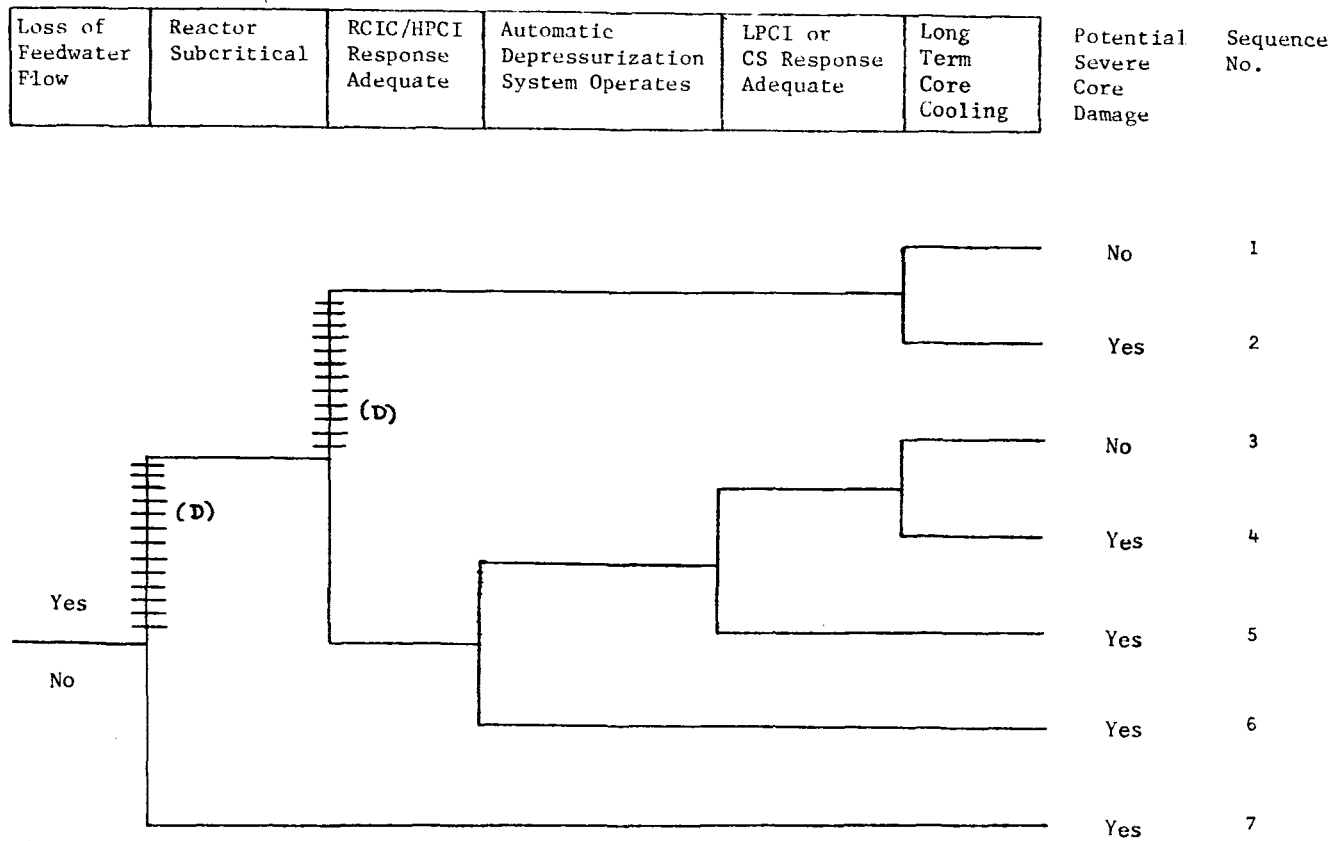
NSIC 100415 - Sequence of Interest for All Drywell Pressure Switches Found Isolated at Fitzpatrick
