NSIC Accession Number: 85370

Date: October 31, 1973

Title: Loss of Offsite Power, Excessive RCS Cooldown, Subsequent Safety Injection, and Failure of a Vital Instrument Bus at R. E. Ginna

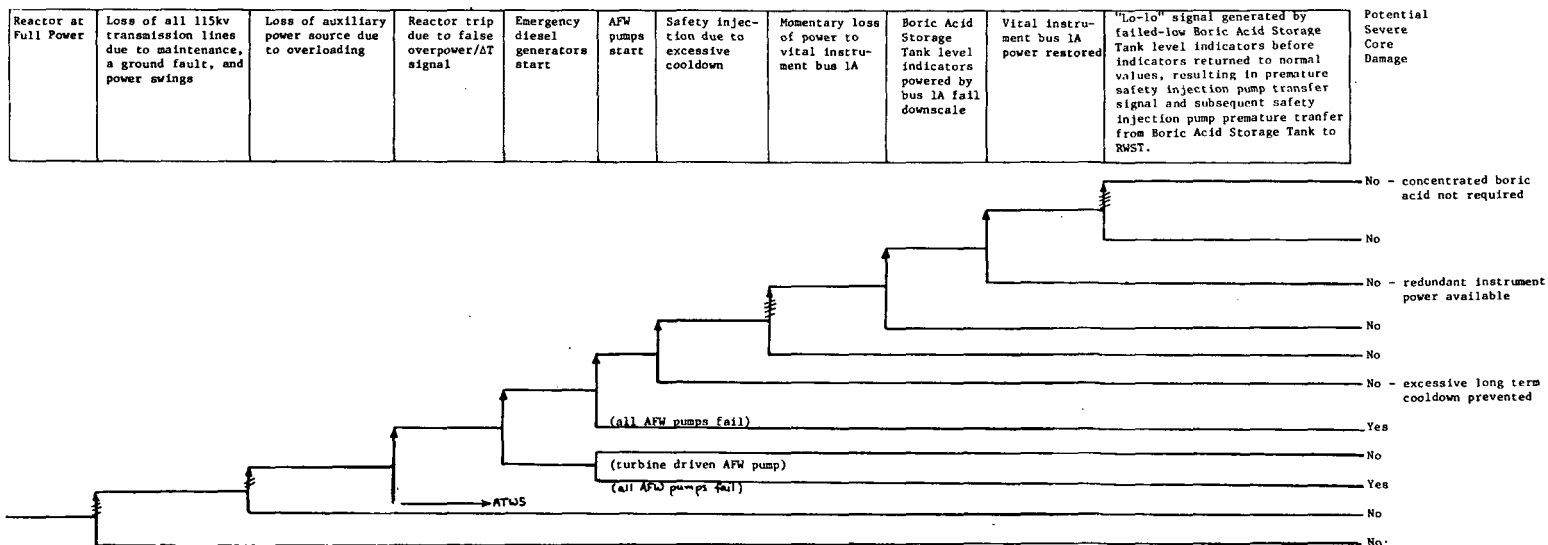
NSIC 85370 - Actual Occurrence for Loss of Offsite Power, Excessive RCS Cooldown, Safety Injection, and Failure of a Vital Instrument Bus at K. E. Ginna
