PRECURSOR DESCRIPTION AND DATA

NSIC Accession Number: 36147

Date: July 15, 1969

Title: Loss of Offsite Power and Load Rejection at Haddam Neck

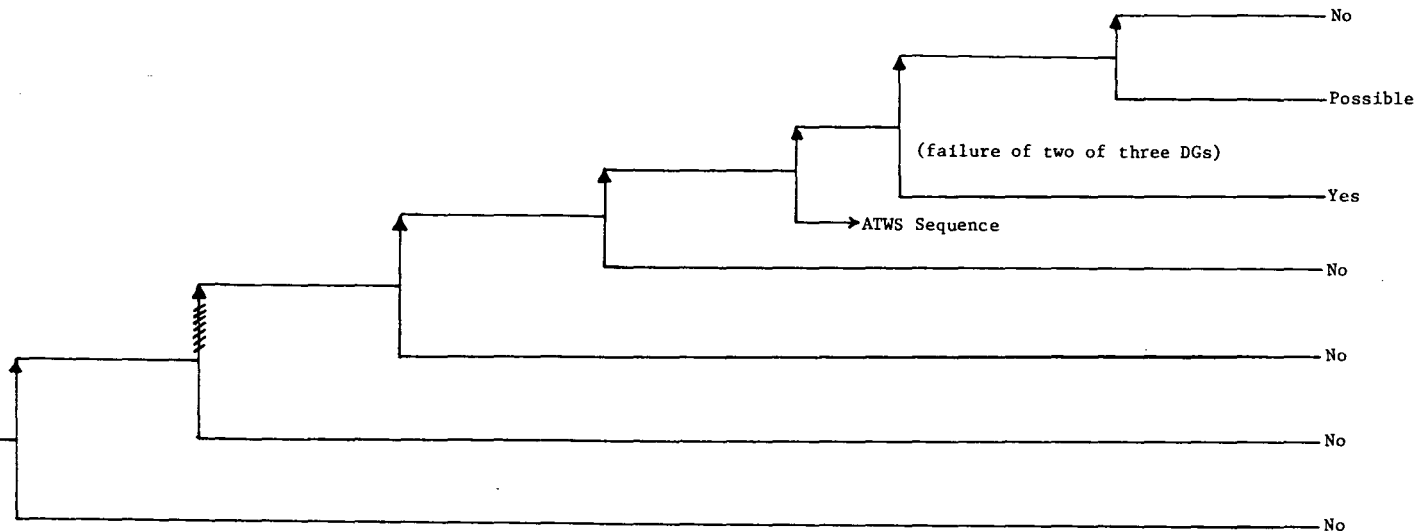
NSIC 36147 - Actual Occurrence for Loss of Offsite Power and load Rejection at Haddam Neck

1. One of the two 115KV offsite power lines (Montville line) was removed from service.
2. When the line was removed from service, trip inputs to the plant electrical system protection system were not defeated.
3. When the dispatcher opened other terminals on the Montville line, trip signals were generated which caused the two station service transformer low side breakers to open, resulting in a loss of offsite power.
4. Three of three diesel generators started and assumed safety related loads (one diesel generator loaded late).
5. One charging pump tripped during the starting sequence and one reactor coolant pump seal failed with excessive leakage (15 gpm seal injection required).

Reactor at Power with Generator Output of 480 MWe	115KV Montville Line Removed From Service	115KV Montville Line Trip Signal Inputs to Protection System Not Defeated	Opening of Other Terminals on 115KV Montville Line Generates Trip Signals Received at Haddam Neck	Both Service Transformer Low Side Breakers Trip, Resulting in a Loss of Offsite Power	Reactor Trip	Three of Three Emergency Diesel Generators Start and Load Their Safety-Related Buses	Auxiliary Feed-water System Provides AFW to Steam Generators	Potential Severe Core Damage
---	---	---	---	---	--------------	--	--	------------------------------

CAUSE: Procedural error resulted in trip signals from an isolated line being received and interpreted as a trip signal related to the single operating offsite power  
SEQUENCE OF INTEREST: loss of offsite power line. Operator error.

1. Switching orders were revised to require defeat of trip signals from isolated lines.
2. The loop containing the leaking RCP seal was isolated for cooldown and evaluation.

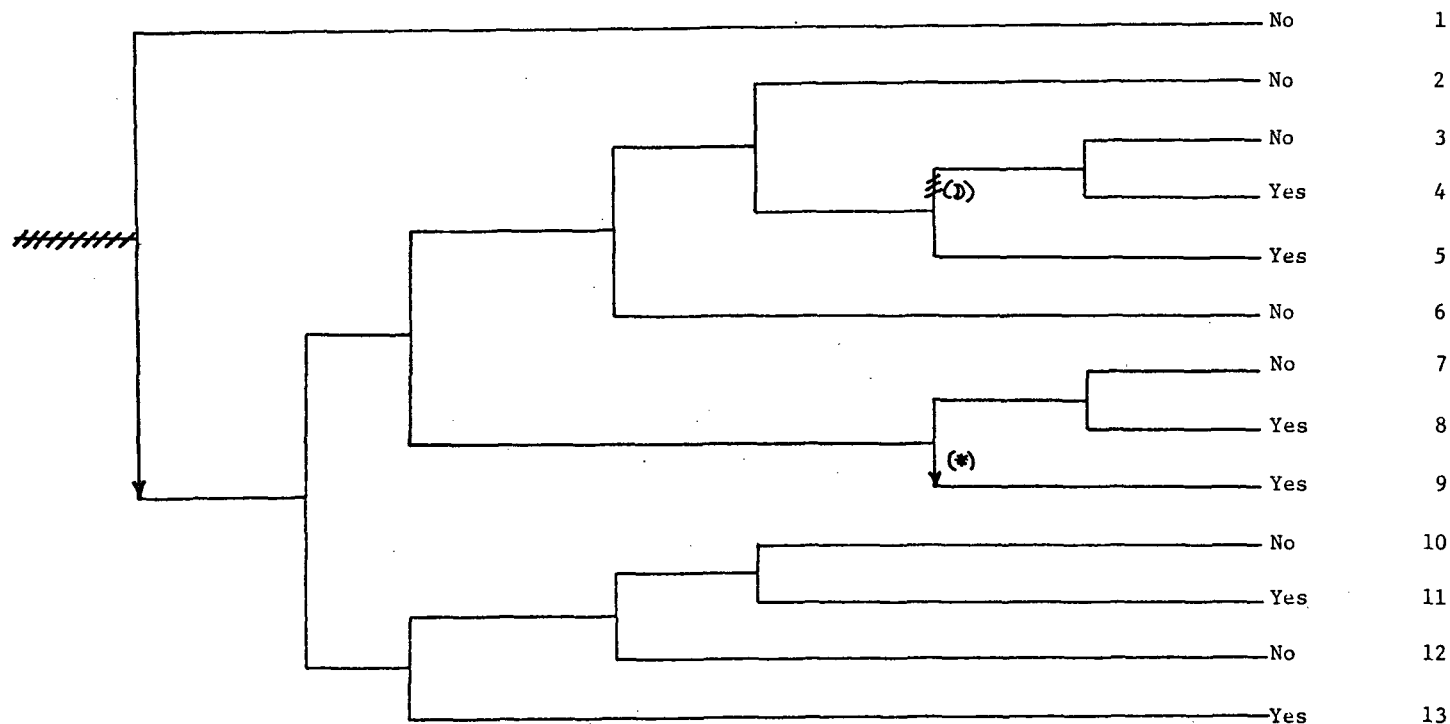
NSIC 36147 - Sequence of Interest for Loss of Offsite Power and load Rejection at Haddam Neck

Loss of Offsite Power	Turbine Generator Runs Back and Assumes House Loads	Emergency Power	Auxiliary Feedwater and Secondary Heat Removal	PORV Demanded	PORV or PORV Isolation Valve Closure	High Pressure Injection	Long Term Core Cooling	Potential Severe Core Damage	Sequence No.
-----------------------	---	-----------------	--	---------------	--------------------------------------	-------------------------	------------------------	------------------------------	--------------

\* Use of HPI after failure of AFW was not included in mitigation procedure.
