PRECURSOR DESCRIPTION AND DATA

NSIC Accession Number: 115875

Title: Total Loss of 115 KV Station Service Power Occurs at Connecticut Yankee

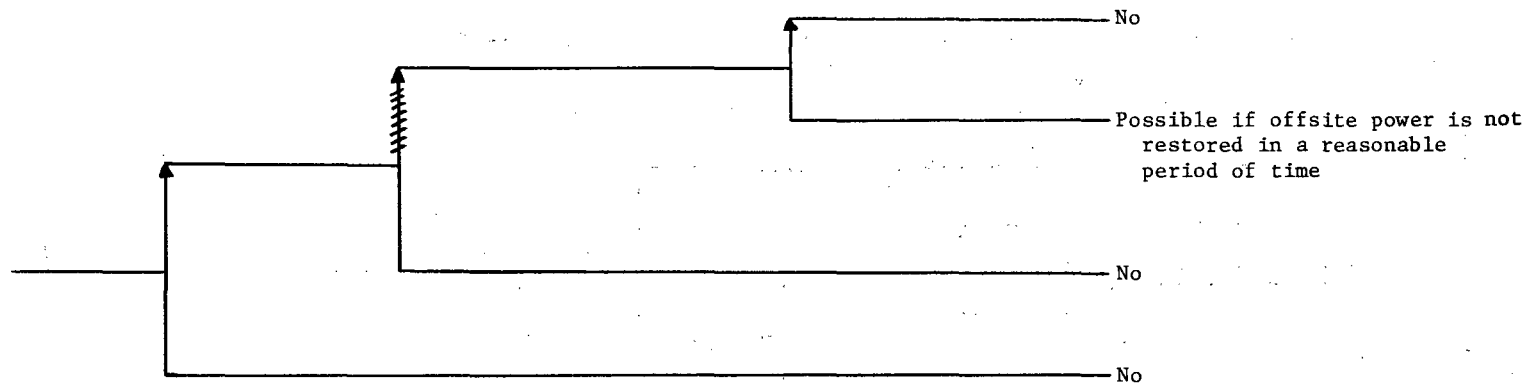
NSIC 115875 — Actual Occurrence for Total Loss of 115kv Station Power Occurs at Connecticut Yankee

1. During refueling, maintenance was being performed on one of the two incoming 115 KV station service lines.
2. While switching to restore this line to service, protective relays sensed a spurious 115 KV fault signal (due to improperly located backup relaying potential sensing circuits) and tripped the automatic circuit breaker on the station service transformer associated with the operating 115 KV line, resulting in a loss of offsite power (3 times).
3. The diesel generators started and loaded safety related loads.

Reactor in refueling shutdown	Maintenance in progress on one of two incoming 115kv station service lines	During switching to restore line to service, improperly placed backup relaying potential sensing circuits sense a spurious 115kv fault and trip a circuit breaker associated with the operating 115kv line	Diesel generators start and assume safety related loads	Potential Severe Core Damage
-------------------------------	--	--	---	------------------------------

1. The position of the applicable backup relaying potential sensing circuits were changed.

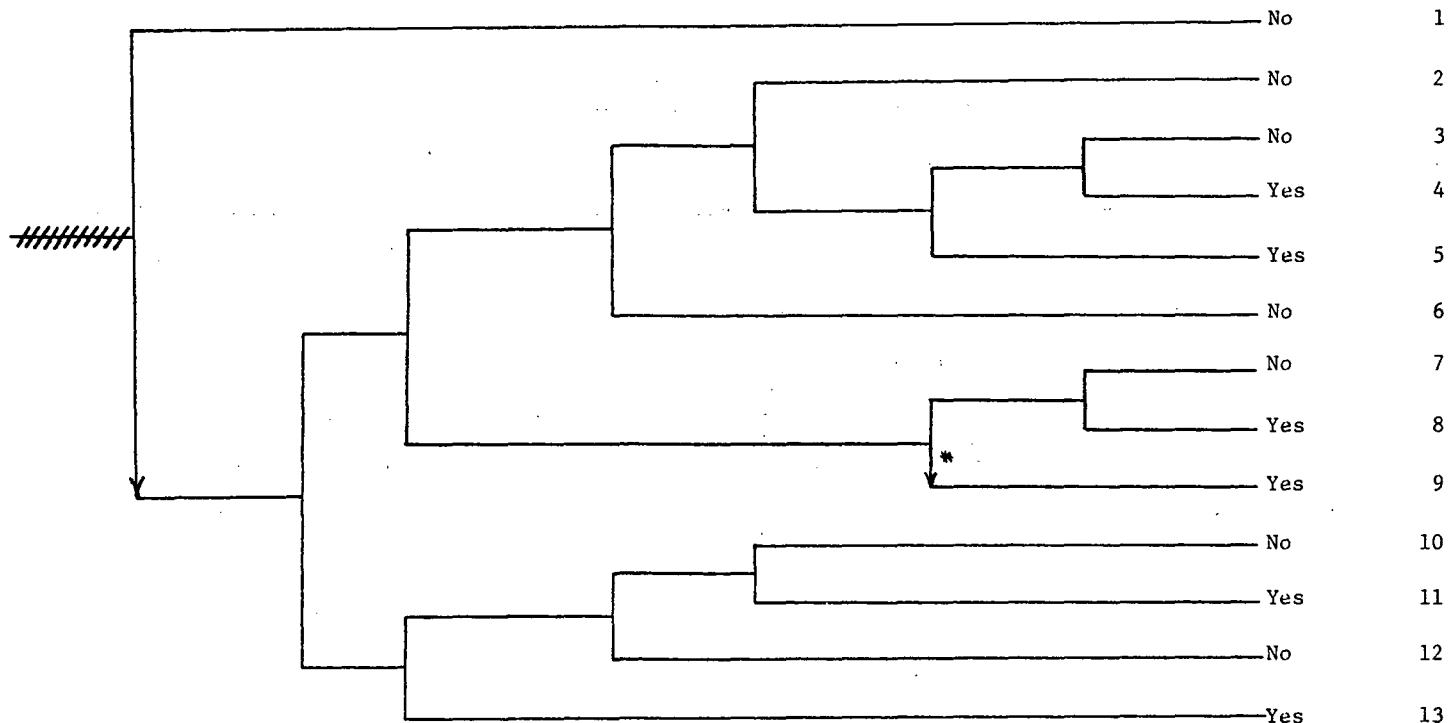
NSIC 115875 — Sequence of Interest for Total Loss of 115kv Station Power Occurs at Connecticut Yankee

Loss of Offsite Power	Turbine Generator Runs Back and Assumes House Loads	Emergency Power	Auxiliary Feedwater and Secondary Heat Removal	PORV Demanded	PORV or PORV Isolation Valve Closure	High Pressure Injection	Long Term Core Cooling	Potential Severe Core Damage	Sequence No.
-----------------------	---	-----------------	--	---------------	--------------------------------------	-------------------------	------------------------	------------------------------	--------------
