NSIC 149961 - Actual Occurrence for HPCI Fails to Start When Its Turbine Stop Valve Fails to Open at Hatch 2

CATEGORIZATION OF ACCIDENT SEQUENCE PRECURSORS

NSIC ACCESSION NUMBER: 149961

ACTUAL OCCURRENCE: HPCI fails to start when turbine stop valve fails to open at Hatch 2

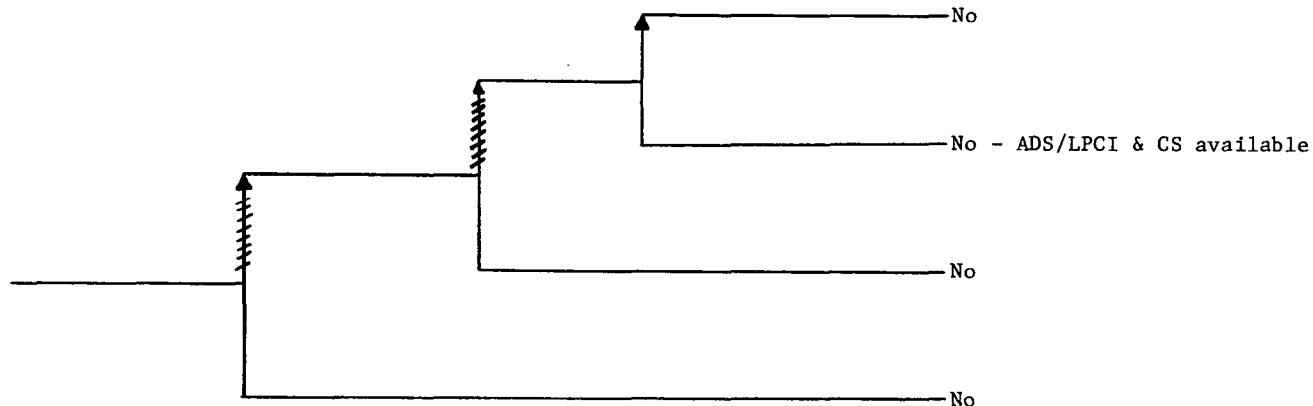
Reactor trip during power accession due to condensate system trip	HPCI failed to initiate on low-low reactor water inventory due to failed turbine stop valve	RCIC system was out of service	Reactor water level controlled by condensate system which had been immediately repaired
---	---	--------------------------------	---

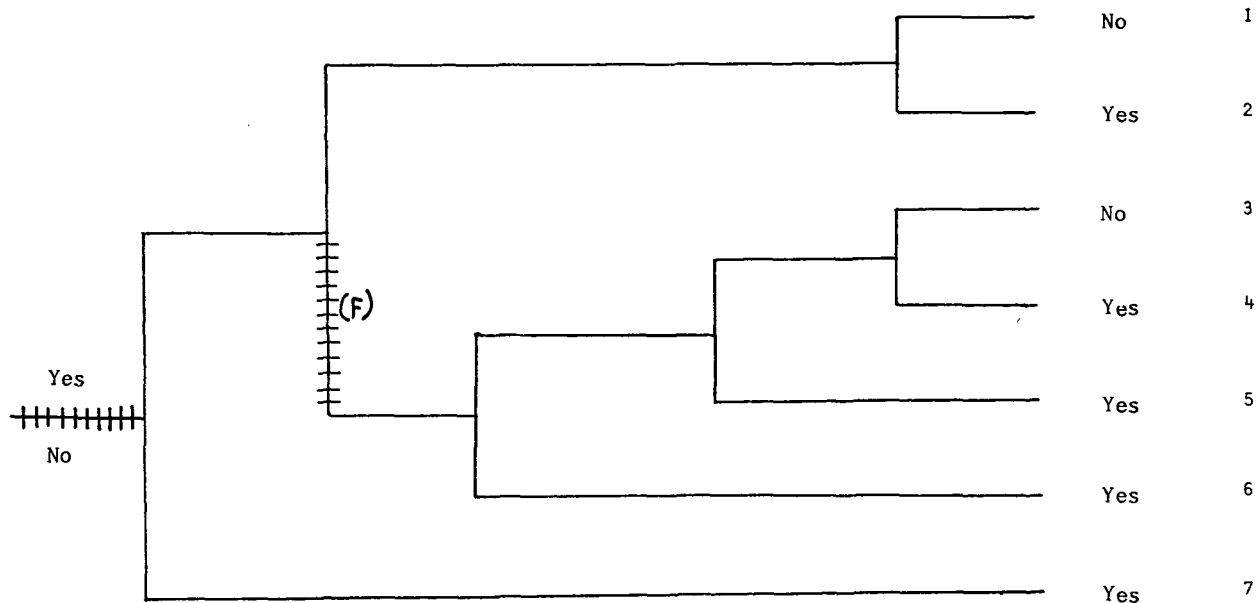
NSIC 149961 — Sequence of Interest for HPCI Fails to Start When the Turbine Stop Valve Fails to Open at Hatch 2

¹ RCIC was out of service.
