# PRECURSOR DESCRIPTION AND DATA

NSIC Accession Number: 61434

Title: Loss of Offsite Power and Failure of an Emergency Condensor Valve to Open at Humboldt Bay (Semi-Annual Report July-December 1970)

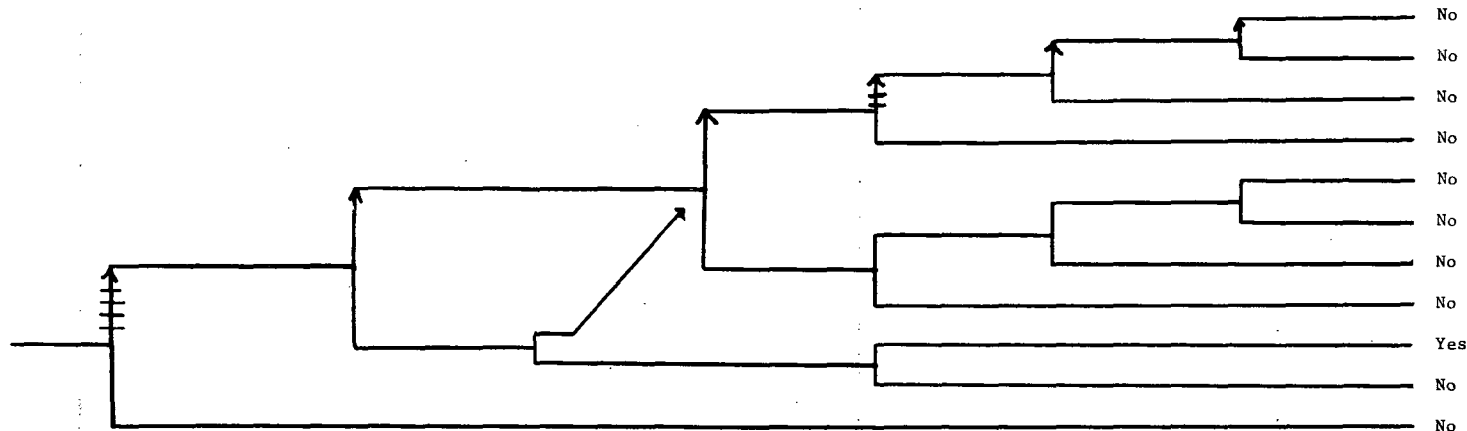
1. With the reactor at power, a switching error at the Humboldt Substation caused protective relaying which resulted in a generator and turbine trip, loss of the 60 KV bus, and consequent loss of offsite power.
2. Loss of normal power resulted in reactor scram, loss of feedwater flow, loss of drywell cooling, and loss of control room indication of reactor vessel pressure and level.
3. The emergency propane generator started and assumed safety-related loads. (A back-up feed was available from the adjacent fossil unit.) A CRD hydraulic pump was started to provide reactor makeup.
4. The emergency condenser return valve failed closed due to an incorrectly adjusted torque switch.

5. Reactor vessel level shrink to the low water level setpoint due to the opening of a safety valve (a result of the failed emergency condenser) combined with the loss of feedwater and an increase in drywell pressure (due to loss of drywell cooling plus a failed relief valve expansion joint) resulted in the actuation of the reactor vent system. This system was manually secured four minutes later.
6. The low pressure core flood and core spray systems subsequently automatically initiated and were used for core cooling until normal power was restored.

NSIC 61434 — Actual Occurrence for Loss of Offsite Power and Failure of an Emergency Condenser Valve to Open at Humboldt Bay

1. Normal power was restored to the plant 2.4 KV bus from an adjacent fossil unit.
2. The emergency condenser isolation valve was repaired and returned to service.

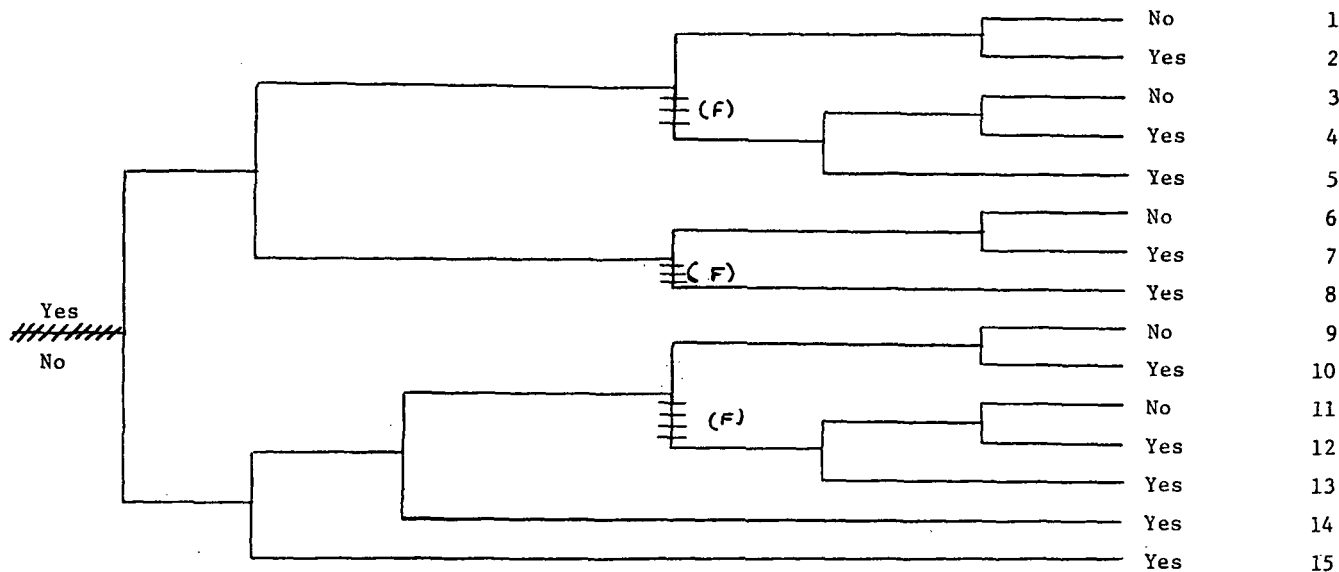
NSIC 61434 - Sequence of Interest for Loss of Offsite Power and Failure of an Emergency Condenser Valve to Open at Humboldt Bay
