# PRECURSOR DESCRIPTION AND DATA

NSIC Accession Number: 64600

Date: June 30, 1971

Title: Loss of Offsite Power at Indian Point 1

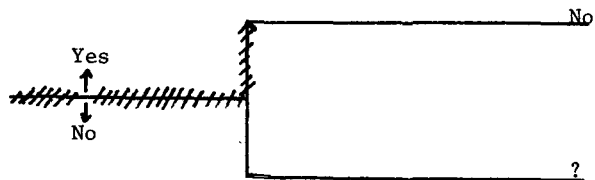
NSIC 64600 — Actual Occurrence for Loss of Offsite Power at Indian Point 1 (Operations Report No. 17)

<sup>1</sup>Operations report does not specify systems utilized after the loss of power occurred beyond this statement.

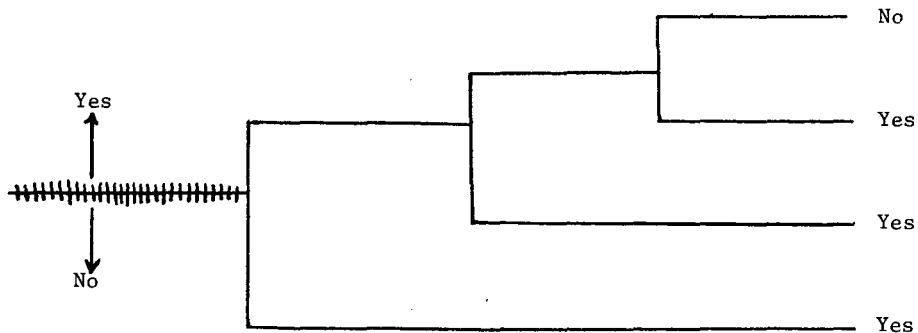
NSIC 64600 — Sequence of Interest for Loss of Offsite Power at Indian Point 1  
(Operations Report No. 17)
