PRECURSOR DESCRIPTION AND DATA

NSIC Accession Number: 73655

Title: Loss of Offsite Power at Indian Point 1

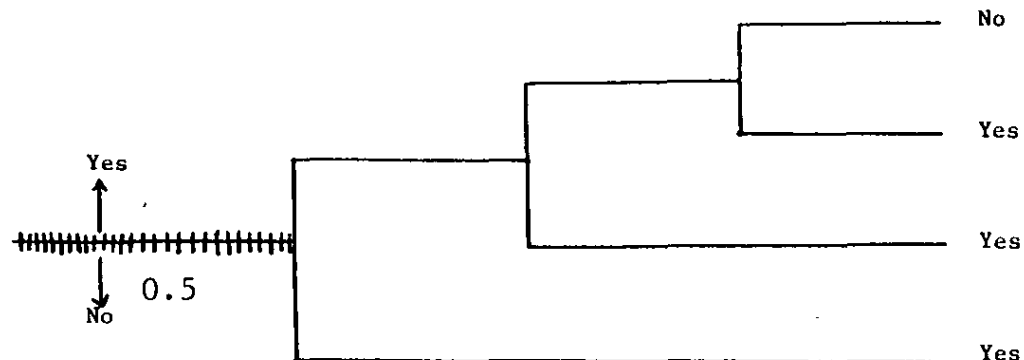
NSIC 73655 - Sequence of Interest for Loss of Offsite Power at Indian Point 1

Loss of offsite power with reactor at power	Onsite power available (Instrument power)	Emergency control air available	Emergency feedwater available	Potential Severe Core Damage
---	---	---------------------------------	-------------------------------	------------------------------

P_{SCD} was assumed equal to other LOOP P_{SCD} 's for plants with a turbine driven auxiliary feed pump

$$P = 5.7E-4 \text{ (SC} = 32\text{)}$$
