# PRECURSOR DESCRIPTION AND DATA

NSIC Accession Number: 108078

Title: Auxiliary Feedwater Pump Flows Restricted at Kewaunee

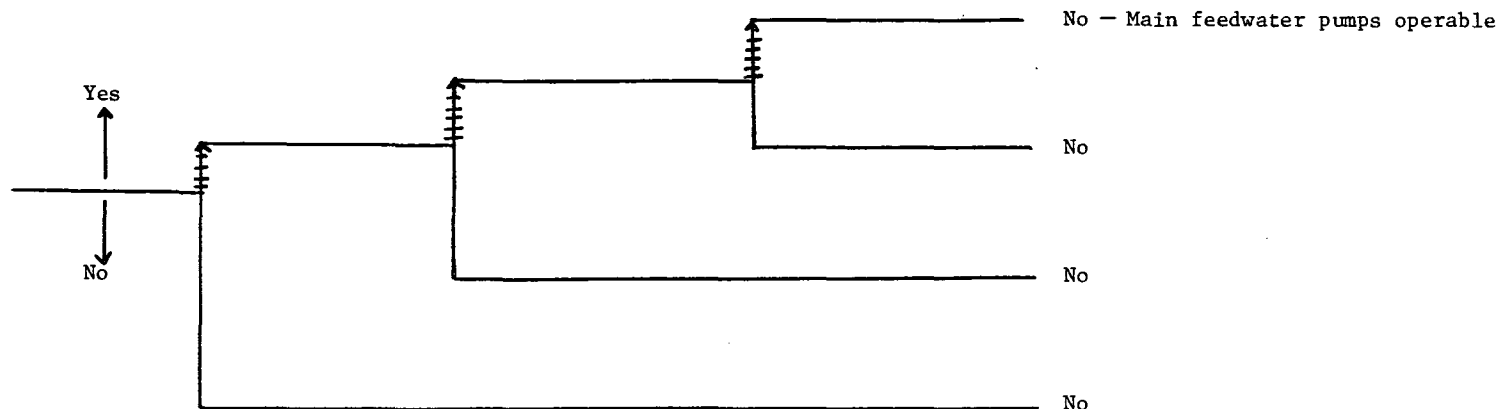
NSIC 108078 - Actual Occurrence for Auxiliary Feedwater Pump Flows Restricted at Kewaunee

Unit in startup operations	Mixed-bed demineralizer leaking resin beads to condensate storage tank	Reduced auxiliary feedwater flow from 1A and 1B motor-driven AFW pumps due to suction strainers clogged with resin	Reduced auxiliary feedwater flow from 1C turbine-driven AFW pump due to suction strainer clogged with resin
----------------------------	--	--	---

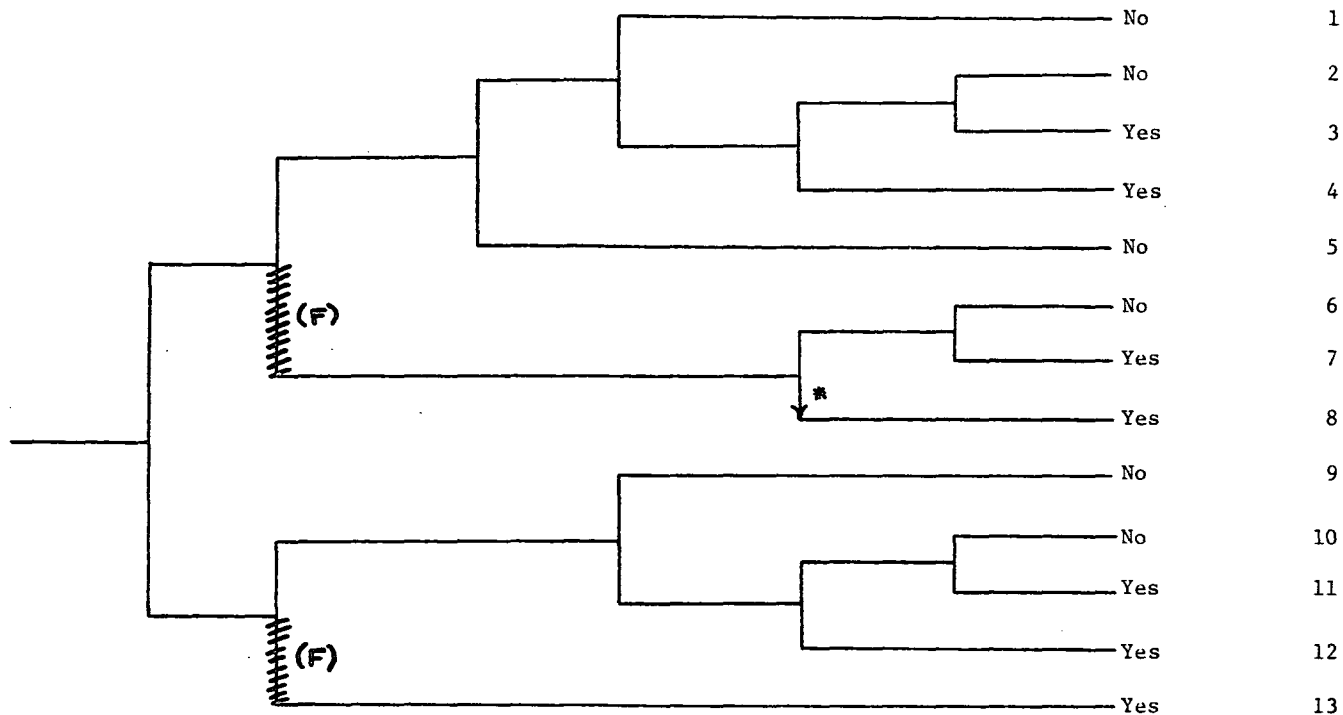
NSIC 108078 — Sequence of Interest for Auxiliary Feedwater Pump Flows Restricted at Kewaunee

Loss of Main Feedwater	Reactor Trip	Auxiliary Feedwater and Secondary Heat Removal	PORV Demanded	PORV or PORV Isolation Valve Closure	High Pressure Injection	Long Term Core Cooling	Potential Severe Core Damage	Sequence No.
------------------------	--------------	--	---------------	--------------------------------------	-------------------------	------------------------	------------------------------	--------------
