PRECURSOR DESCRIPTION AND DATA

NSIC Accession Number: 147399

Title: Both Diesel Generators Unavailable at Kewaunee

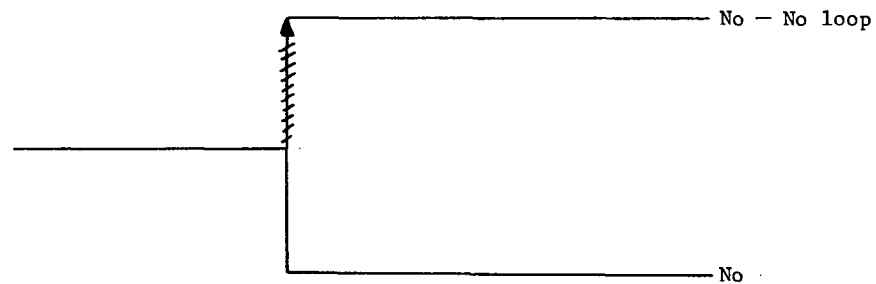
NSIC 147399 - Actual Occurrence for Both Diesel Generators  
Unavailable at Kewaunee

1. With the reactor at full power, diesel generator 1B was removed from service for maintenance.
2. During the testing of diesel 1A, manual speed control was lost due to excessive wear to the bronze pinion in the syncho-motor gear housing. The pinion damage was caused by improper gear alignment and failure of a governor limit switch.

Reactor at Power and Diesel Gen- erator 1B Removed From Service for Maintenance	Diesel Generator 1A Fails to Run Due to Loss of Manual Speed Control - A Result of a Worm Pinion in the Synchro-Motor Gear Housing and a Failed Limit Switch	Potential Severe Core Damage
---	--	---------------------------------------

CAUSE: Excessive wear on pinion in synchro-gear motor housing plus  
failed limit switch

The pinion and limit switch were replaced and adjusted and the diesel generator was tested and returned to service.

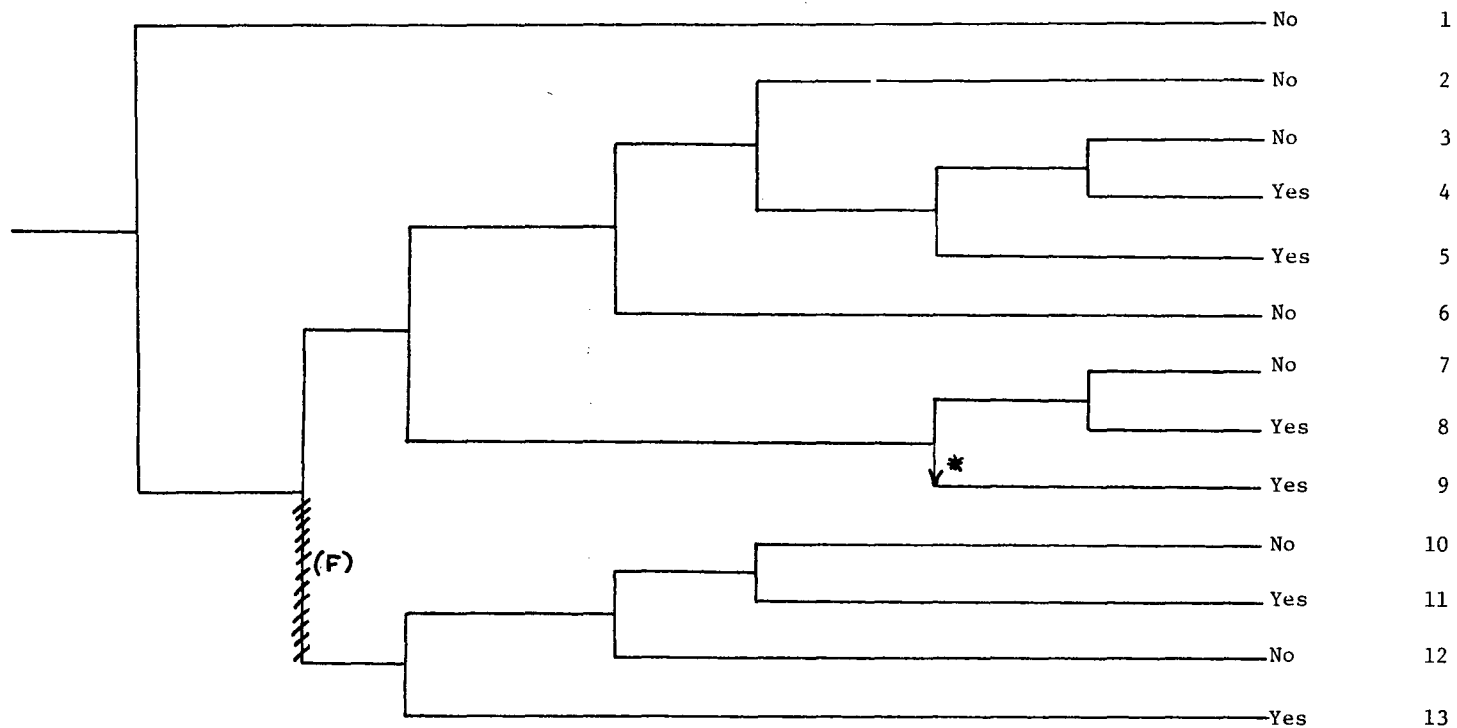
NSIC 147399 — Sequence of Interest for Both Diesel Generators Unavailable at Kewaunee

Loss of Offsite Power	Turbine Generator Runs Back and Assumes House Loads	Emergency Power	Auxiliary Feedwater and Secondary Heat Removal	PORV Demanded	PORV or PORV Isolation Valve Closure	High Pressure Injection	Long Term Core Cooling	Potential Severe Core Damage	Sequence No.
-----------------------	---	-----------------	--	---------------	--------------------------------------	-------------------------	------------------------	------------------------------	--------------

SEQUENCE OF INTEREST: Loss of offsite power
