NSIC Accession Number: 78418

Title: Failure of Charging Pump Valves to Open After an Ice Storm at Maine Yankee

CATEGORIZATION OF ACCIDENT SEQUENCE PRECURSORS

REACTOR NAME: Maine Yankee

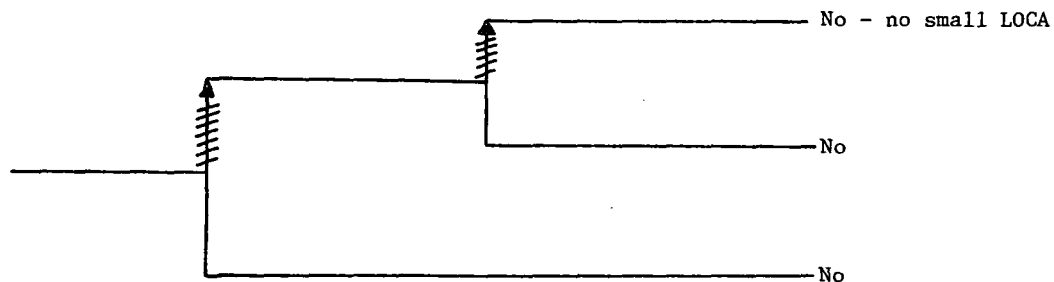
The failure sequence was:

1. During ECCS valve surveillance testing, the suction valve from the RWST to charging pump 14A failed to open due to ice on the valve stem, a result of an ice storm earlier in the day.
2. The suction valve from the RWST to charging pump 14B failed to open completely, also because of ice on the valve stem.

NSIC 48418 - Actual Occurrence for Failure of Charging Pump Valves to Open After an Ice Storm at Maine Yankee

CAUSE: Ice on valve stems

The ice was removed from the valve stems and protective covers fabricated for the valves.

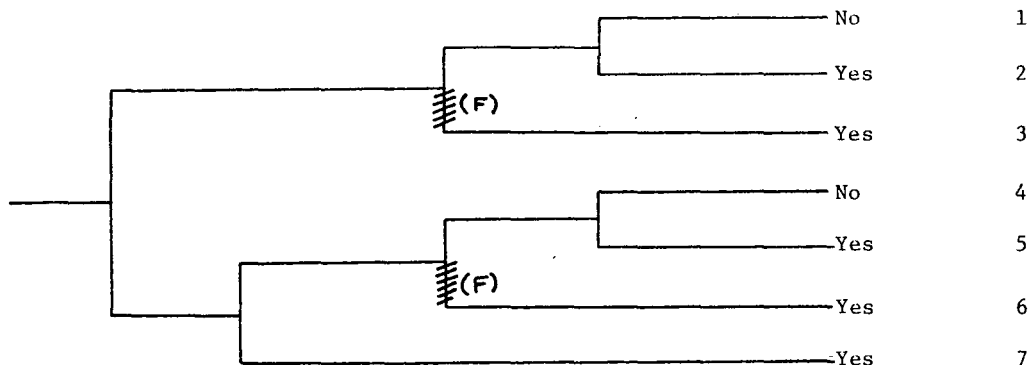
NSIC 78418 — Sequence of Interest for Failure of Charging Pump Valves to Open  
After an Ice Storm at Maine Yankee

SEQUENCE OF INTEREST: small LOCA
