# PRECURSOR DESCRIPTION AND DATA

NSIC Accession Number: 66996

Title: Pressure Transient and Blowdown at Millstone Point 1

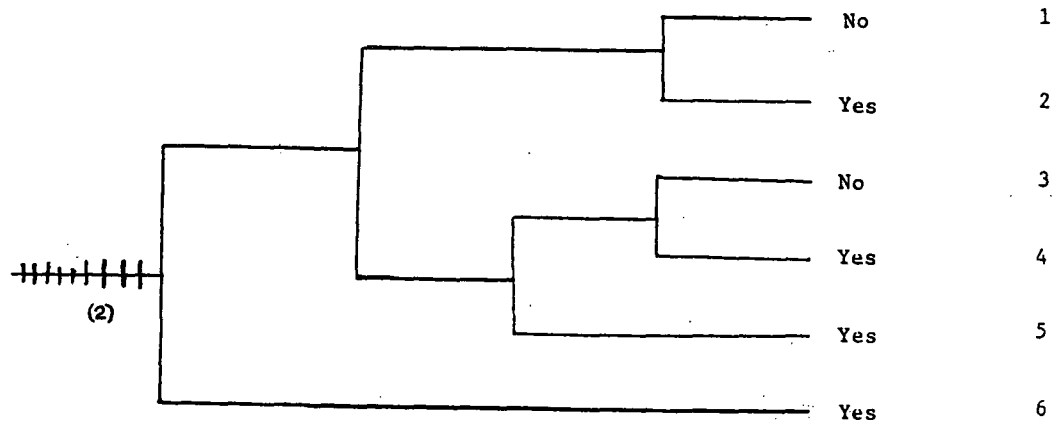
NSIC 66996 — Sequence of Interest for Pressure Transient and Blowdown at Millstone Point 1

<sup>2</sup> Stuck open relief valve.
