PRECURSOR DESCRIPTION AND DATA

NSIC Accession Number: 116780

Title: Gas Turbine Becomes Inoperable During Plant Trip at Millstone - 1

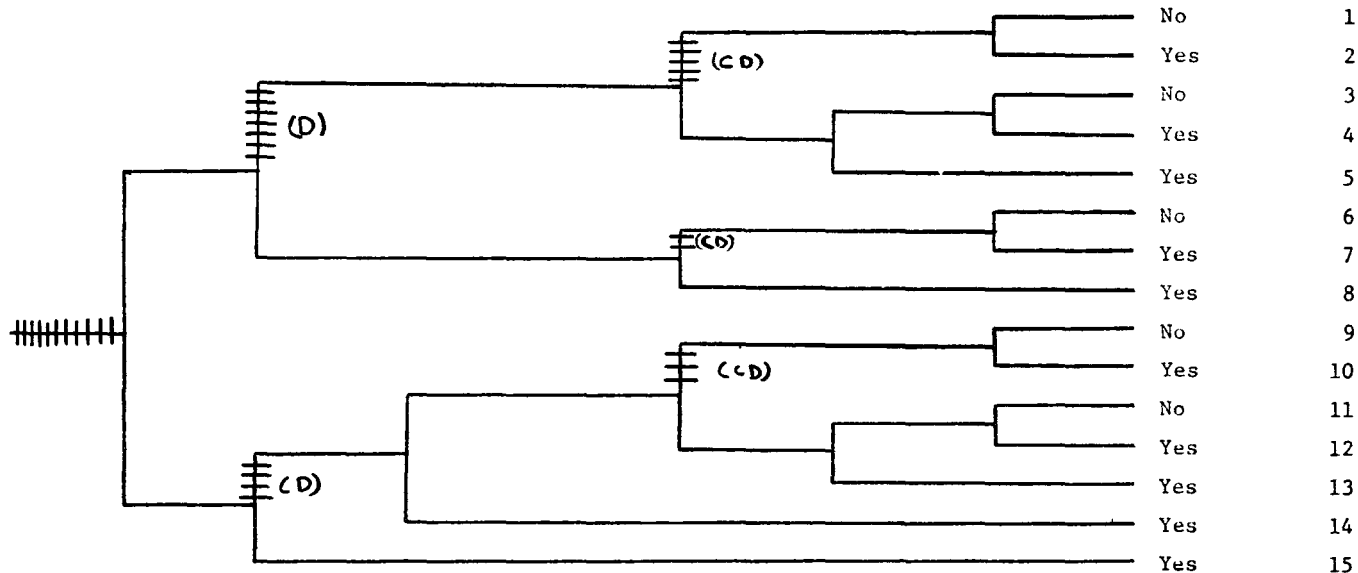
Loss of Offsite Power	Reactor Scram	Diesel Start and Load	Reactor Made Sub- critical by the SBLCS Or Rods Are Manually Driven In	RCIC/HPCI Initiates	ADS/LPCI CS Initiates	Long Term Core Cooling	Potential Severe Core Damage	Sequence No.
-----------------------------	------------------	-----------------------------	---	------------------------	-----------------------------	---------------------------------	---------------------------------------	-----------------
