NSIC Accession Number: 116212

Date: August 3, 1976

Title: Inadvertant Load Shedding on Safety-Related Buses at Millstone 2

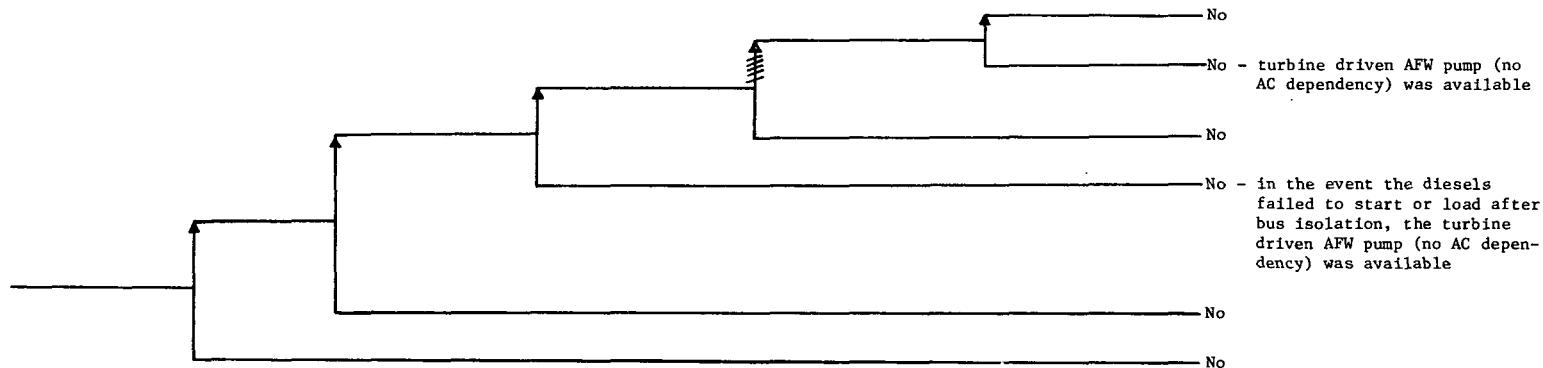
NSIC 116212 - Actual Occurrence for Inadvertent Load Shedding on Safety-Related Buses at Millstone 2

5. On July 16, 1976, with the plant at 100% power, a 1500 HP circulating water pump was started. The current inrush from the pump start resulted in a voltage drop on the safety-related bus to below the revised undervoltage trip point.

6. The ESAS sensed the undervoltage condition, isolated the safety-related buses from the plant electrical system, tripped the reactor, shed bus loads, started the diesel generators, and connected them to the safety-related buses.

7. When the service water and reactor building closed cooling water pumps were sequenced on to the safety-related buses, the inrush current for each component caused the bus voltage to drop below the new undervoltage setpoint for each component and these loads tripped off the buses.

8. At the completion of the load sequence the emergency buses were energized but the main loads were unconnected due to the additional load shed signals.

Reactor at 100% power and undervoltage trip setpoints reset to assure adequate voltage to safety-related components in the event of degraded grid voltage	Operator starts circulating water pump	Pump current in-rush results in voltage drop on safety-related bus below revised undervoltage trip point	Safety-related buses isolate, reactor trip, bus load shed, diesel generators start and connect to safety-related buses	Service water and reactor building closed cooling water pumps trip on undervoltage during sequencing due to current in-rush dropping bus voltage below revised undervoltage trip setpoints	Operator resets undervoltage trip setpoints and successfully loads service water and reactor building closed cooling water pumps	Potential Severe Core Damage
---	--	--	--	--	--	---------------------------------------

9. The undervoltage bistables were immediately reset to their previous setpoints and the reserve station transformer connected to the safety-related buses. The service water and reactor building closed cooling water pumps were started satisfactorily five minutes after their previous trip.

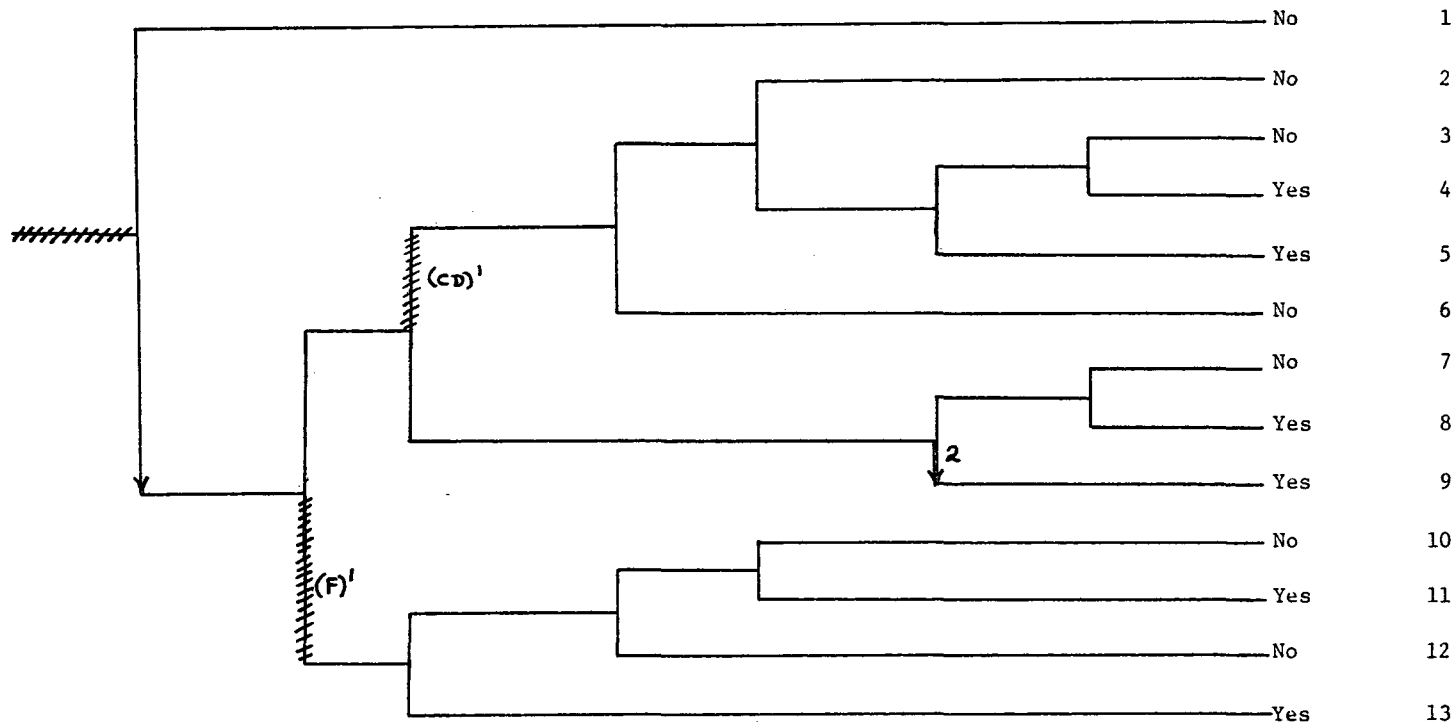
NSIC 116212 — Sequence of Interest for Inadvertent Load Shedding on Safety-Related Buses at Millstone 2

Loss of Offsite Power	Turbine Generator Runs Back and Assumes House Loads	Emergency Power	Auxiliary Feedwater and Secondary Heat Removal	PORV Demanded	PORV or PORV Isolation Valve Closure	High Pressure Injection	Long Term Core Cooling	Potential Severe Core Damage	Sequence No.
-----------------------	---	-----------------	--	---------------	--------------------------------------	-------------------------	------------------------	------------------------------	--------------

¹Success requires immediate operator action to reset undervoltage trip setpoints and reload safety-related loads.

²Operating procedures did not provide for use of HPI for core cooling
