PRECURSOR DESCRIPTION AND DATA

NSIC Accession Number: 74242

Title: High Coolant Level at Nine Mile Point

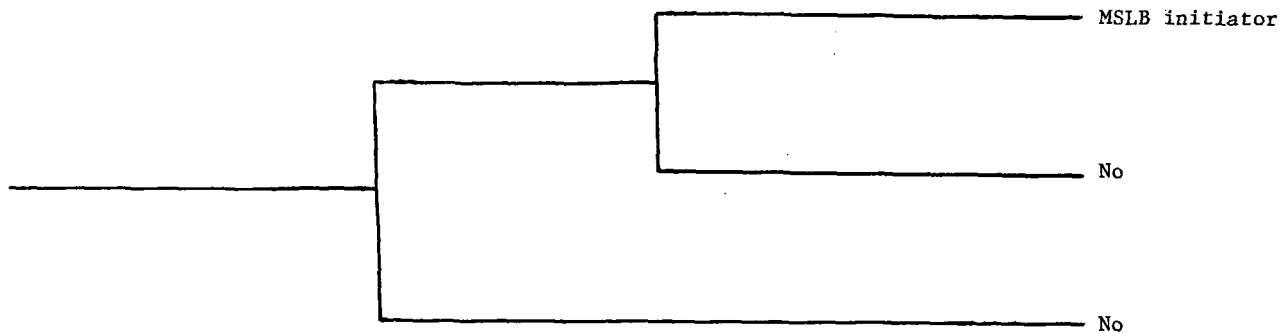
NSIC 74242 -- Actual Occurrence of High Coolant Level at Nine Mile Point

1. Surveillance testing of the reactor protection system high/low water sensors was being conducted. The sensor support was accidentally bumped causing a turbine trip and an anticipatory reactor trip.
2. Following the trip the reactor water level began to decrease rapidly, causing the feedwater system to respond by overfeeding, as it should, in the automatic mode.
3. After 20 seconds the operator took manual control since in his opinion the feedwater flow was high.
4. The manual transfer of control was slow and some water spilled into the main steamline.

A Turbine/Reactor Trip Occurred During Surveillance Testing of the High/Low Level Scram Sensors	The Feedwater System Overfeed The Reactor to Compensate for the Shrinking Water Level	The Operator Incorrectly Took Control of the Feedwater System and Caused Water to Flow Into the Steam Lines	Potential Severe Core Damage
---	---	---	------------------------------

Since the automatic response of the feedwater system was correct, a review of the expected system response to transients was given to the operating staff.

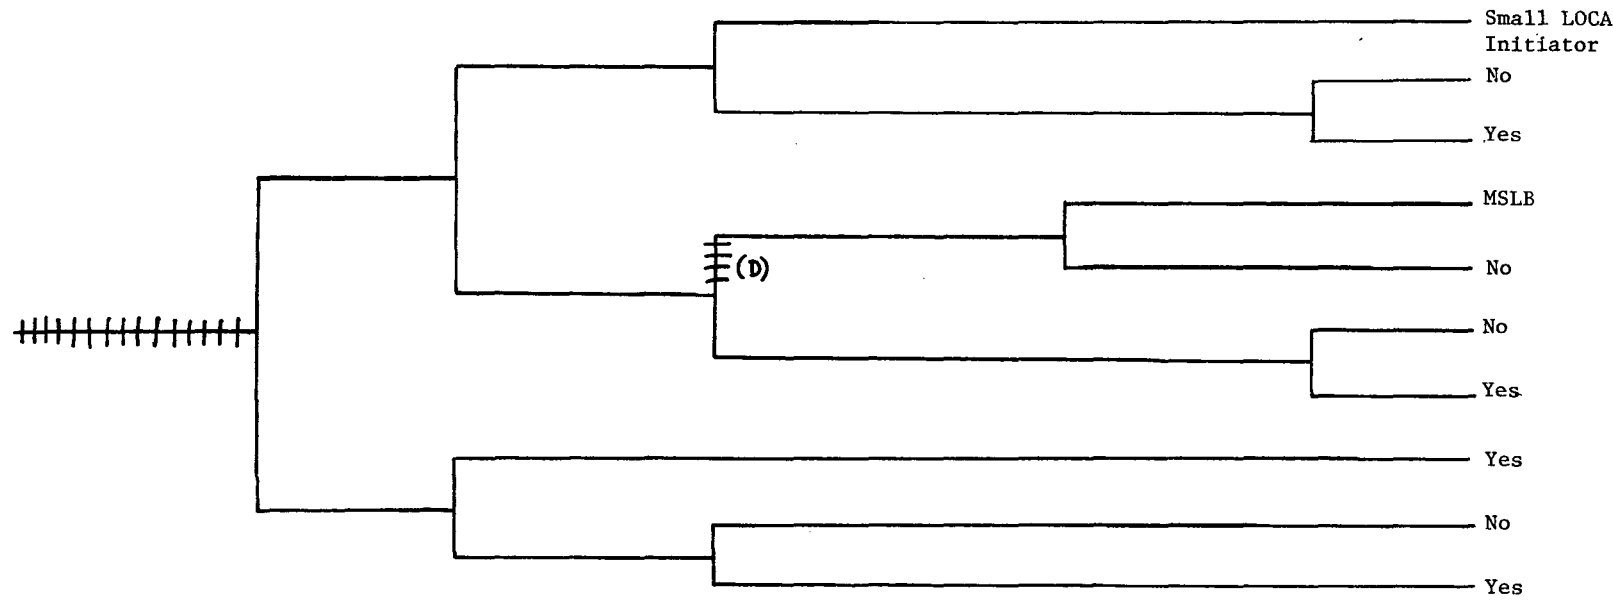
NSIC 74242 — Sequence of Interest for High Coolant Level at Nine Mile Point

Excessive Coolant Inventory	Reactor Scram	Reactor Vessel or Turbine Isolate	Reactor Coolant Overflows Into Steam Lines, Is Discharged Through Relief Valves, Which Stick Open	Steam Line Break Due to Turbine Missiles, etc.	Long Term Core Cooling Success	Potential Severe Core Damage
-----------------------------	---------------	-----------------------------------	---	--	--------------------------------	------------------------------
