PRECURSOR DESCRIPTION AND DATA

NSIC Accession Number: 86990

Title: Loss of Incoming Power at Nine Mile Point from a Worker Bumpng a Relay

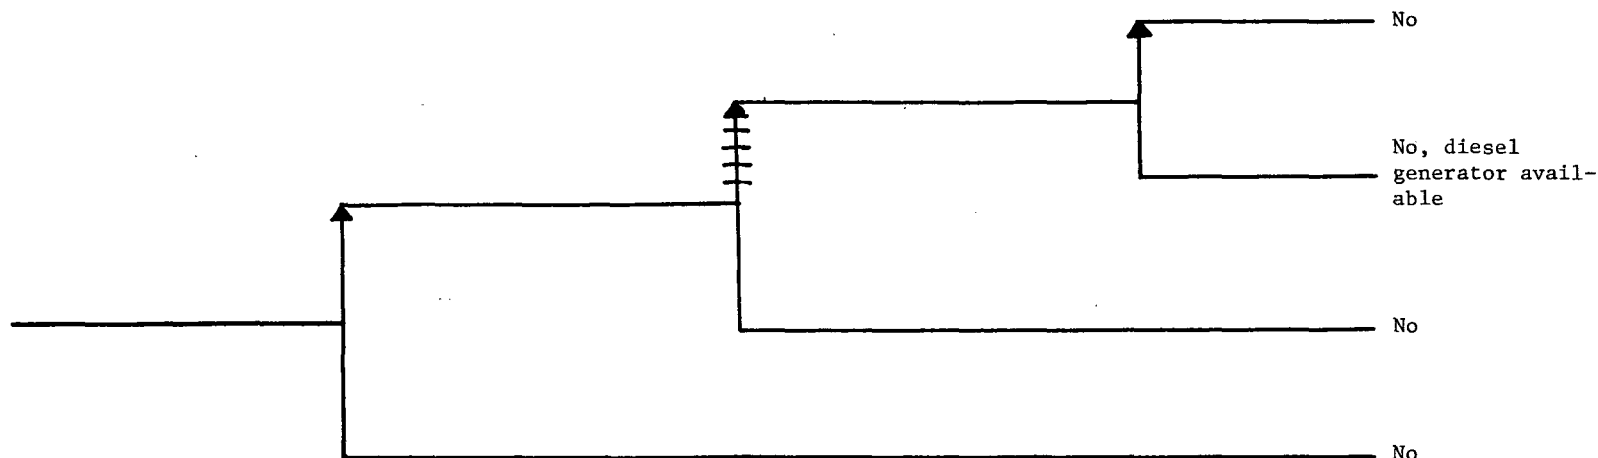
The Reactor Was Shutdown For AEC Operator Examination	The R40 Breaker Was Open To Facilitate Work On The 115 kv Line. Power Was Supplied Through The Remaining 115 kv Line	An Electrician Bumped A Relay Causing The Remaining 115 kv Line To Trip	The Breaker Was Reclosed And Power Was Restored Within 10 Sec	Potential Severe Core Damage
---	--	---	---	------------------------------

The R10 breaker was reclosed within 10 seconds.

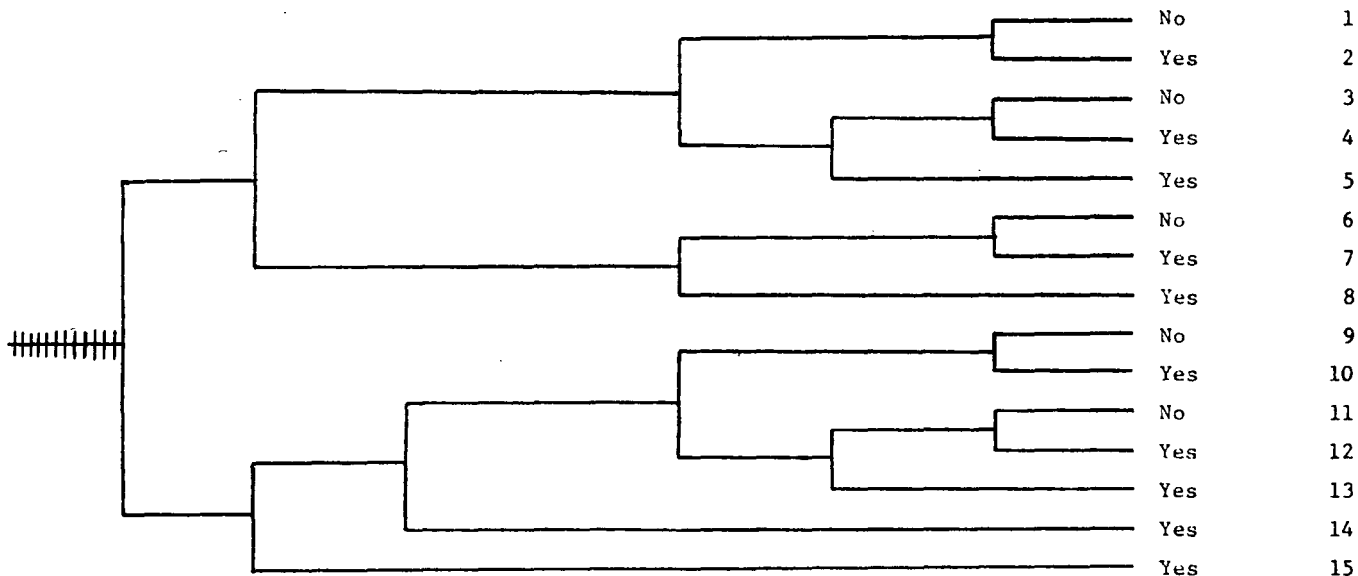
NSIC 86990 — Sequence of Interest of Loss of Incoming Power of Nine Mile Point from Worker Bumping Relay

Loss of Offsite Power	Reactor Scram	Diesel Start and Load	Reactor Made Sub- critical by the SBLCS Or Rods Are Manually Driven In	RCIC/HPCI Initiates	ADS/LPCI CS Initiates	Long Term Core Cooling	Potential Severe Core Damage	Sequence No.
-----------------------------	------------------	-----------------------------	---	------------------------	-----------------------------	---------------------------------	---------------------------------------	-----------------
