NSIC Accession Number: 77916

Date: December 29, 1972

Title: Several Valves Malfunction at Oyster Creek

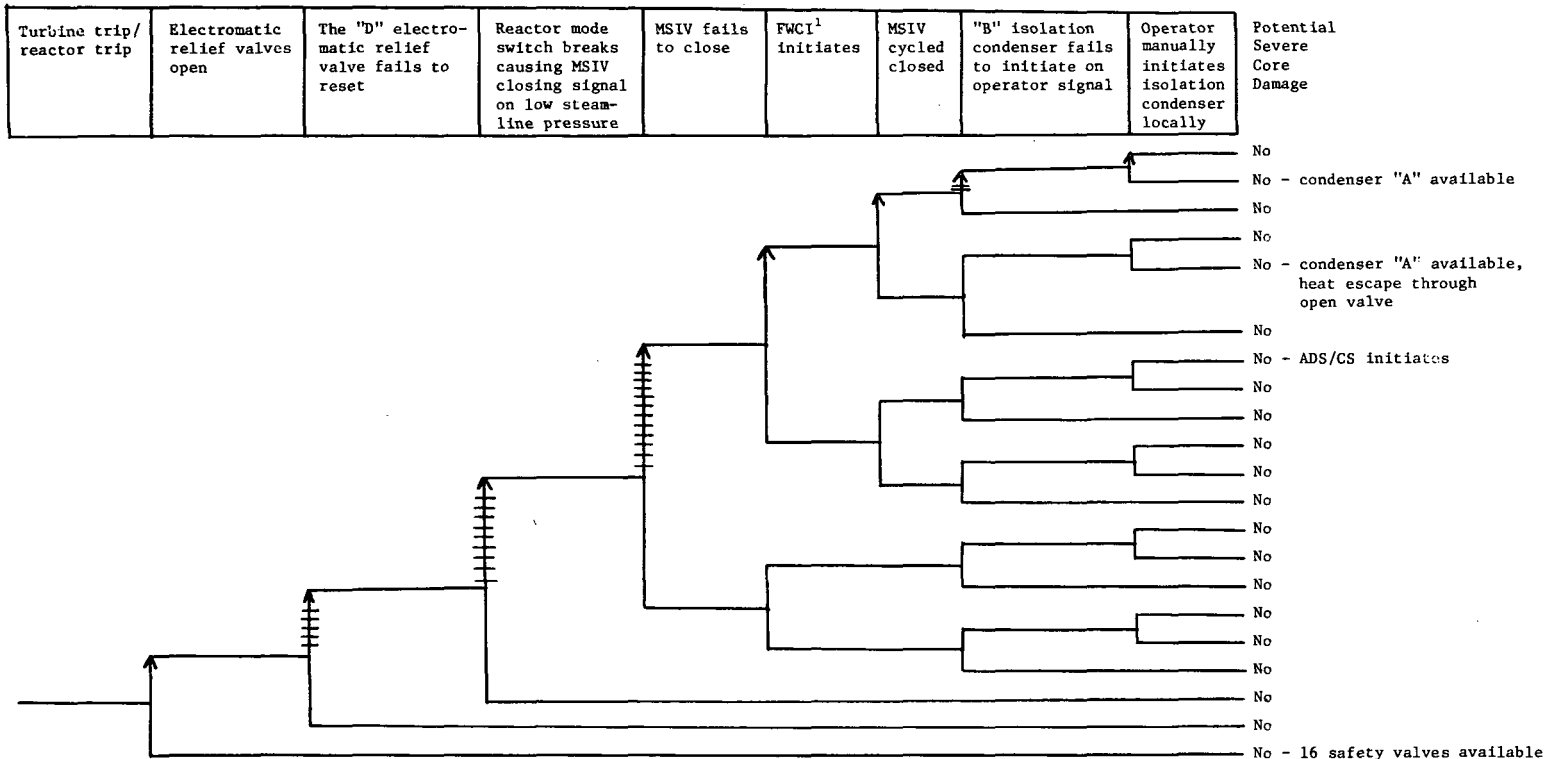
NSIC 77916 — Actual Occurrence of Several Valve Malfunctions at Oyster Creek

¹ FWCI system was presumed to operate.

² Only one MSIV failed, thus the core is isolated.

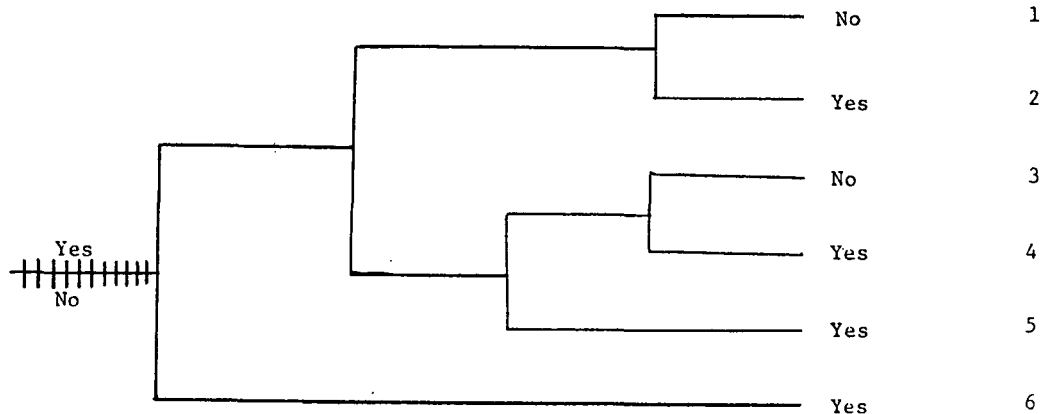
NSIC 77916 — Sequence of Interest for Several Valves Malfunctions at Oyster Creek
